# ROOF REPLACEMENT CONSIDERATIONS and PROJECT MANAGEMENT

SCCA Meeting – February 19, 2022

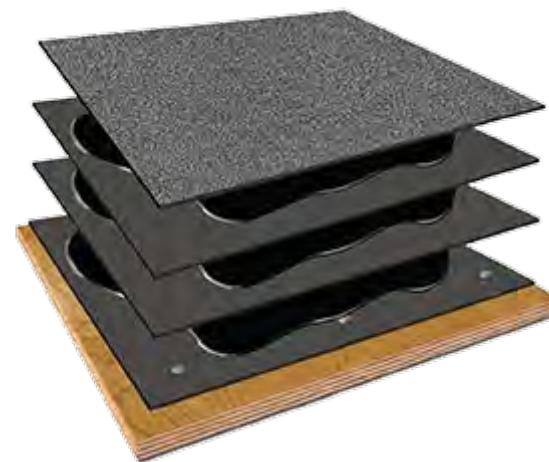
# Built-Up Roofing (BUR)

Oxidized Asphalt or Coal Tar

Alternating plies of reinforcement

- Rag, paper, asbestos
- Fiberglass

Typically 3-5 plies of felts installed

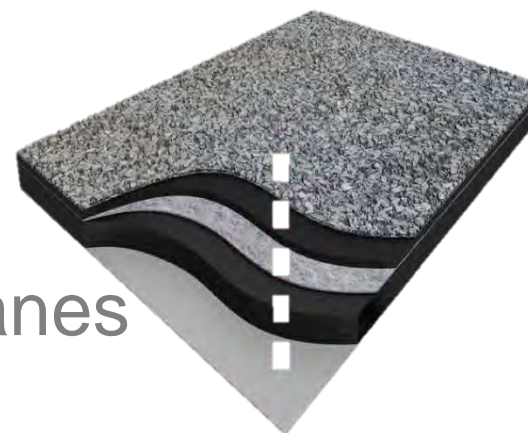
## Modified Bitumen (SBS & APP) Enters The Market (1970's)

- Modifiers added to asphalt to improve performance
- Reinforced membranes - Polyester, fiberglass, composite
- Factory controlled, watertight membranes
- Typical multi-ply system > 200 mils

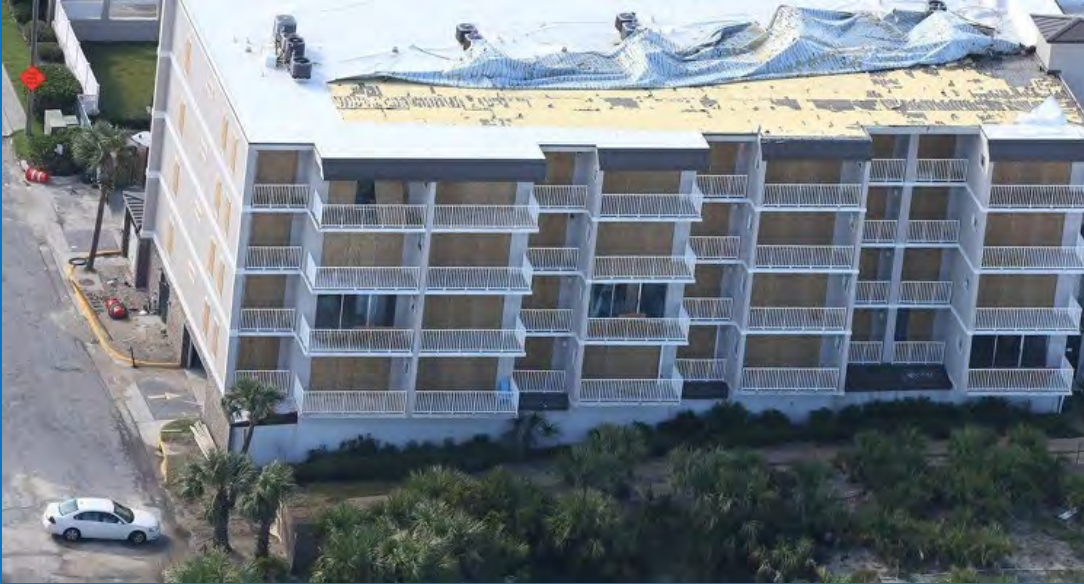
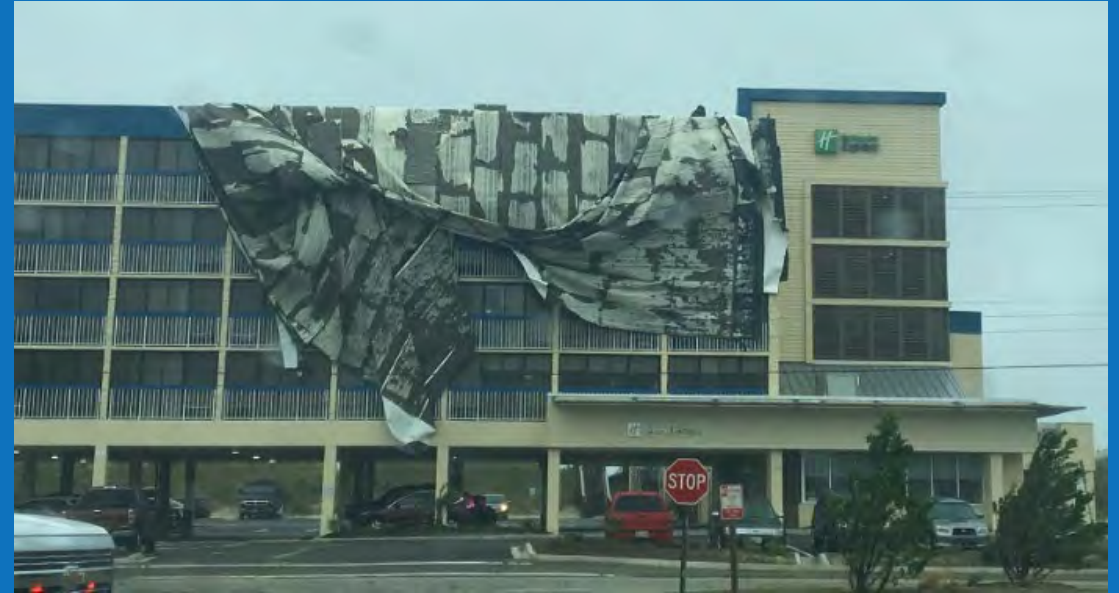
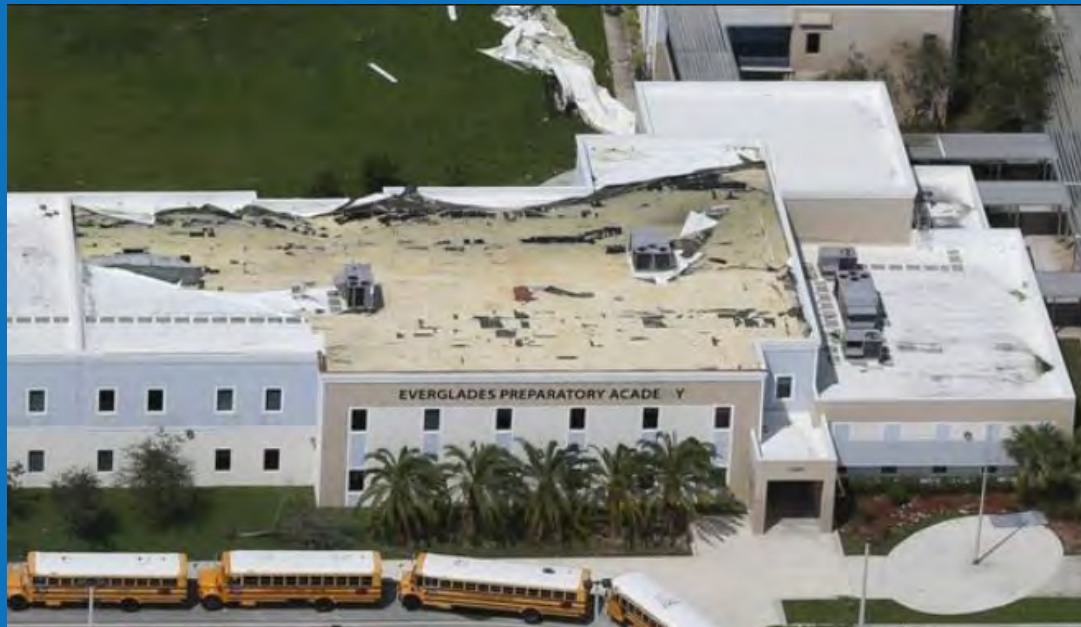
## Wind resistance:

Lightweight, flexible single-ply membranes are more susceptible to large-scale wind damage.

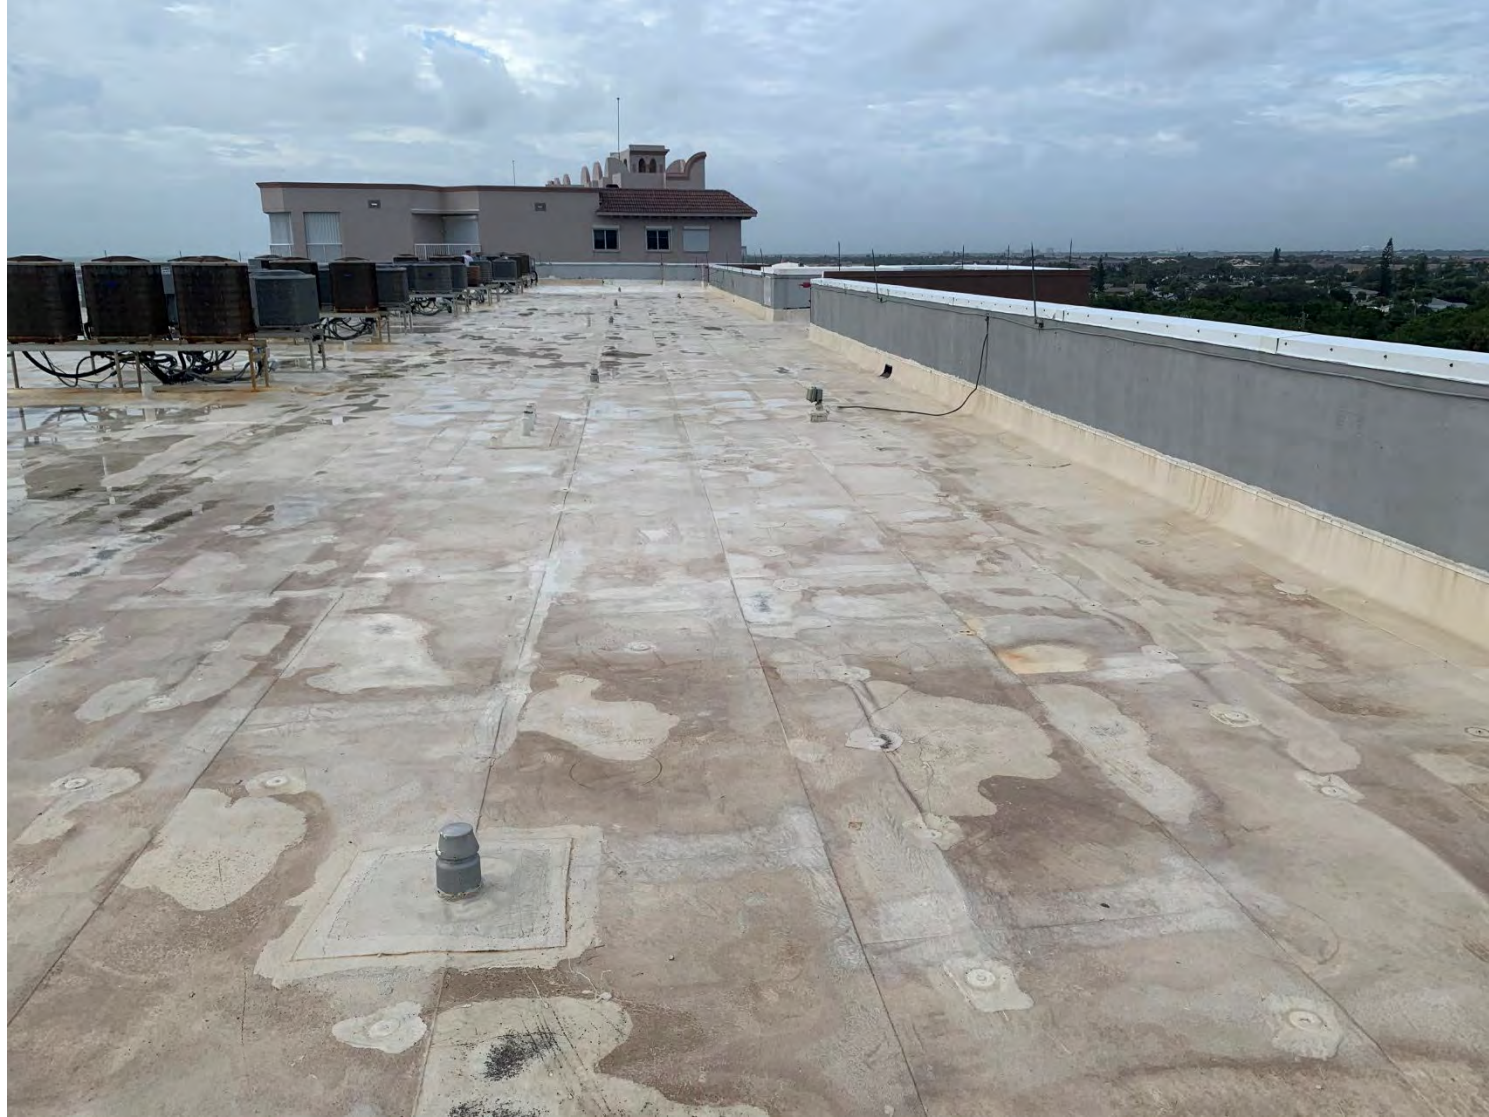
# The “Cost” of Doing it on Your Own

- Failed project photos

- *No paper trail*
- *The board didn't even know who hired this contractor*
- *Board members no longer there*
- *Permit pulled after the roof was installed*
- *No oversight during installation*
- *No warranty issued*
- *Not a Florida Building Code approved assembly*
- *Major negligence and malfeasance*
- *Lawsuit*

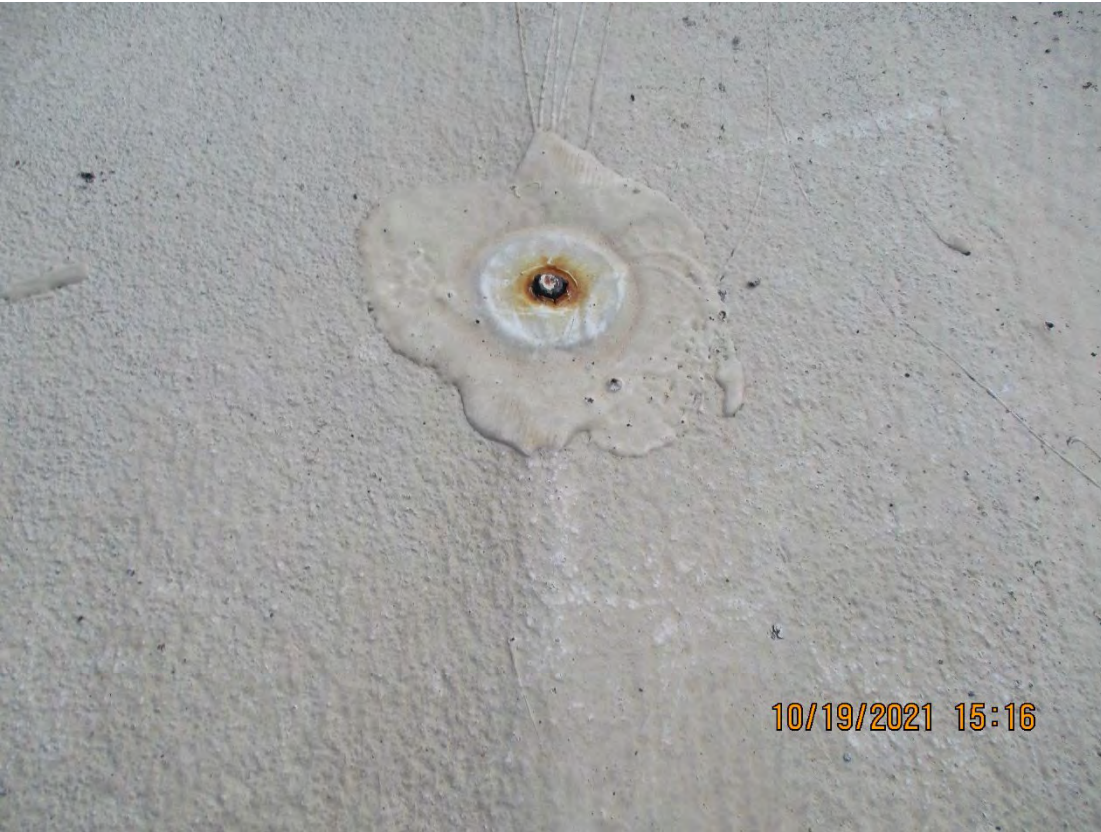
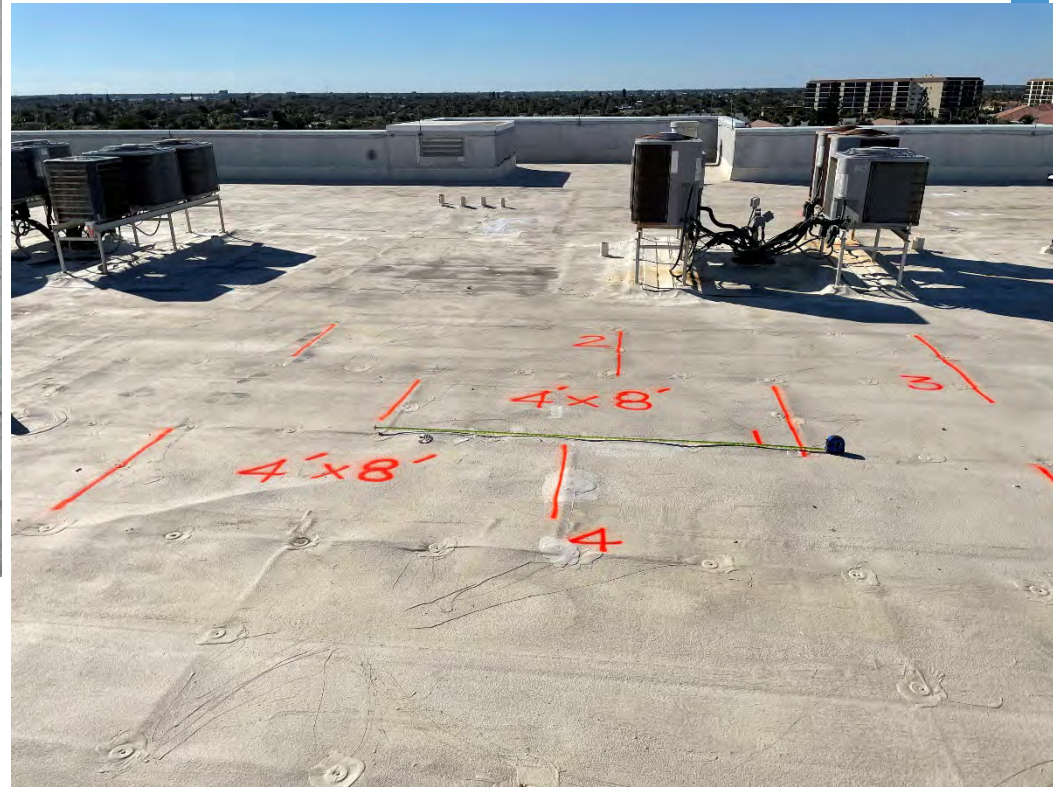
# The “Cost” of Doing it on Your Own

- Failed project photos

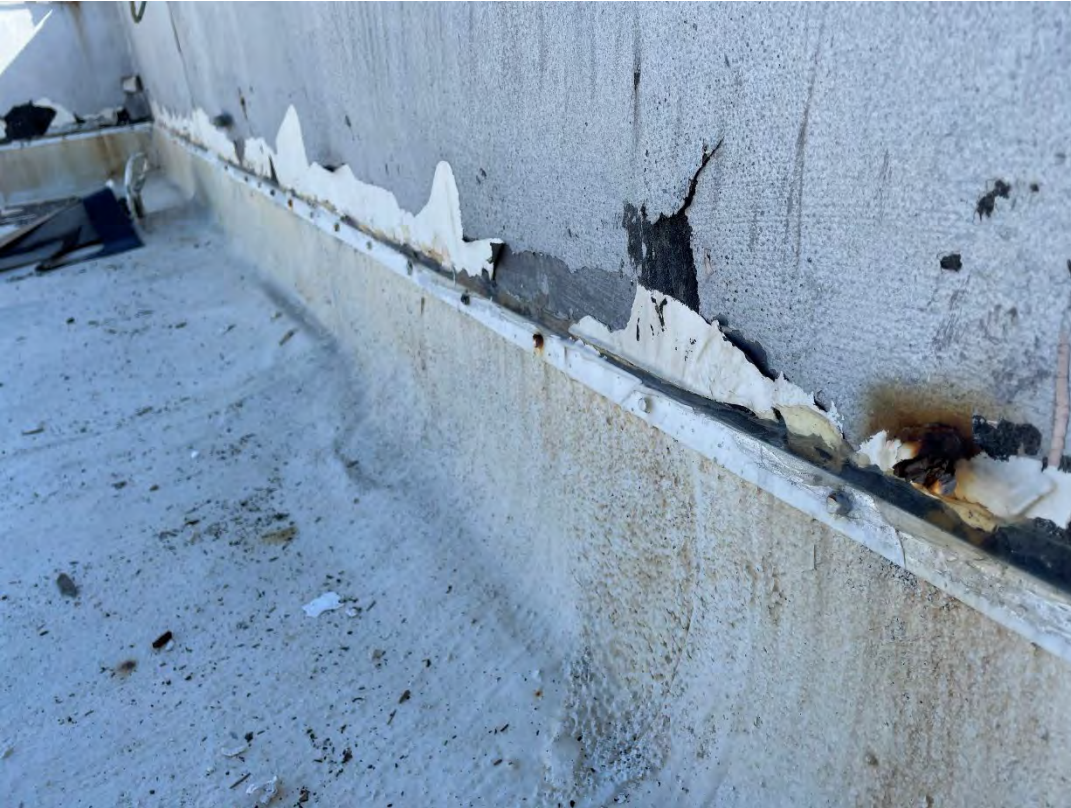
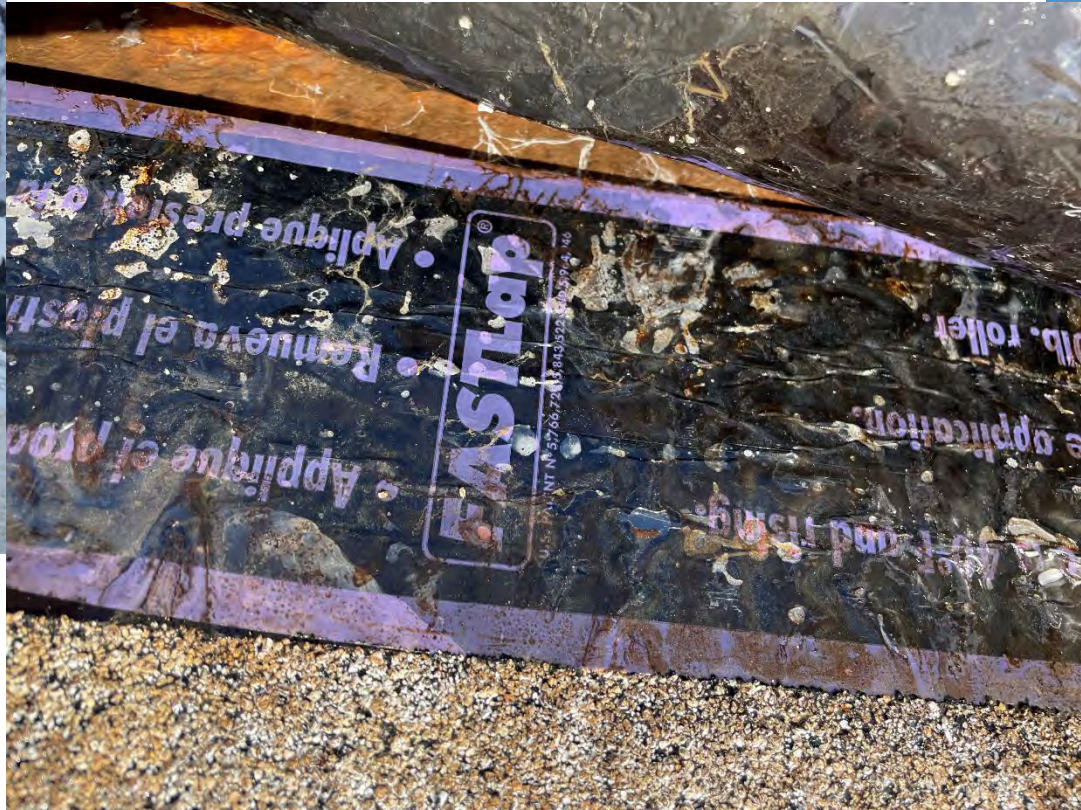
# The “Cost” of Doing it on Your Own

- Failed project photos

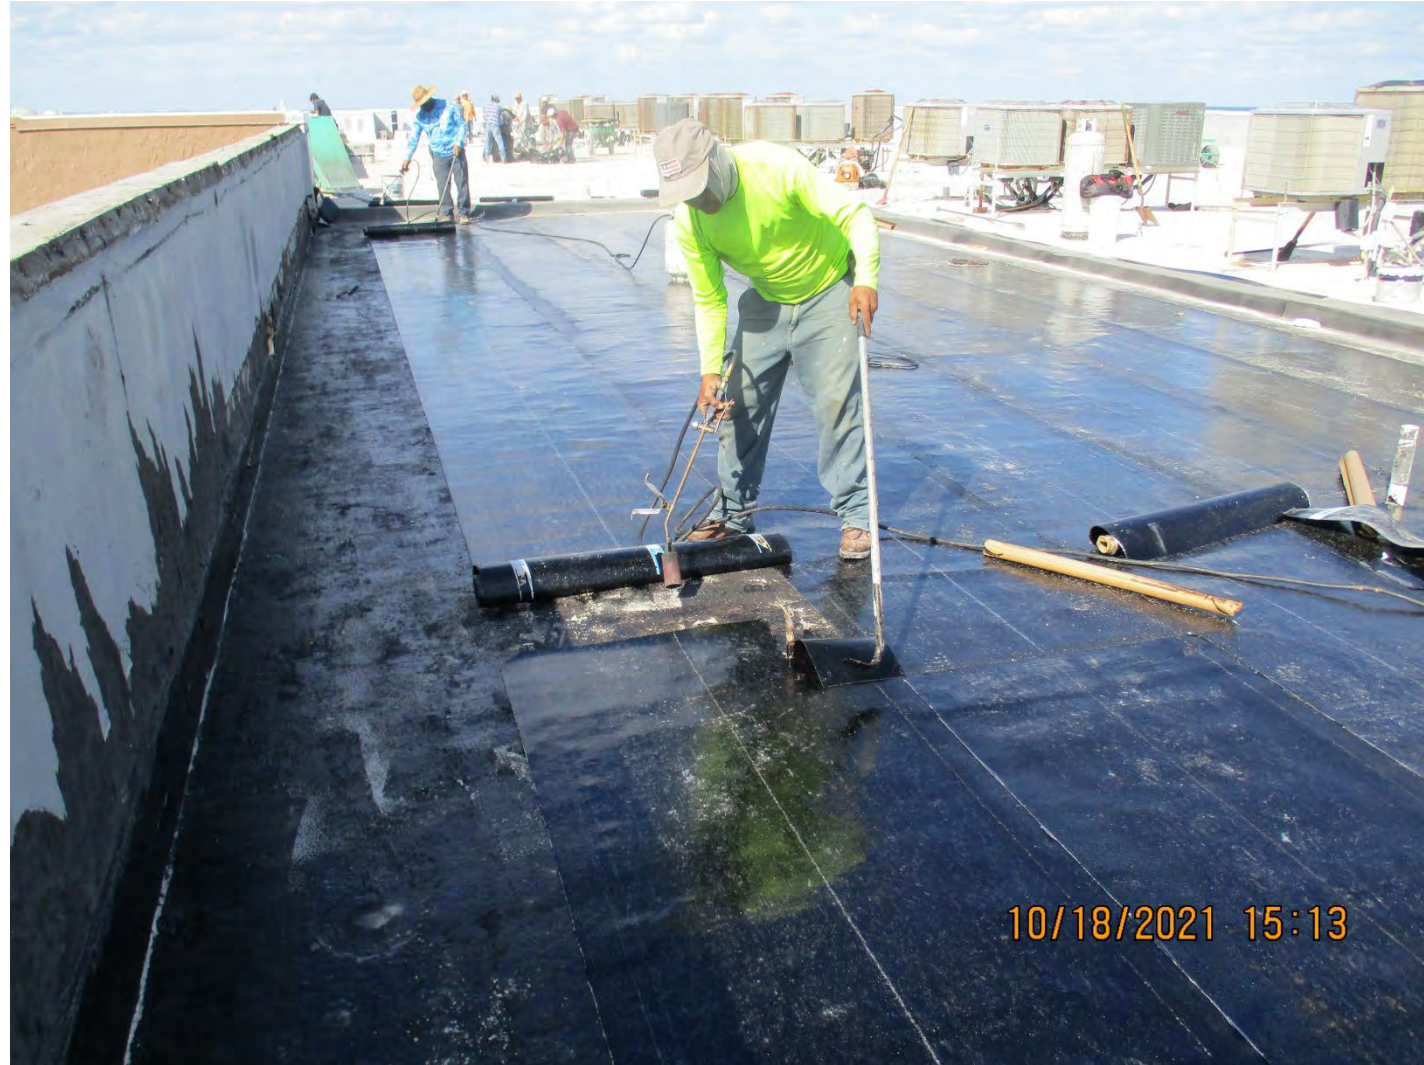
**VAPOR  
BARRIER  
INSTALLATION**

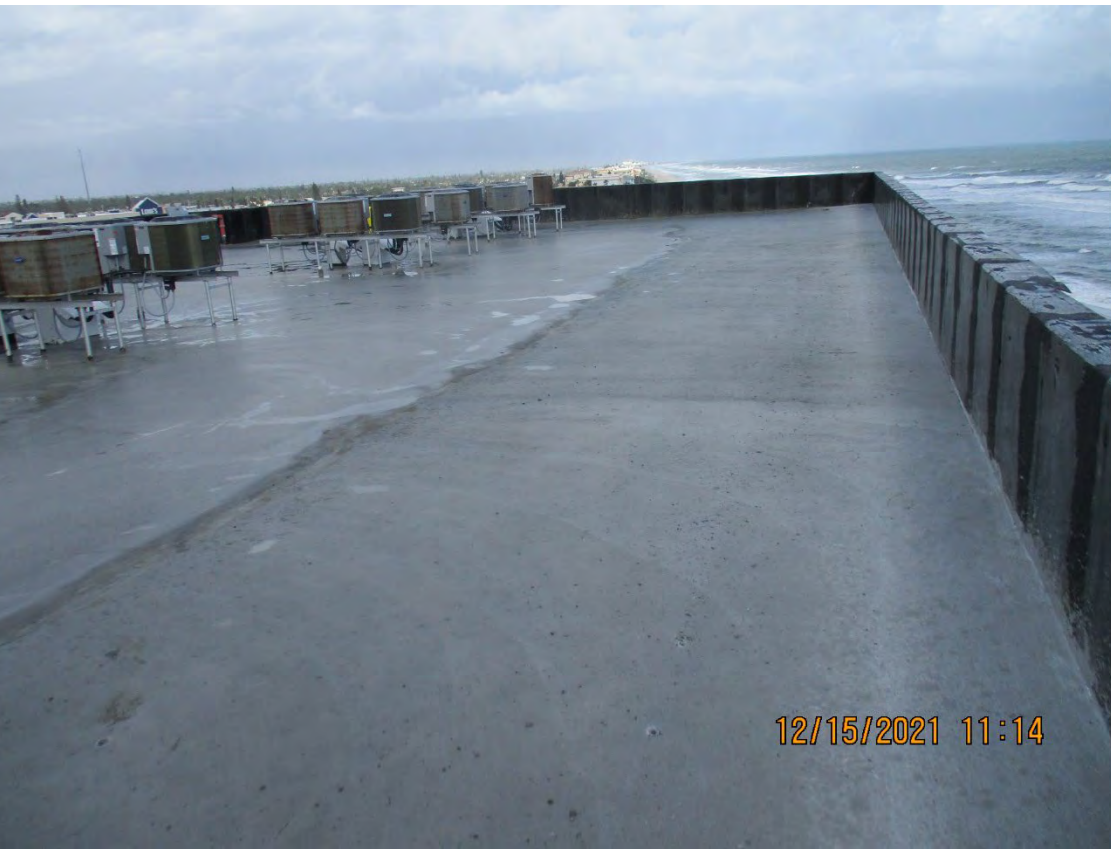
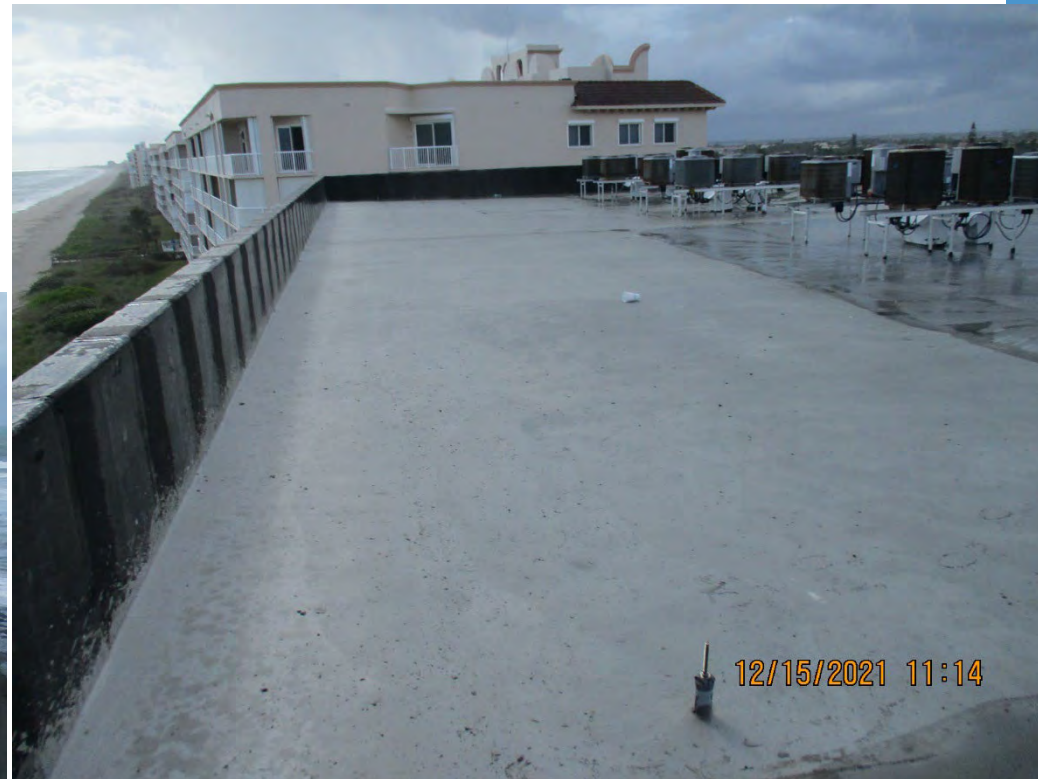
LIGHTWEIGHT  
CONCRETE  
INSTALLATION

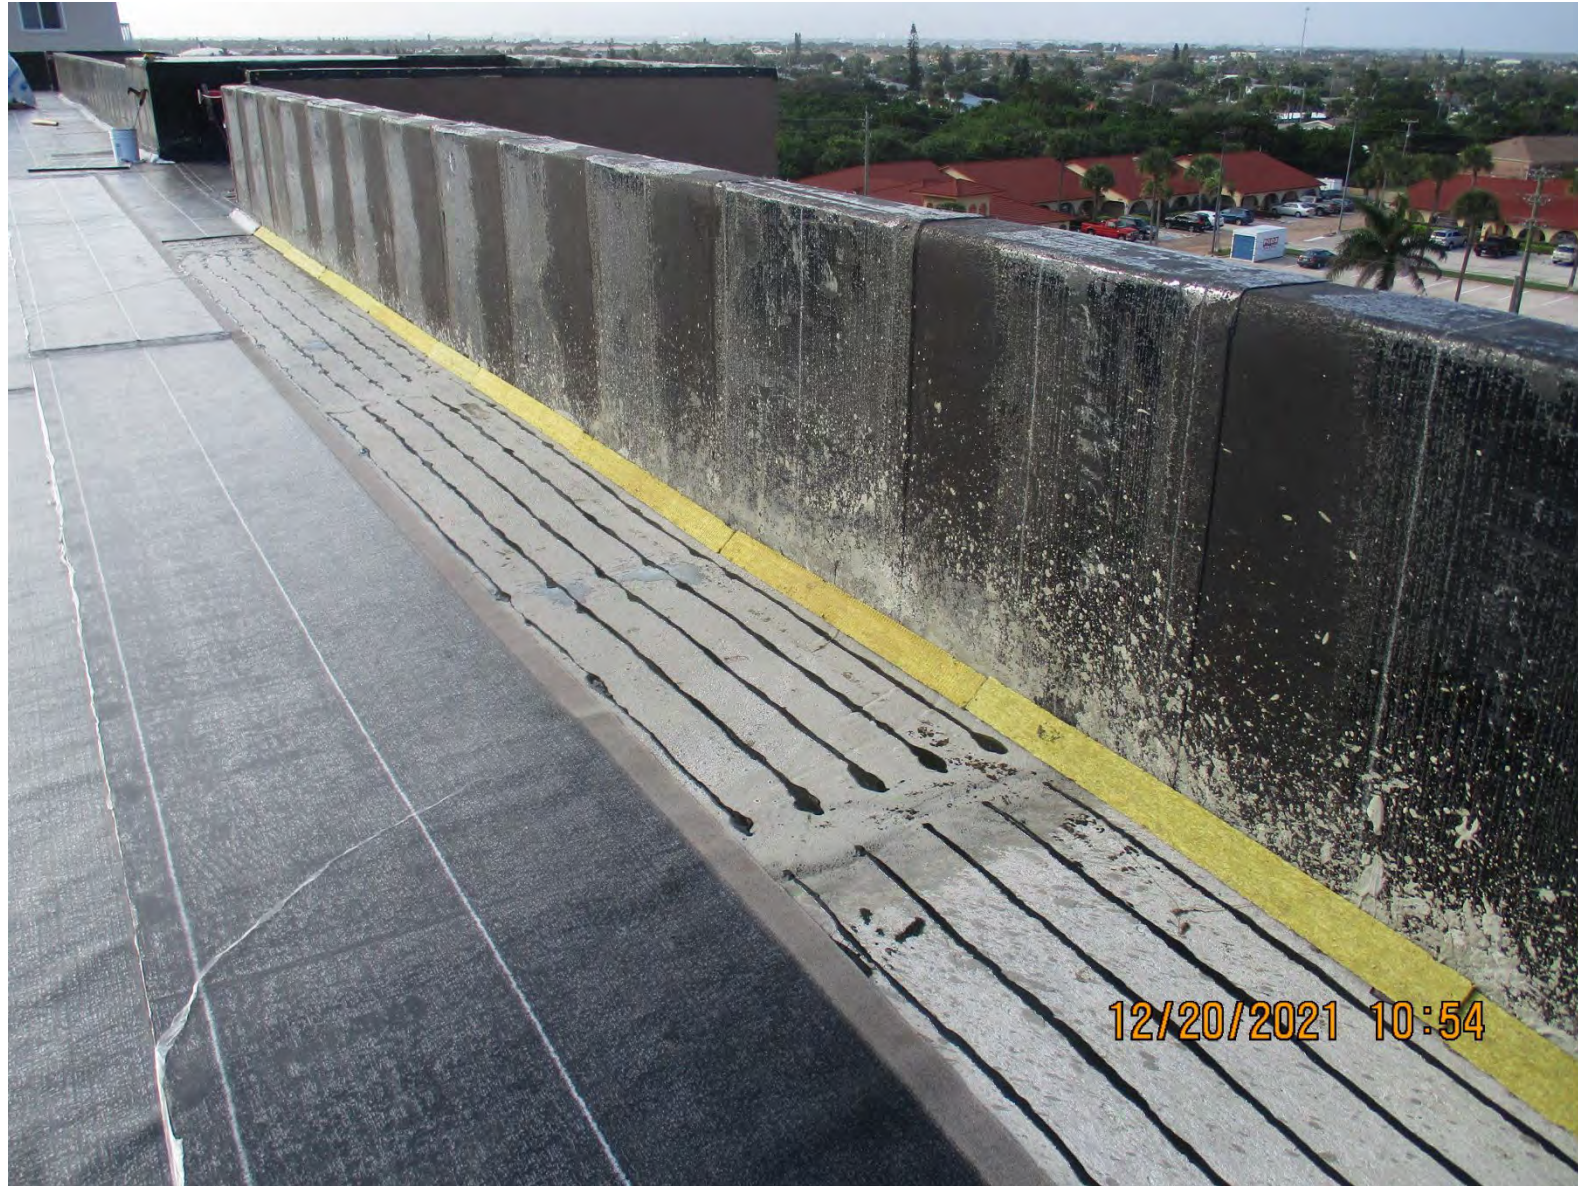
**RIBBON  
ADHERED  
BASE PLY**

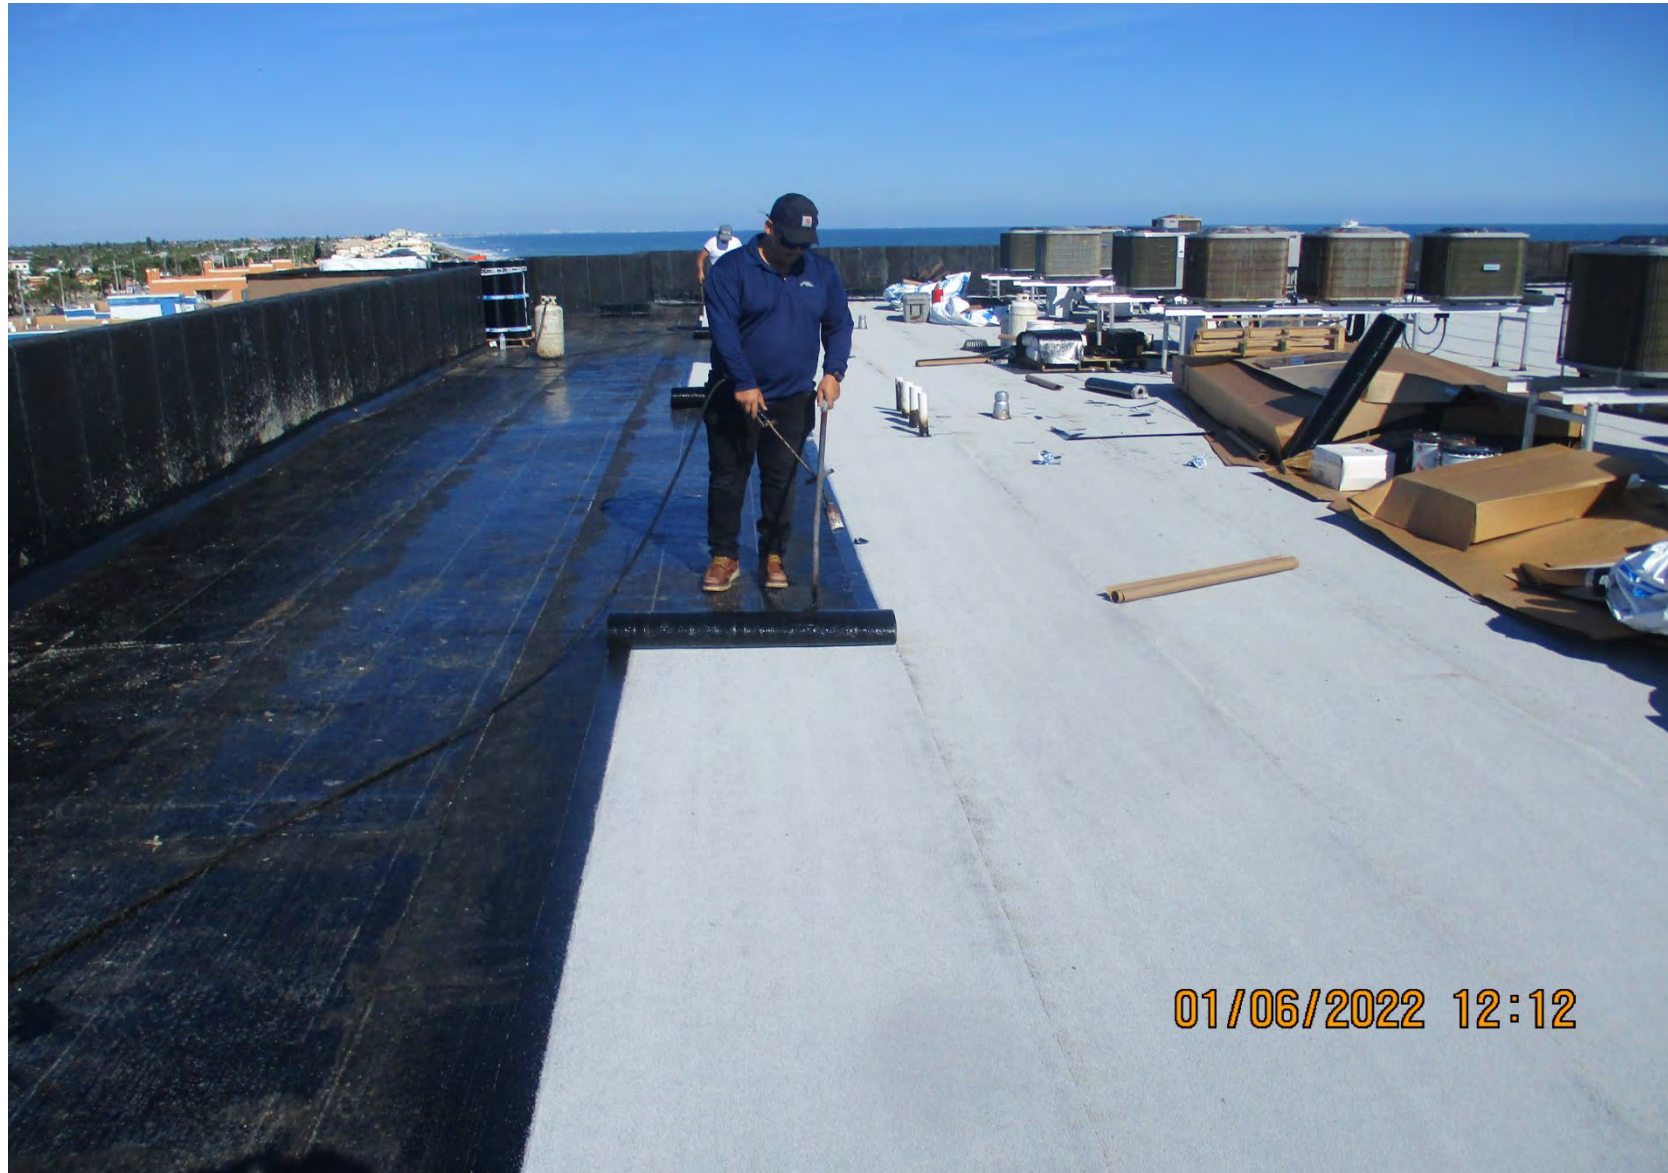
**TORCH  
APPLIED  
CAP PLY**

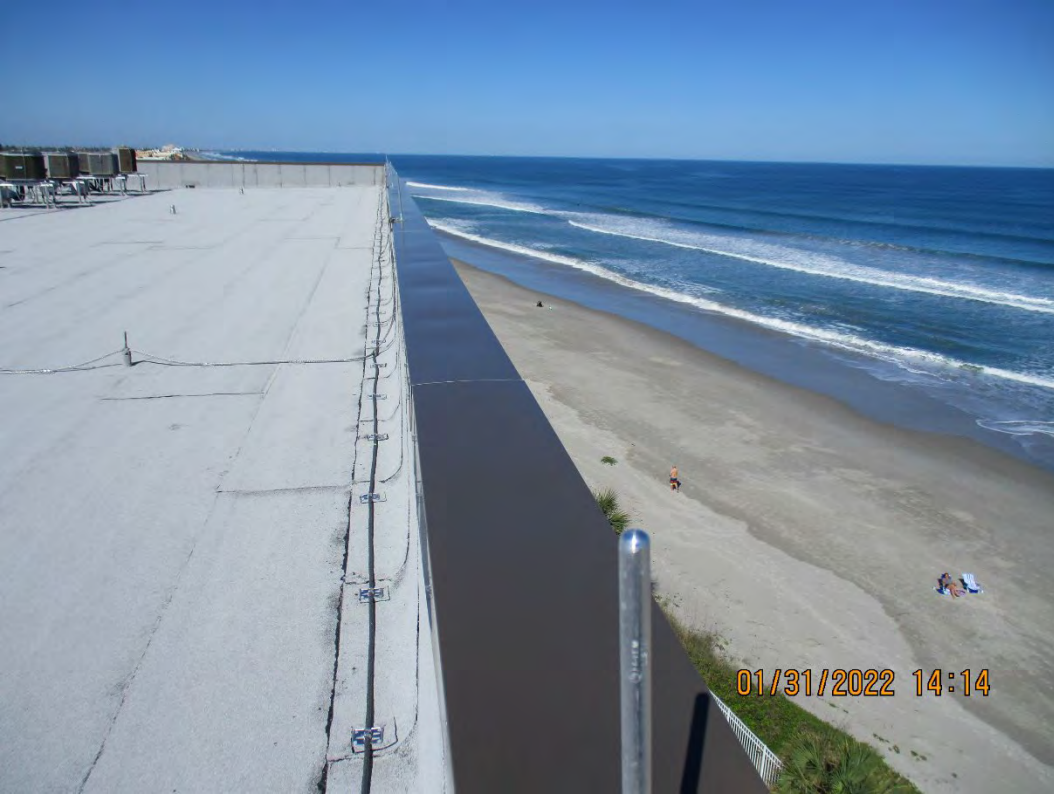
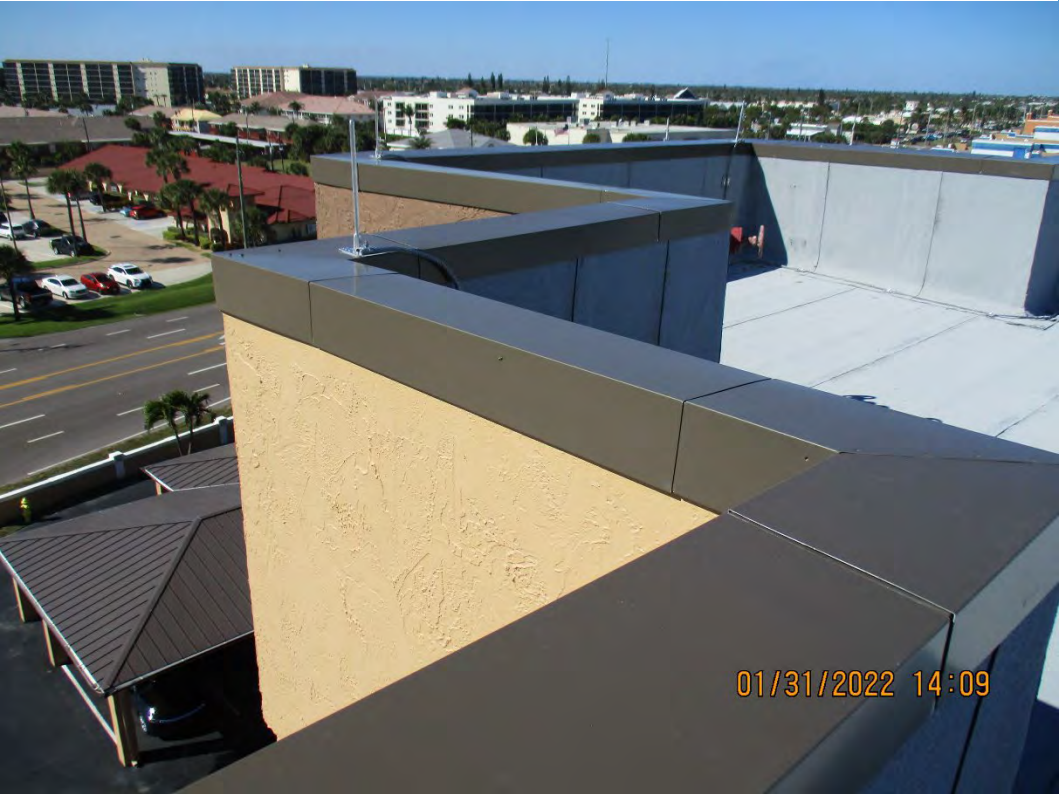
**PREMANUFACTURED  
EDGE  
SYSTEM**

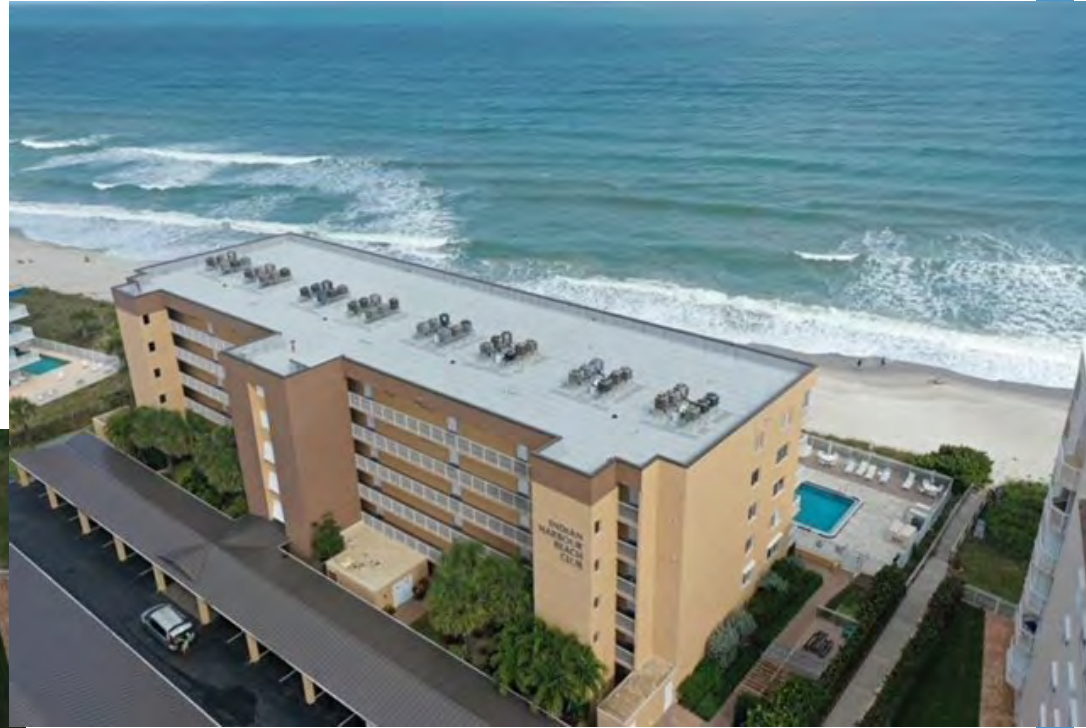
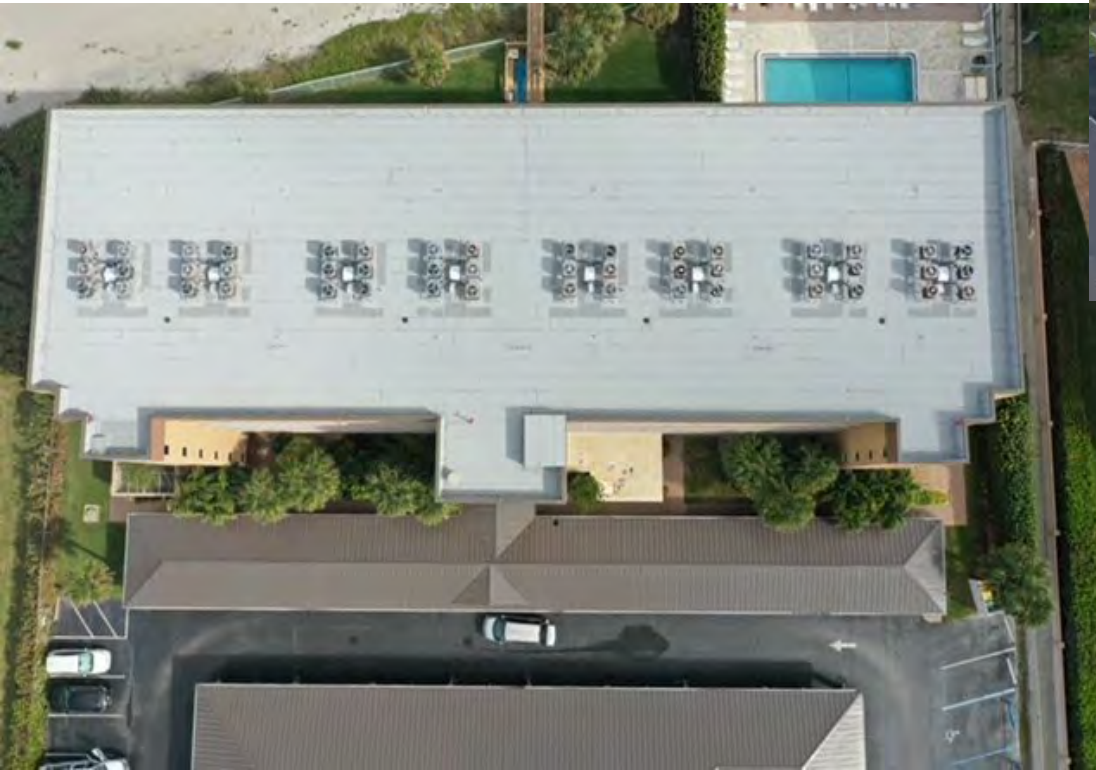
**NEW, 20 YEAR ND**

**SOPREMA SBS 2 PLY**

**“RESILIENT” ROOF SYSTEM**

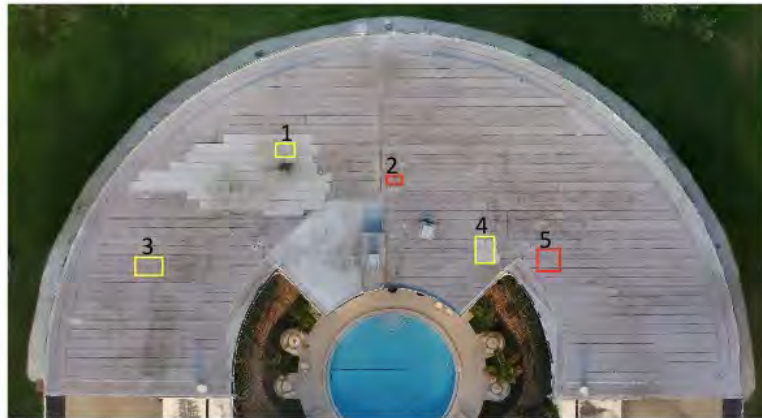
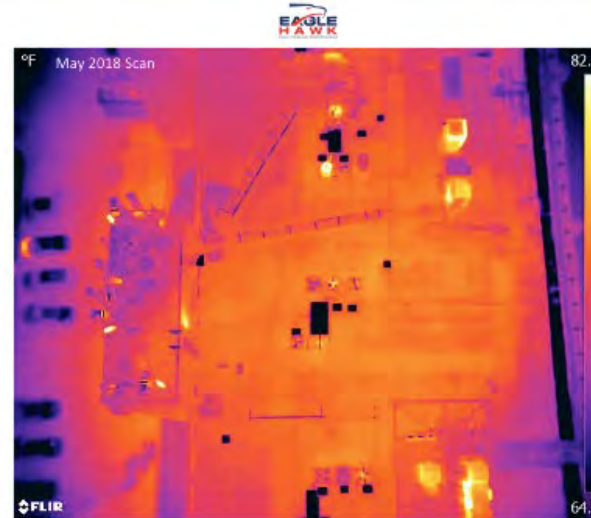
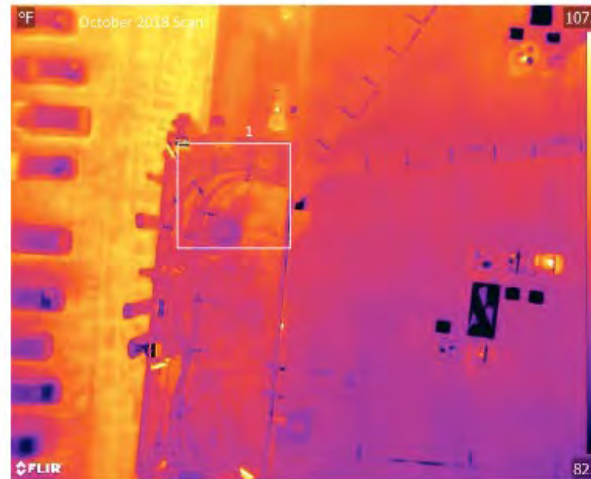
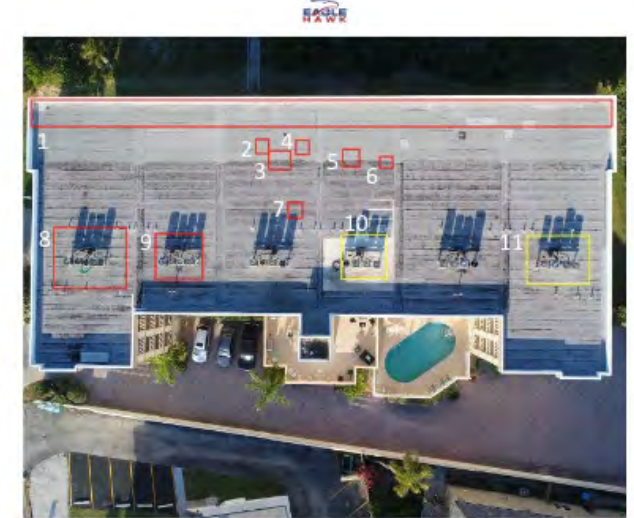
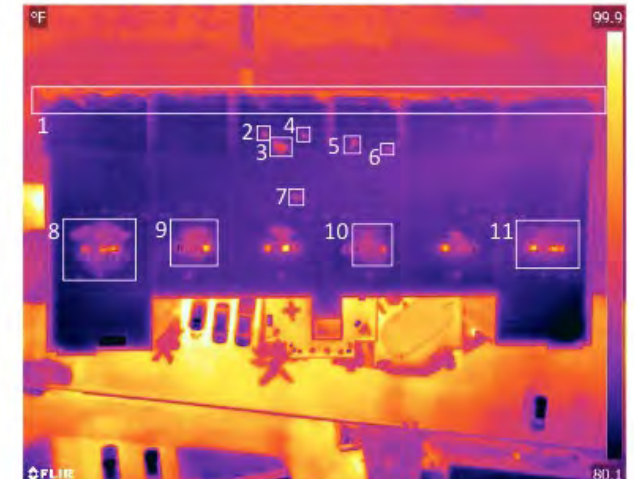
Area #	Approximate Size (sqft)	Description
1	40	This area shows evidence of wetness in the insulation propagating from a material failure.
2	10	This area shows evidence of wetness in the insulation propagating from a material seam failure
3	10	This area shows evidence of wetness in the insulation propagating from a material failure.
4	50	This area shows evidence of wetness in the insulation propagating from a material failure.
5	20	This area shows evidence of wetness in the insulation propagating from a material failure.
<b>Total</b>	<b>130</b>

*Looking for “trends” and collecting data frequently ensures savings* 42
