SCCA Meeting 11-20-2021
**“The Importance of
Proactive Structural
Condominium Maintenance”**

Keystone Engineering
Jim Emory, PE, SI, CGC

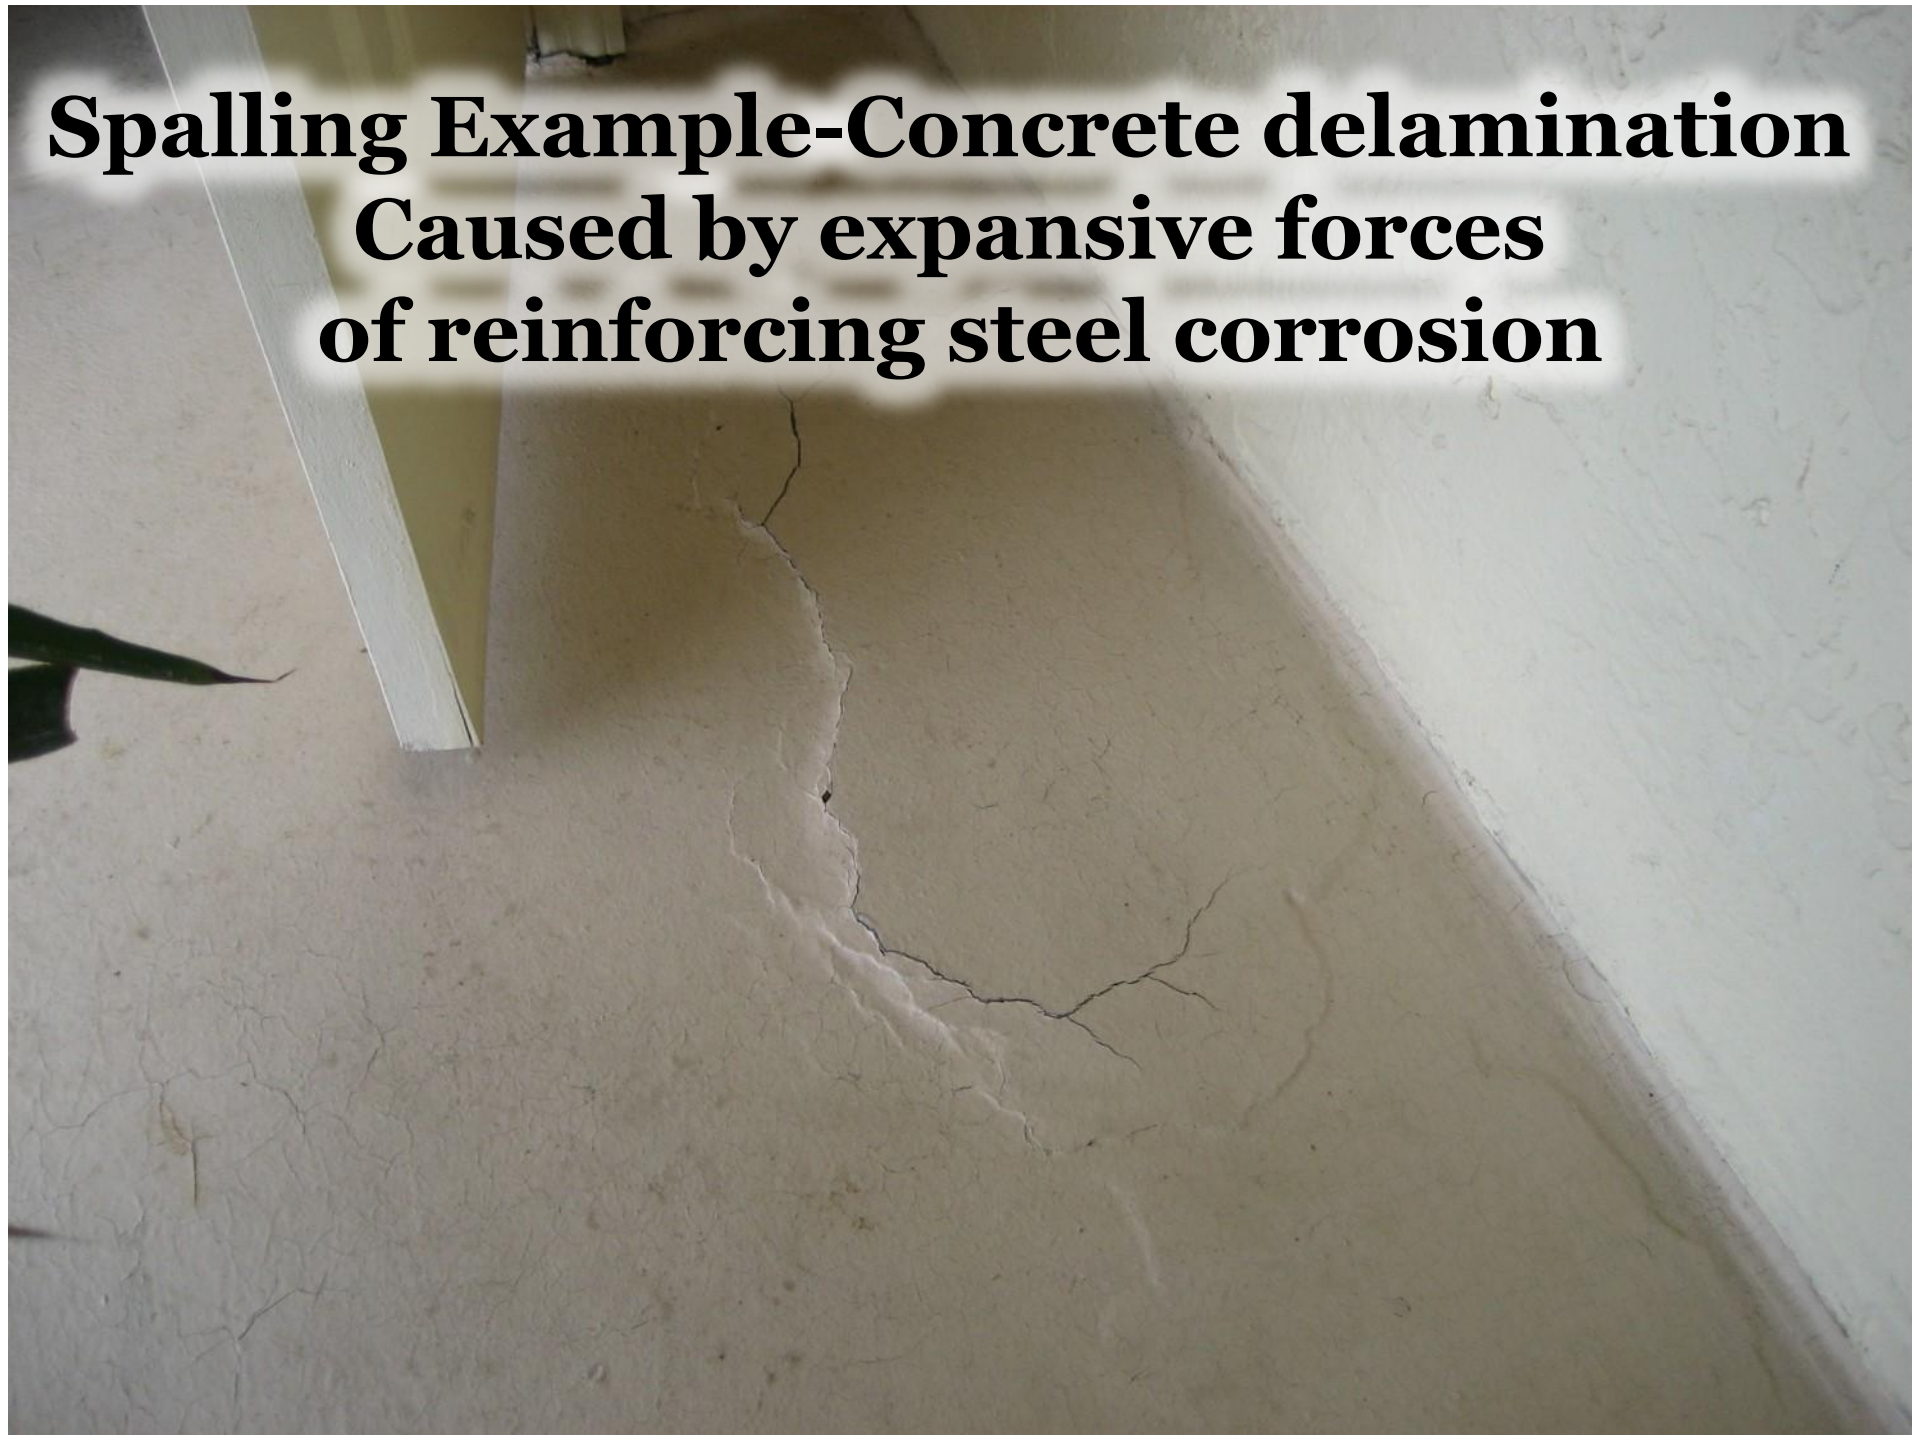
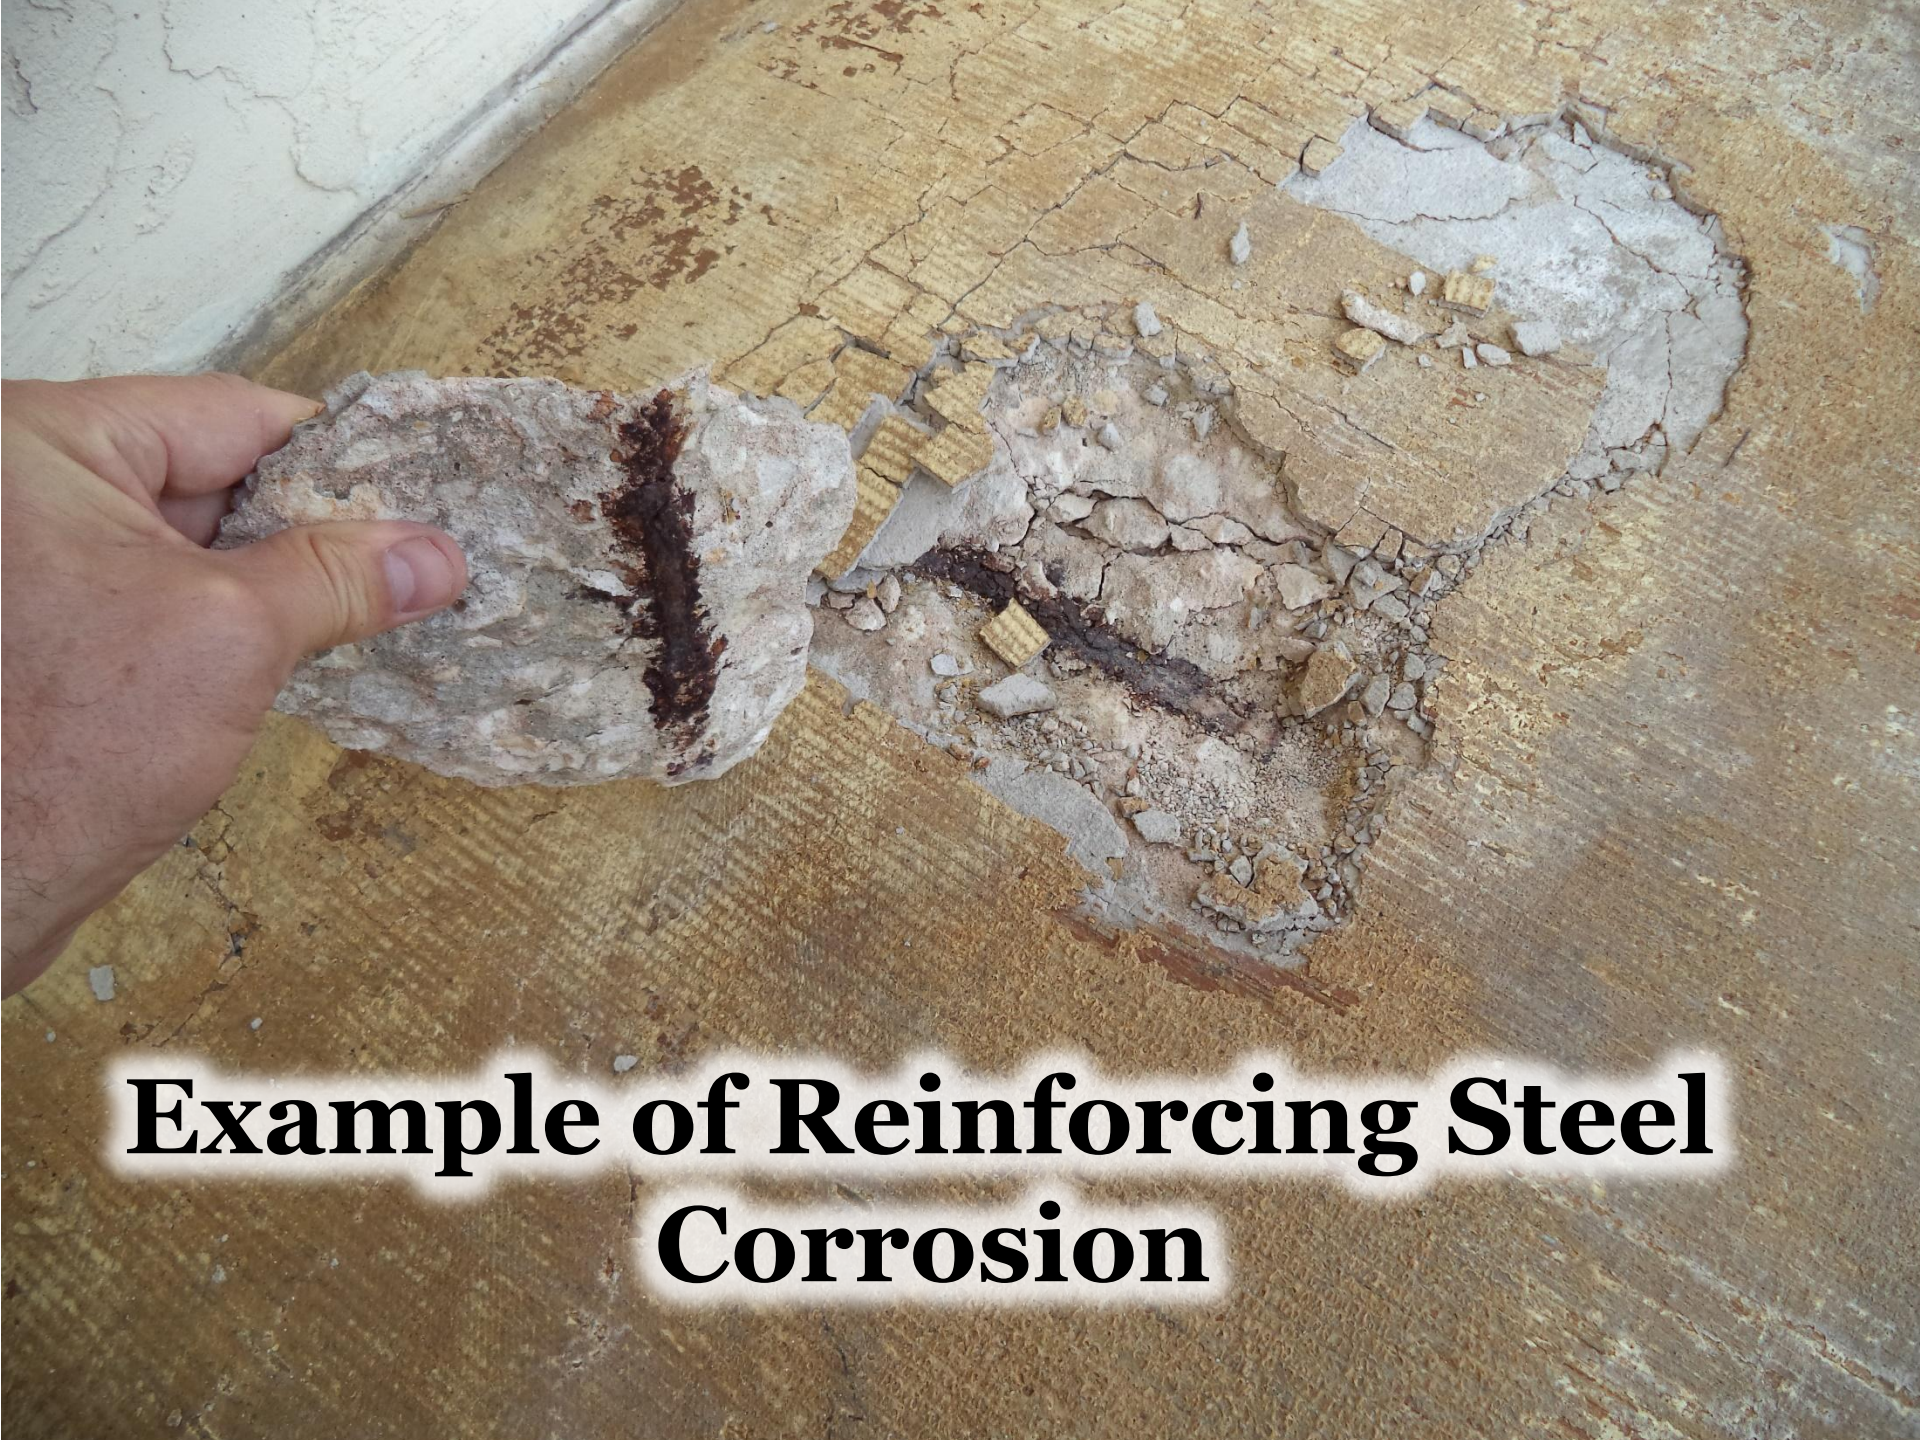
**Spalling Example-Concrete delamination
Caused by expansive forces
of reinforcing steel corrosion**

**Example of Reinforcing Steel
Corrosion**

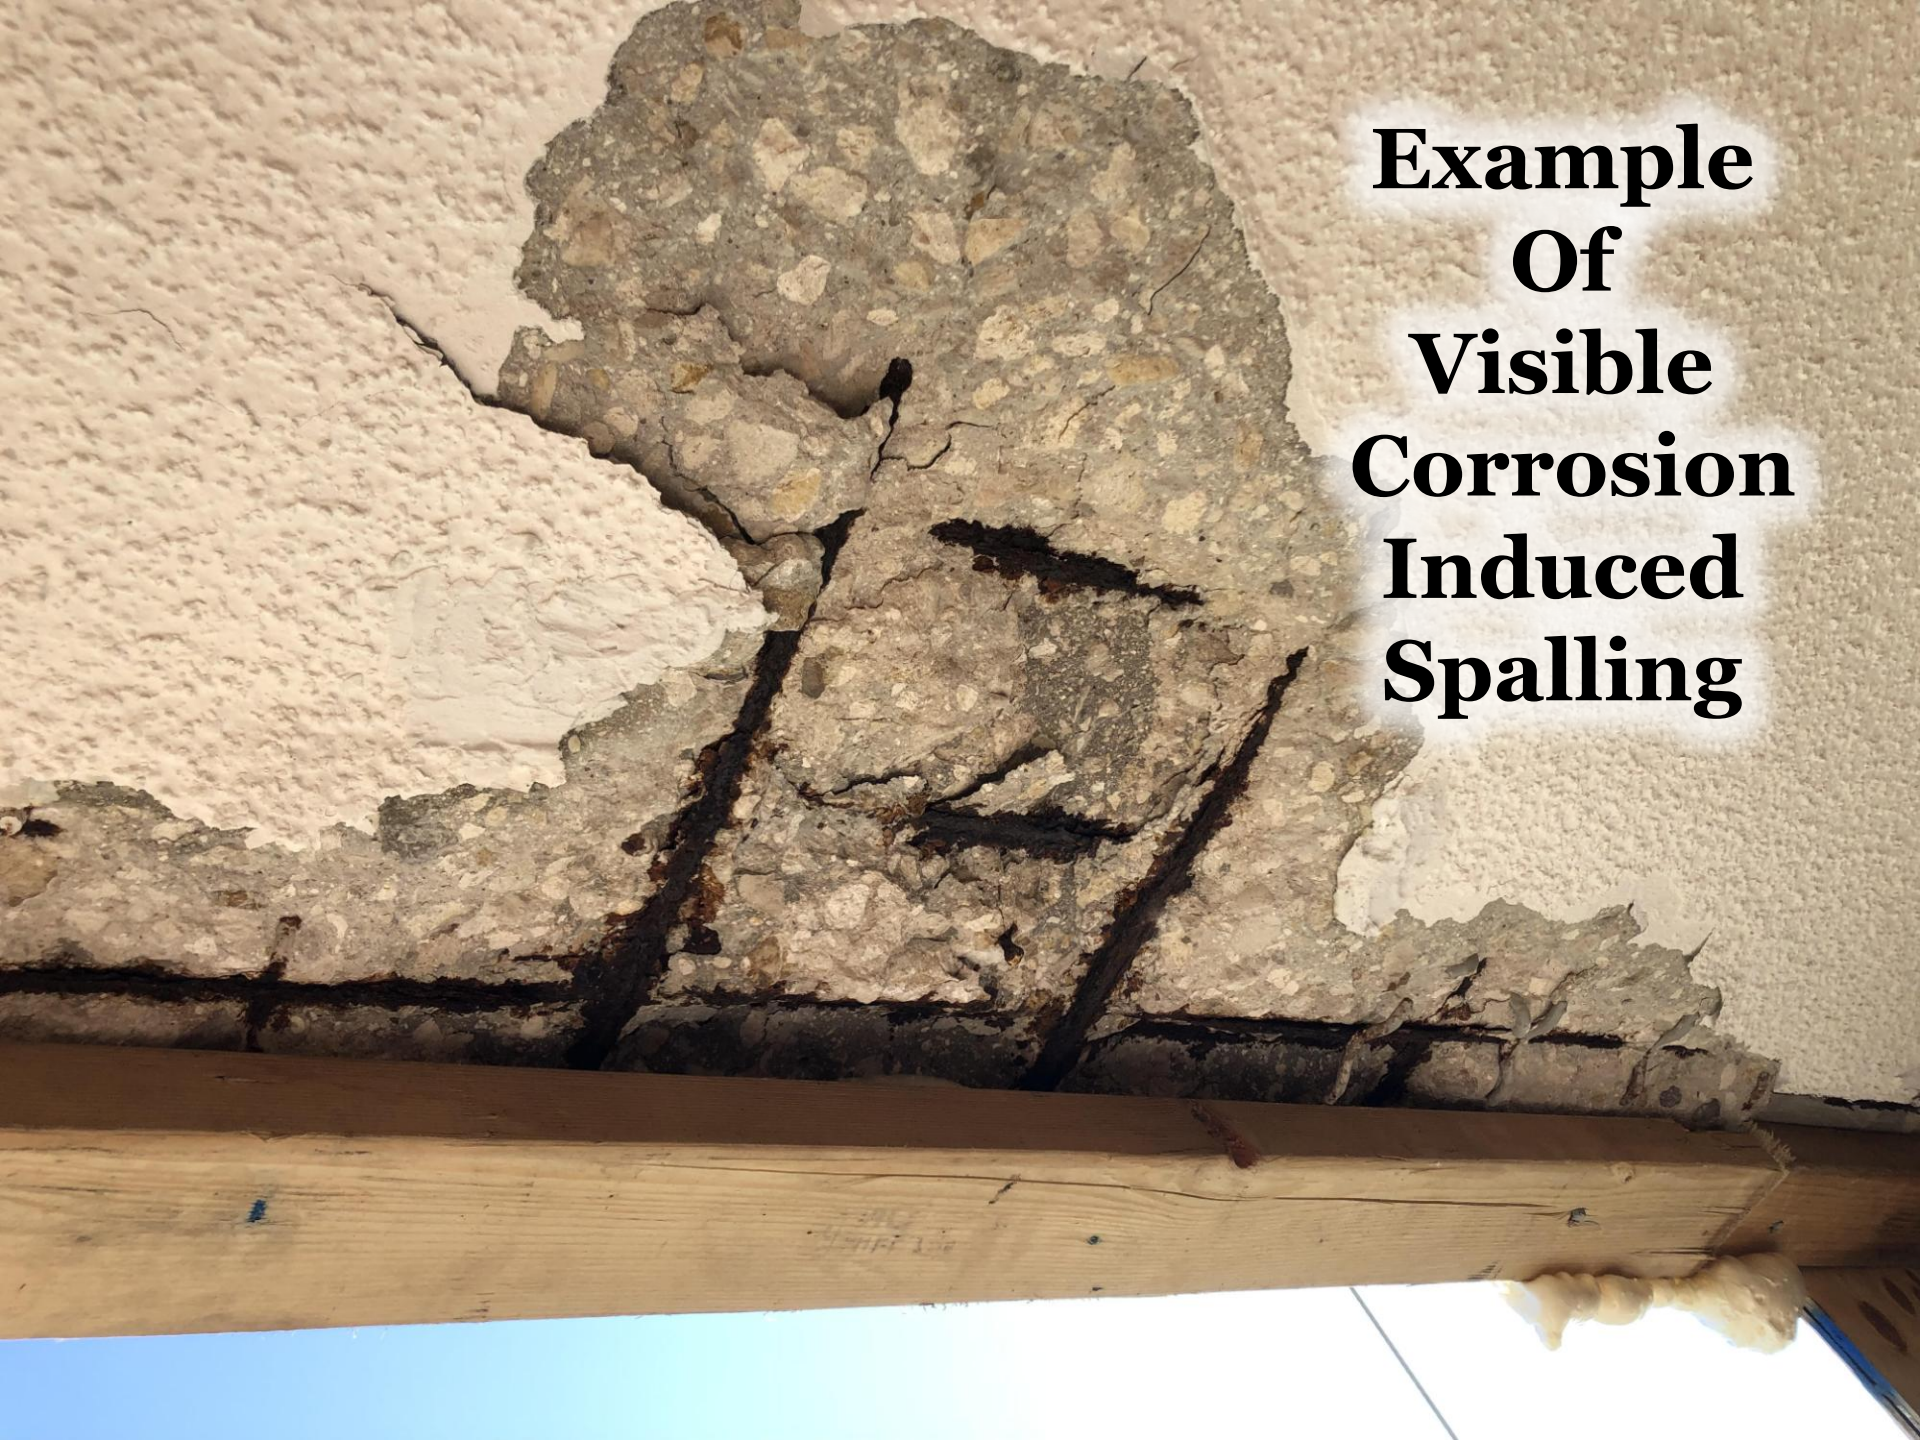
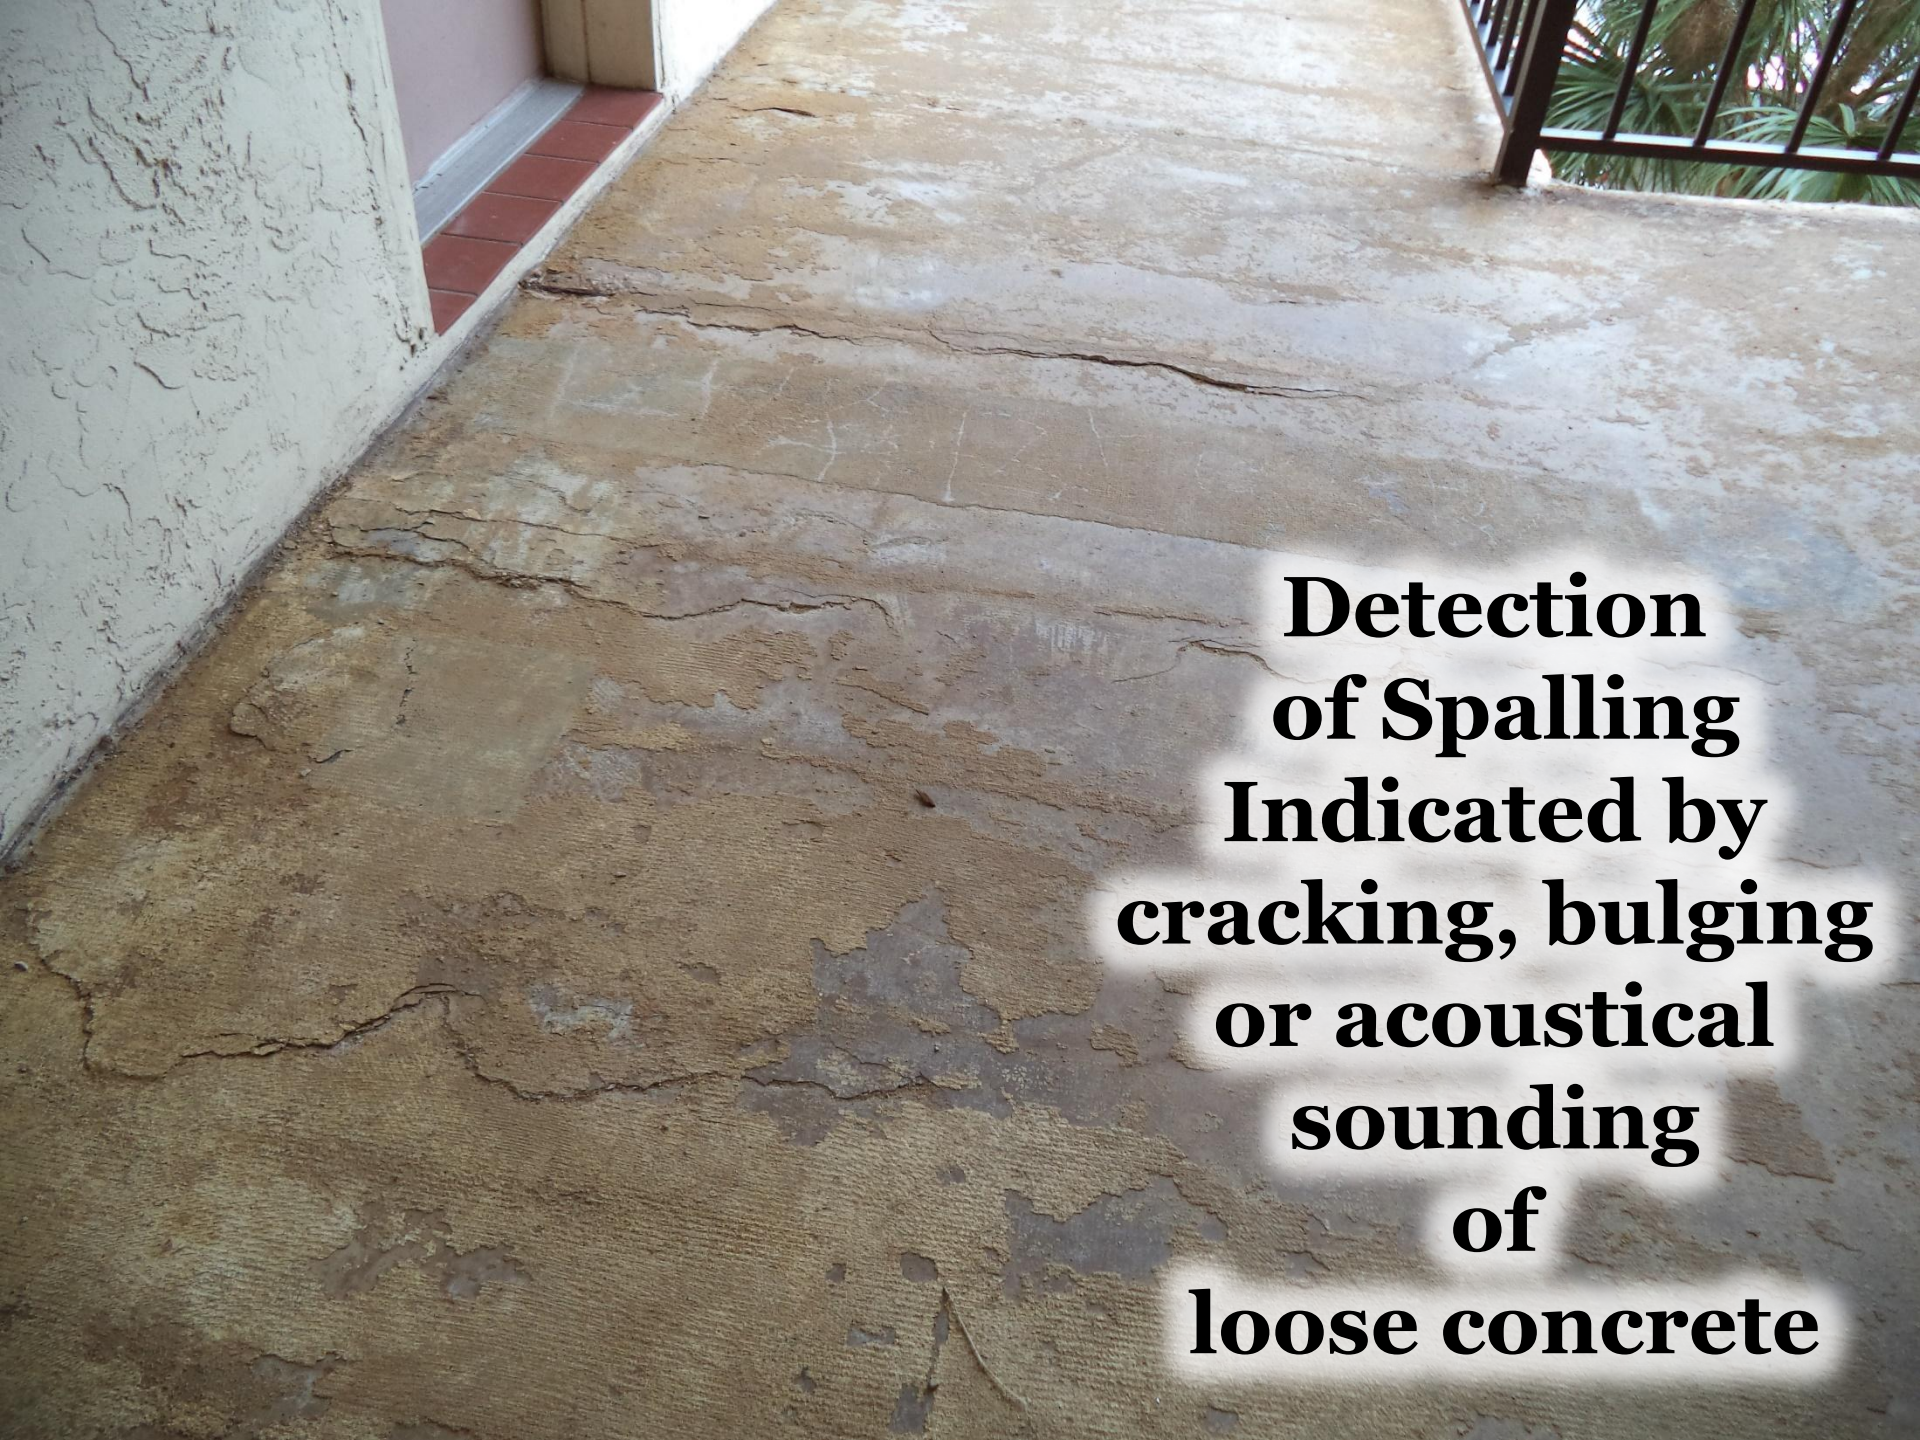
**Example
Of
Visible
Corrosion
Induced
Spalling**

**Detection
of Spalling
Indicated by
cracking, bulging
or acoustical
sounding
of
loose concrete**

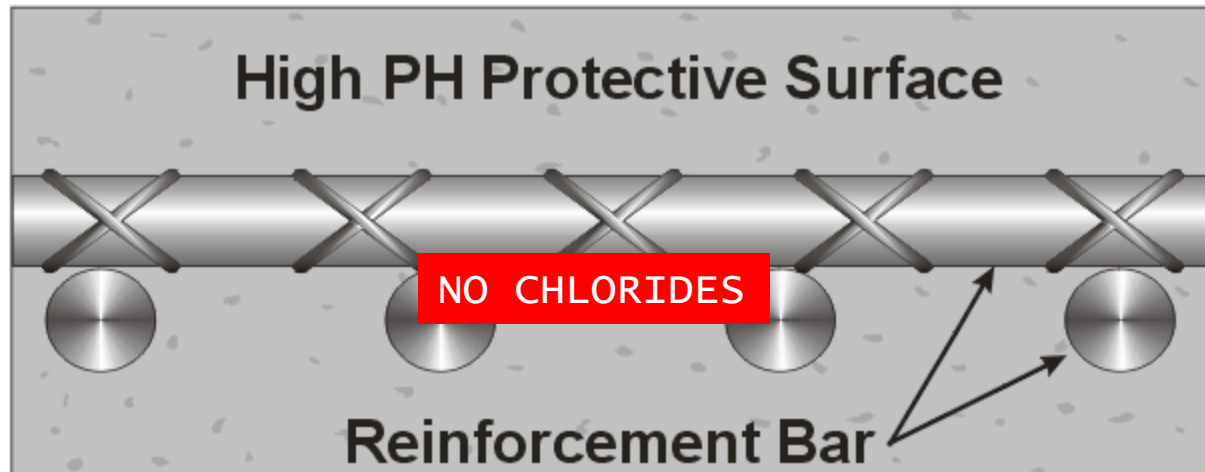
New Concrete Slab

Reinforcing Steel Corrosion

- ▣ Caused by chloride (salt) contamination
- ▣ Changes concrete chemistry
- ▣ Creates corrosive environment
- ▣ Sources of water intrusion provide path
- ▣ Causes Spalling

Corrosion Process

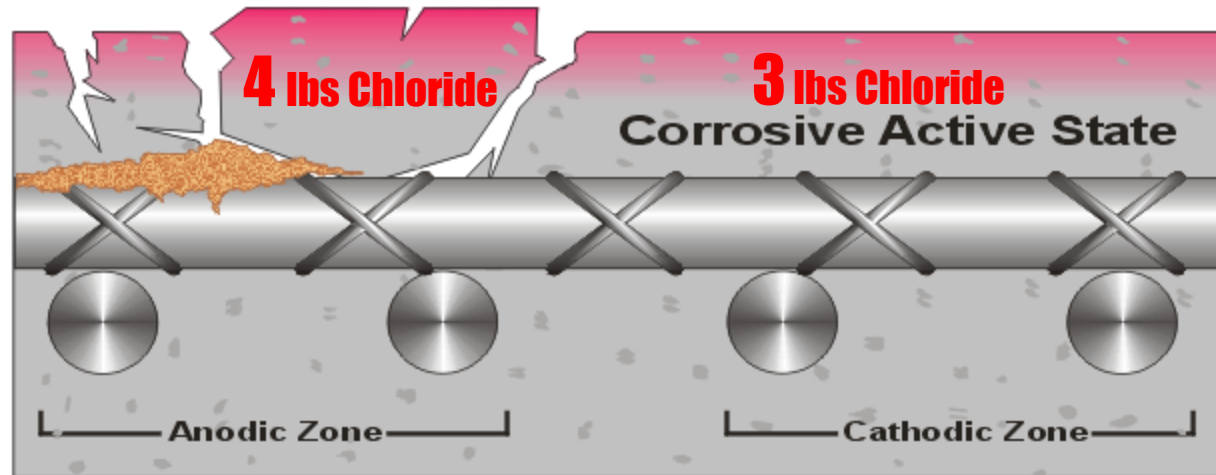
Cracking & Spalling

Corrosion Process

CHLORIDES
