SCCA Meeting 11-20-2021
**“The Importance of
Proactive Structural
Condominium Maintenance”**

Keystone Engineering
Jim Emory, PE, SI, CGC

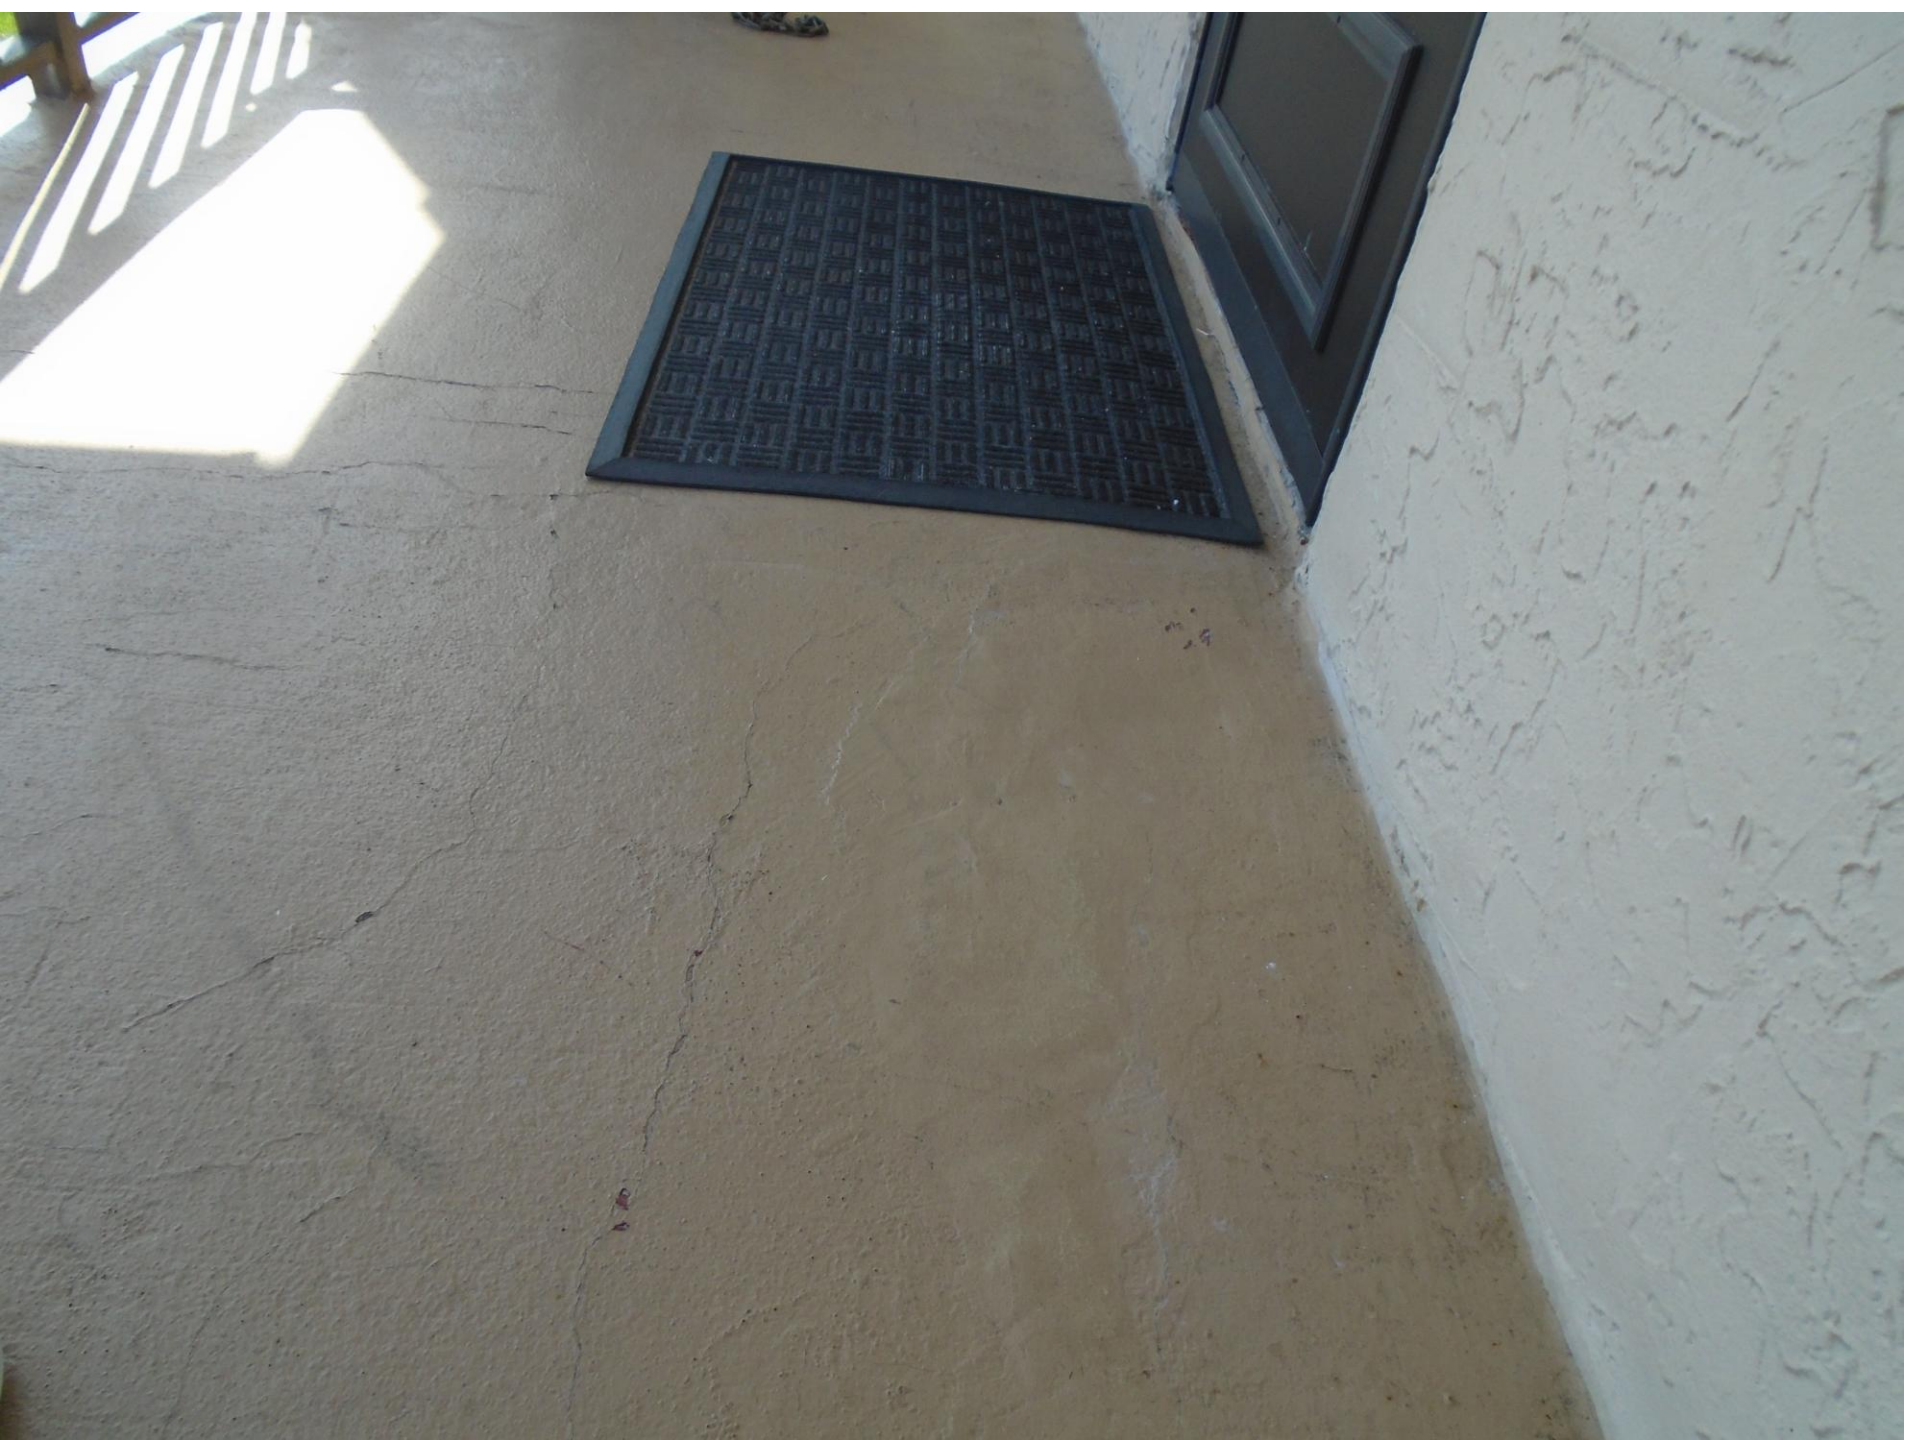
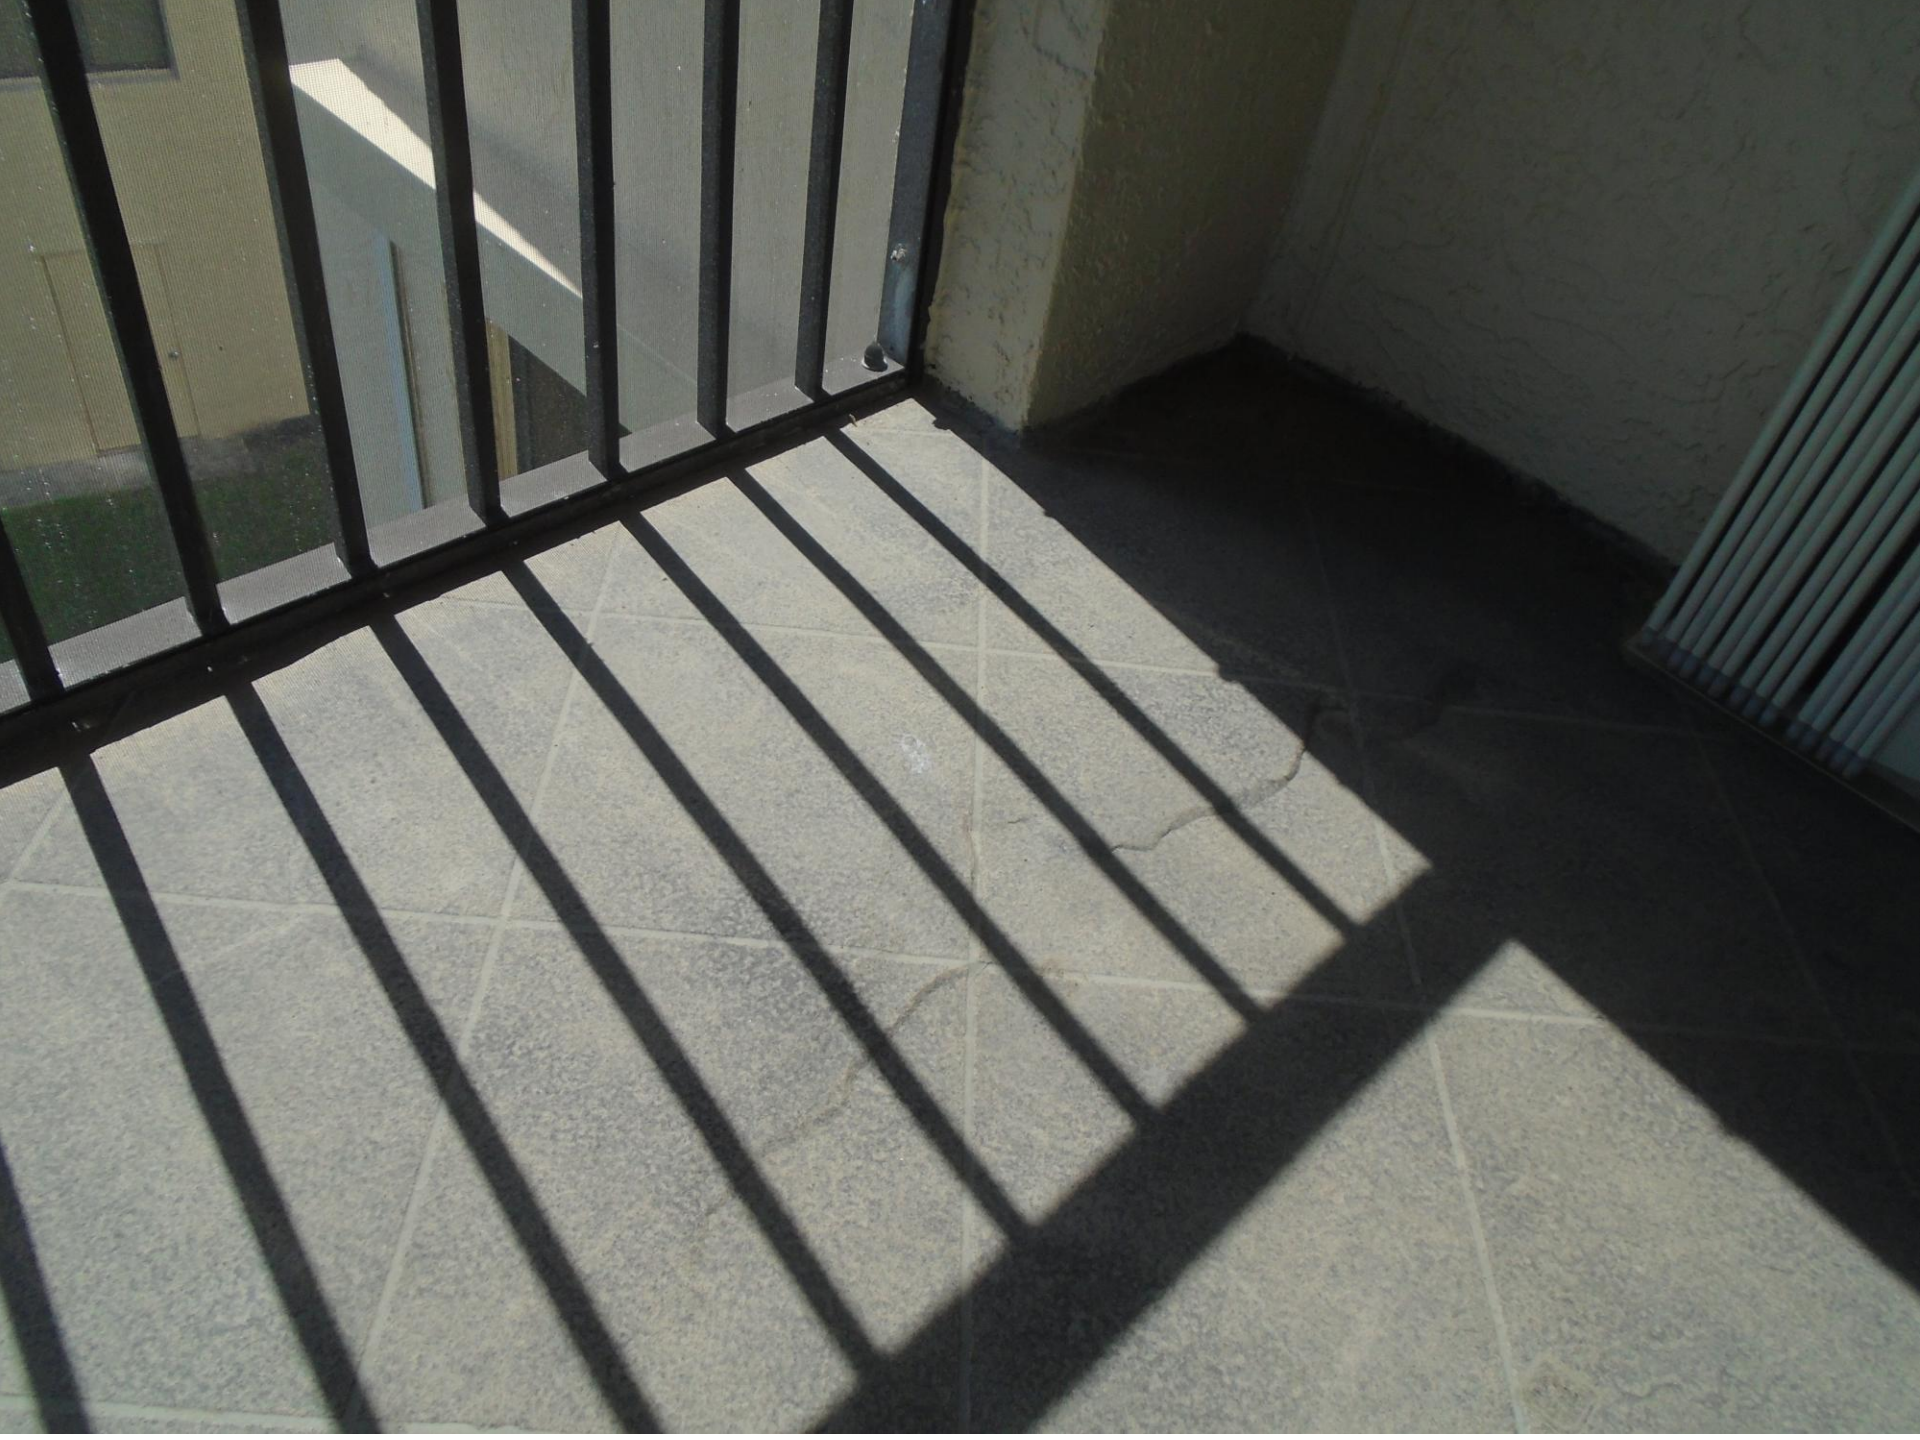
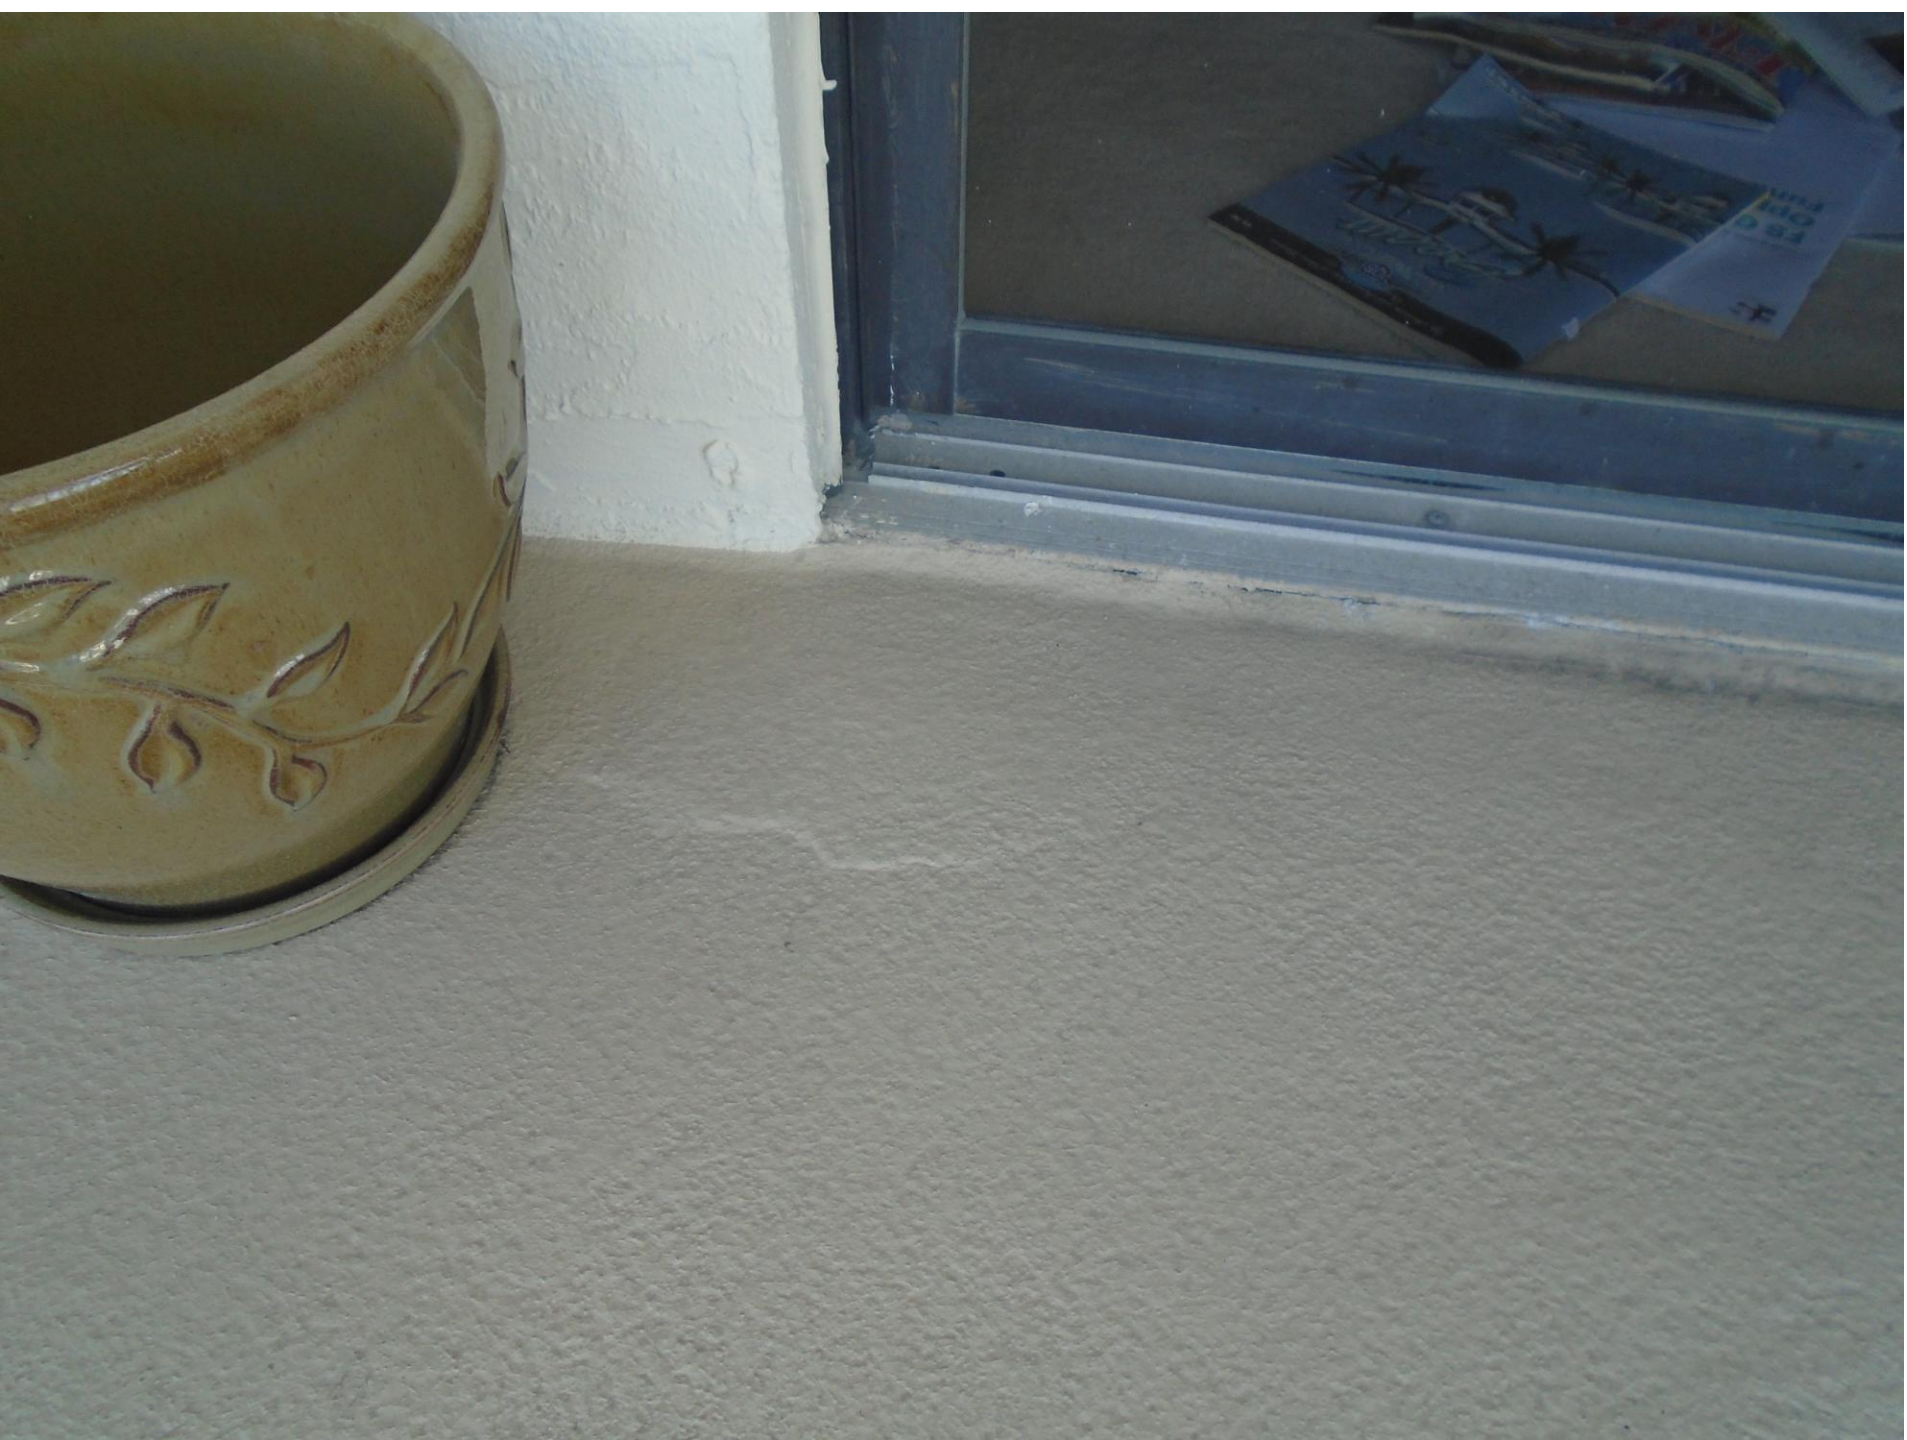
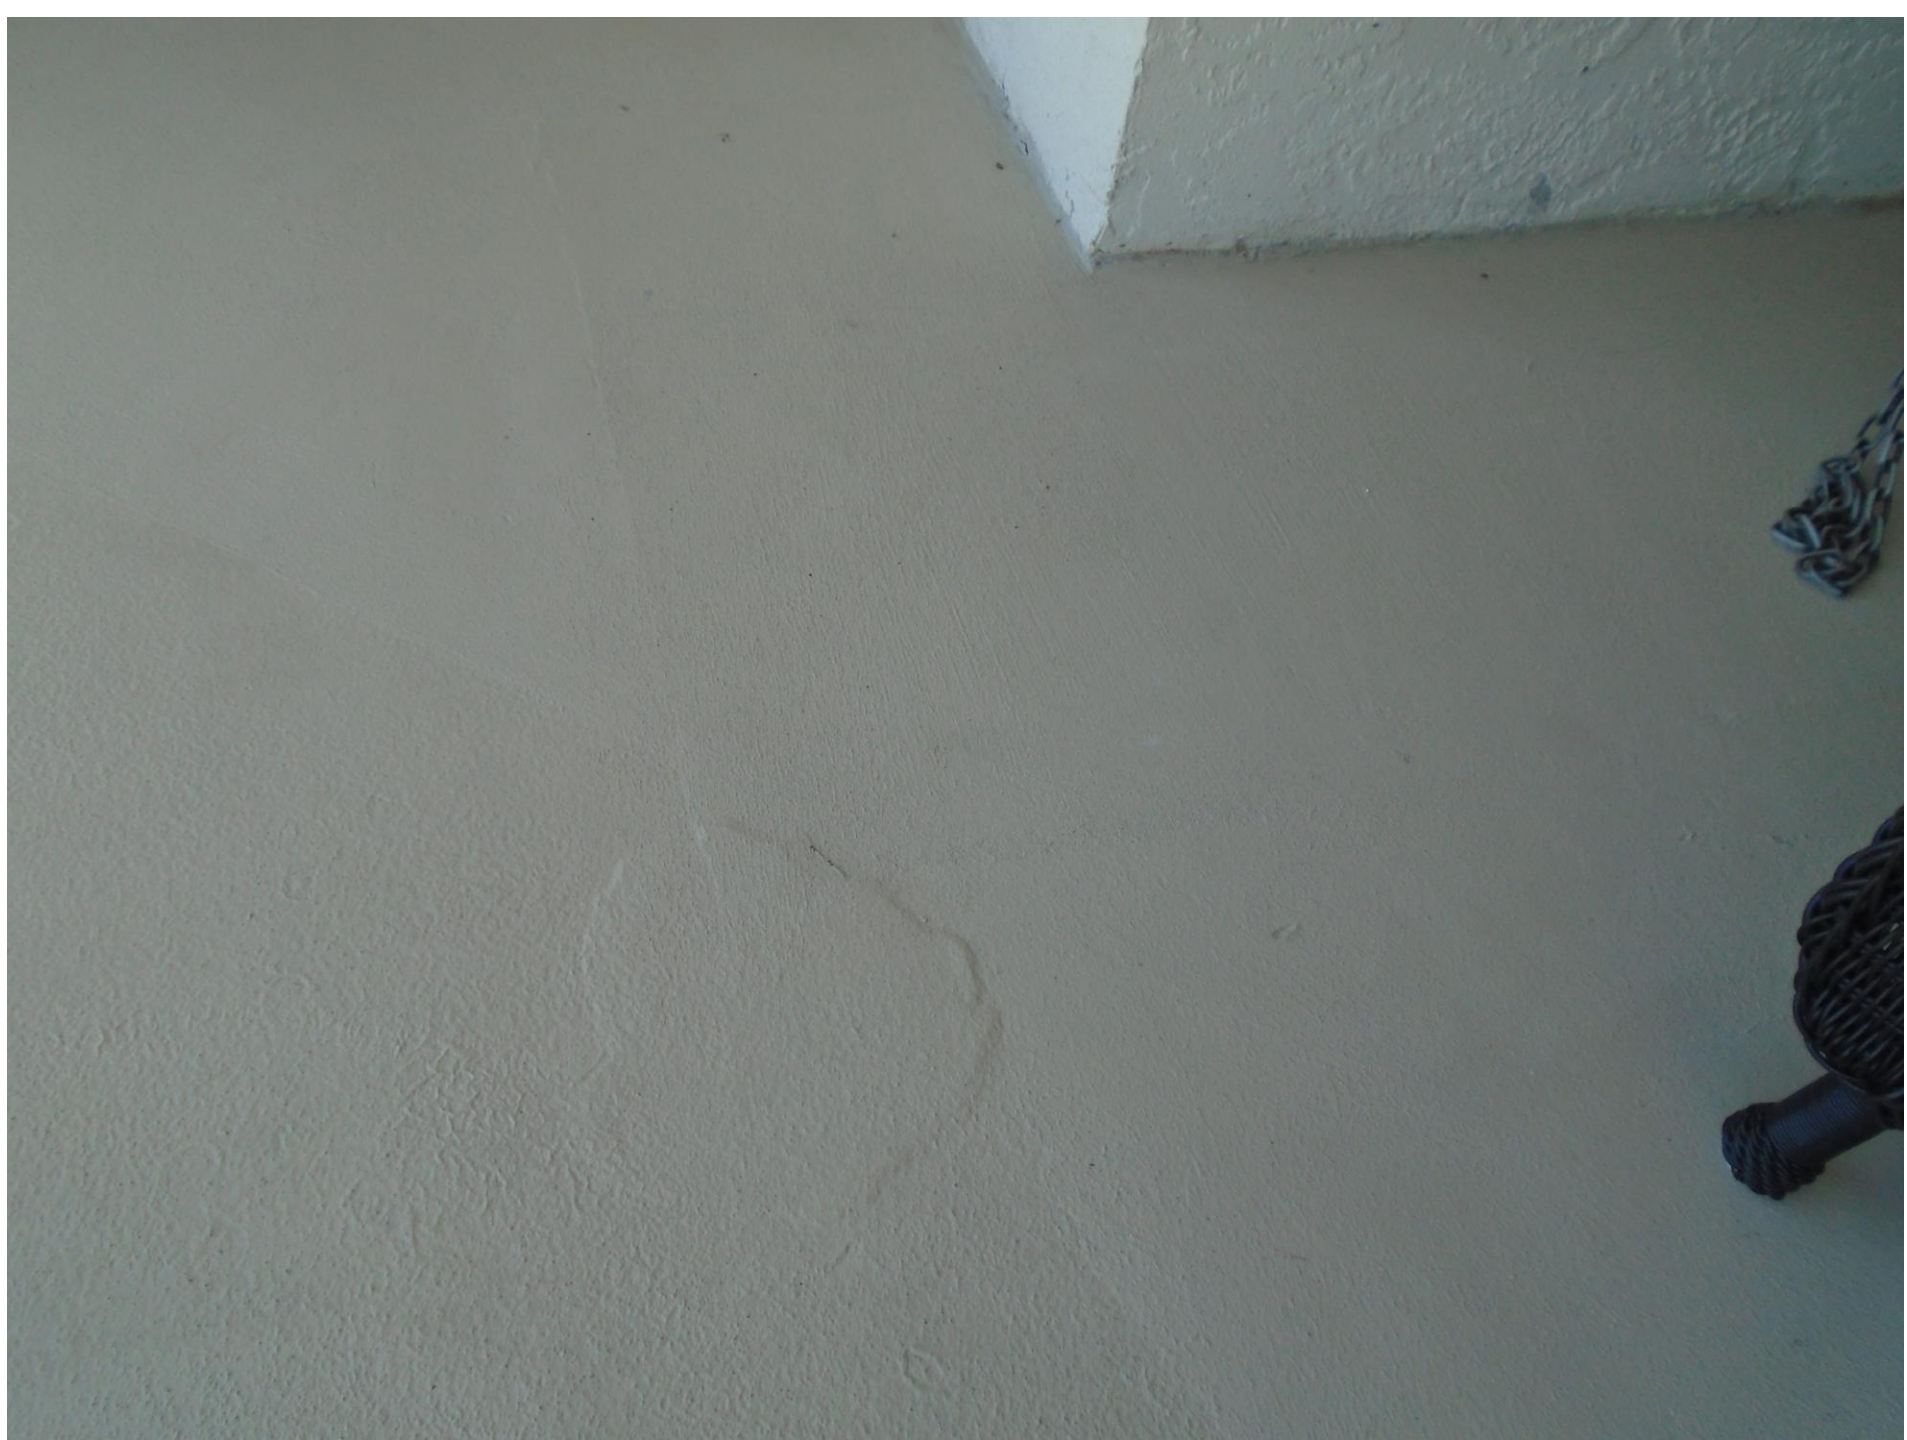
Slab Surface Spalling

A photograph of a concrete slab showing signs of surface spalling. The concrete is a light tan color and has several irregular, jagged holes and pits of varying sizes scattered across its surface. A metal railing with vertical bars is visible in the upper right corner. The text "Slab Surface Spalling" is overlaid in the center in a white, bold, serif font.
