SCCA Meeting 11-20-2021
**“The Importance of
Proactive Structural
Condominium Maintenance”**

Keystone Engineering
Jim Emory, PE, SI, CGC

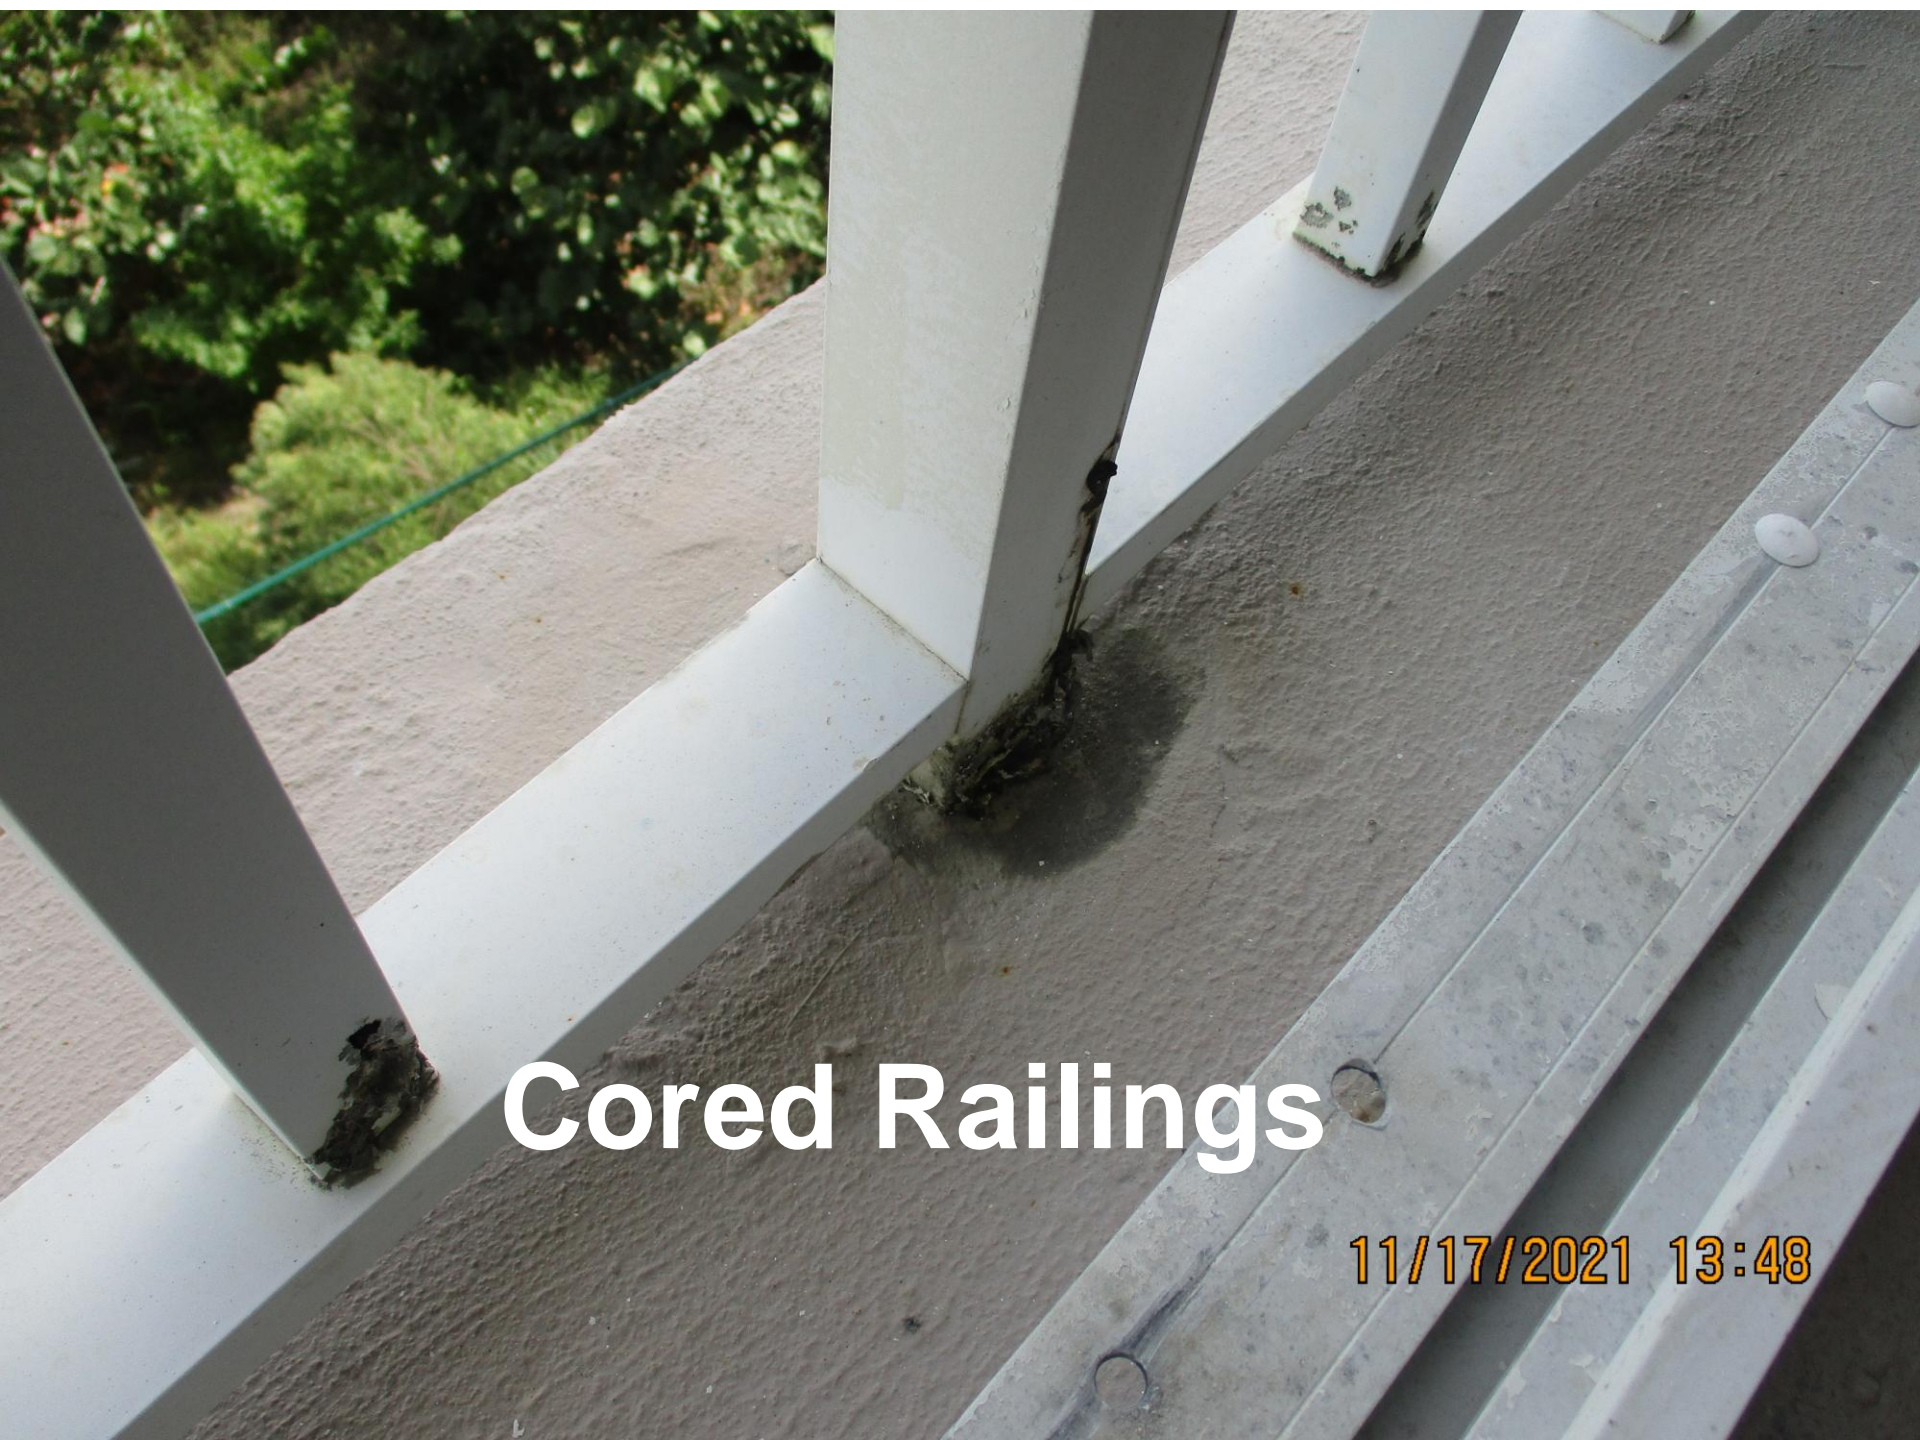
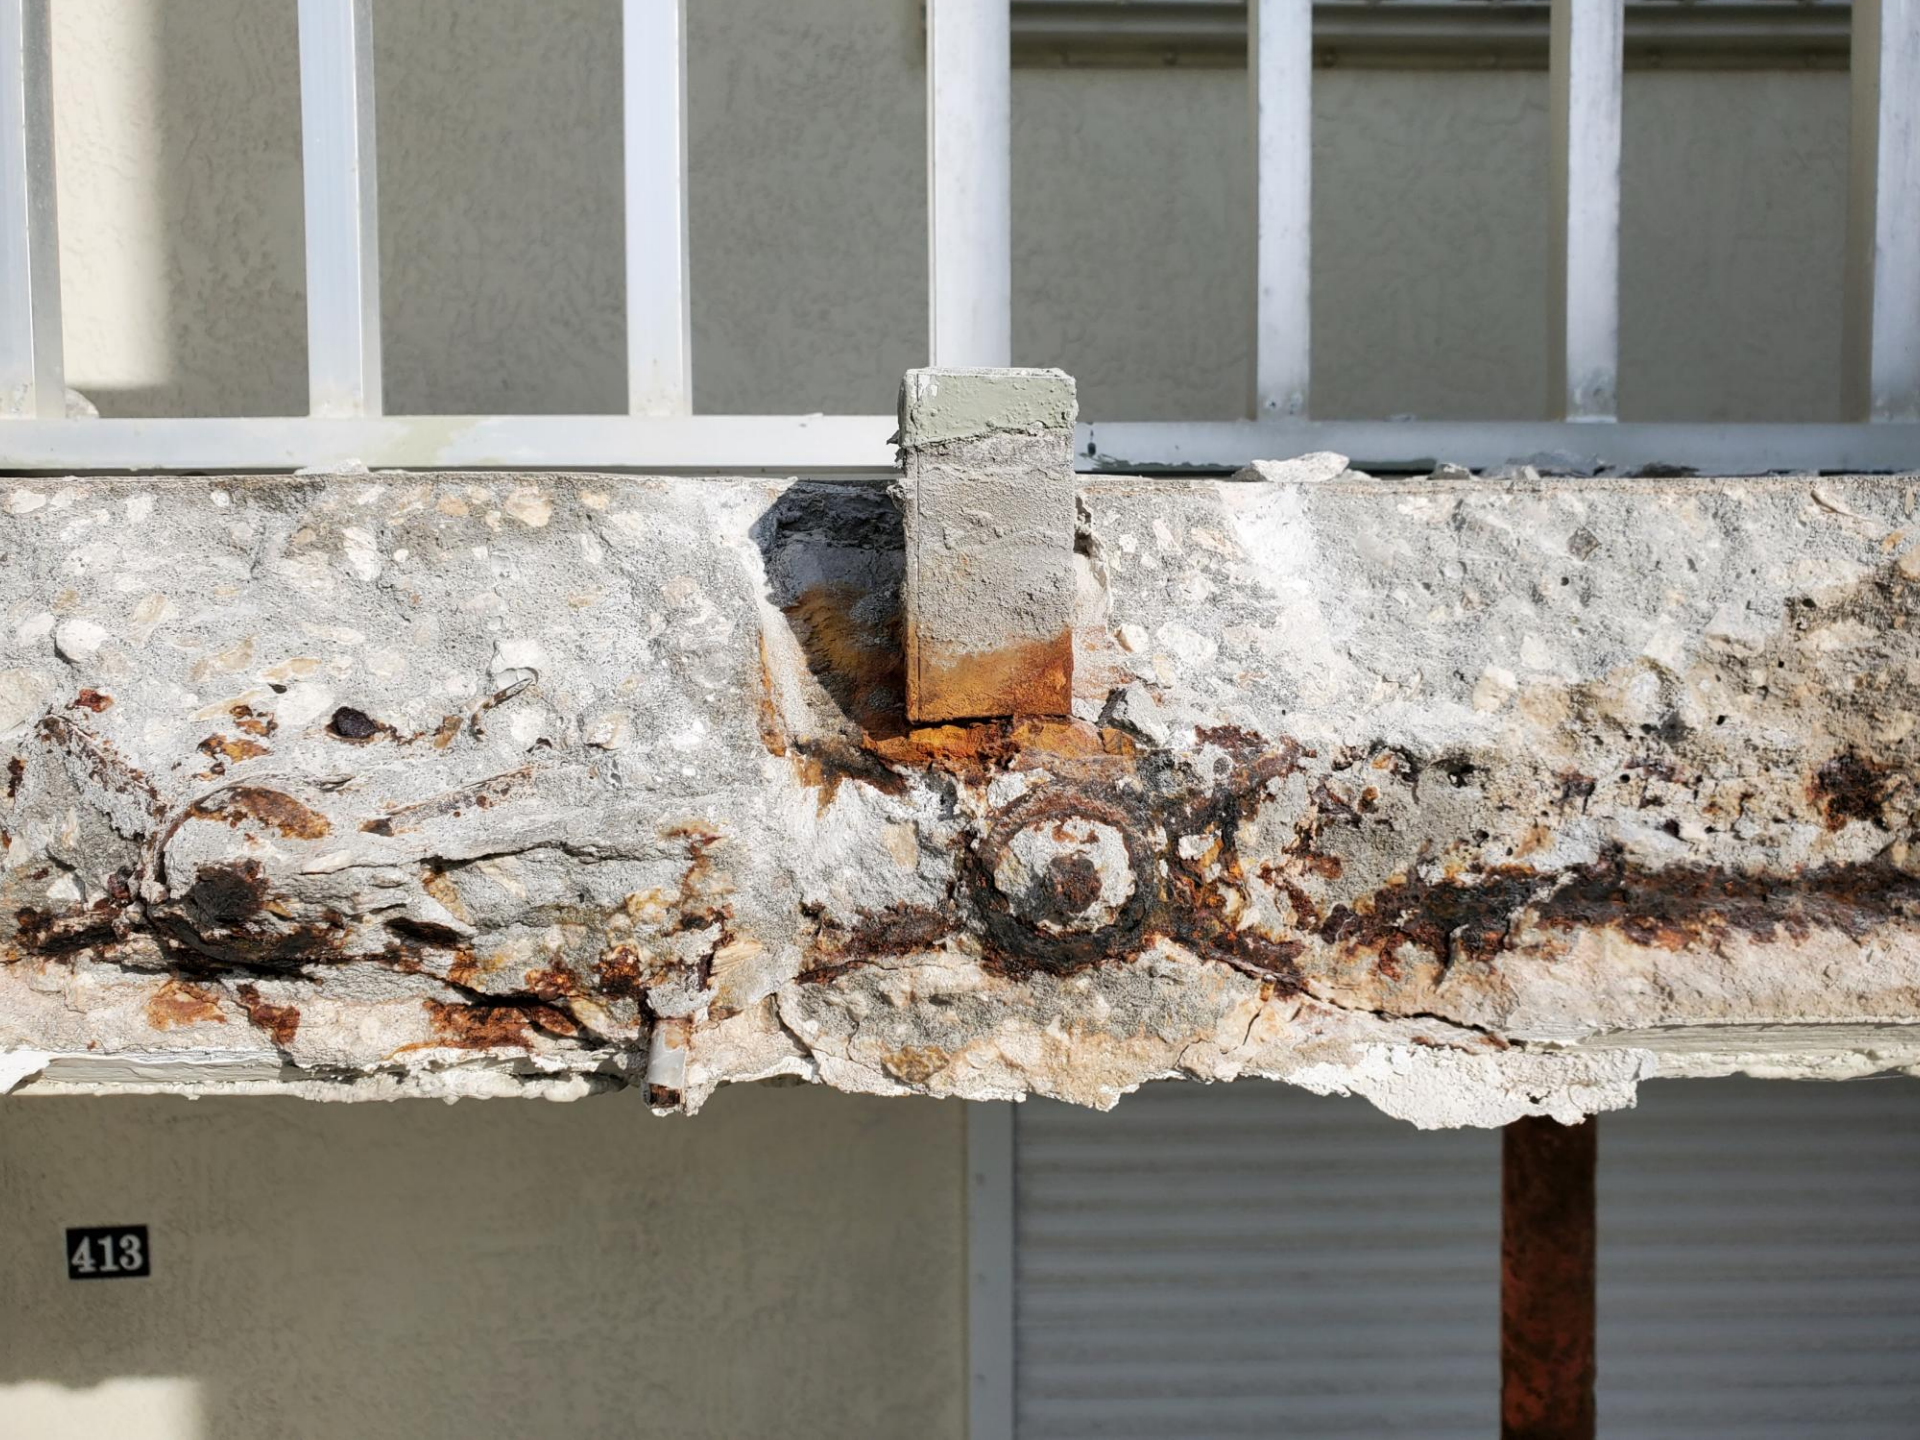
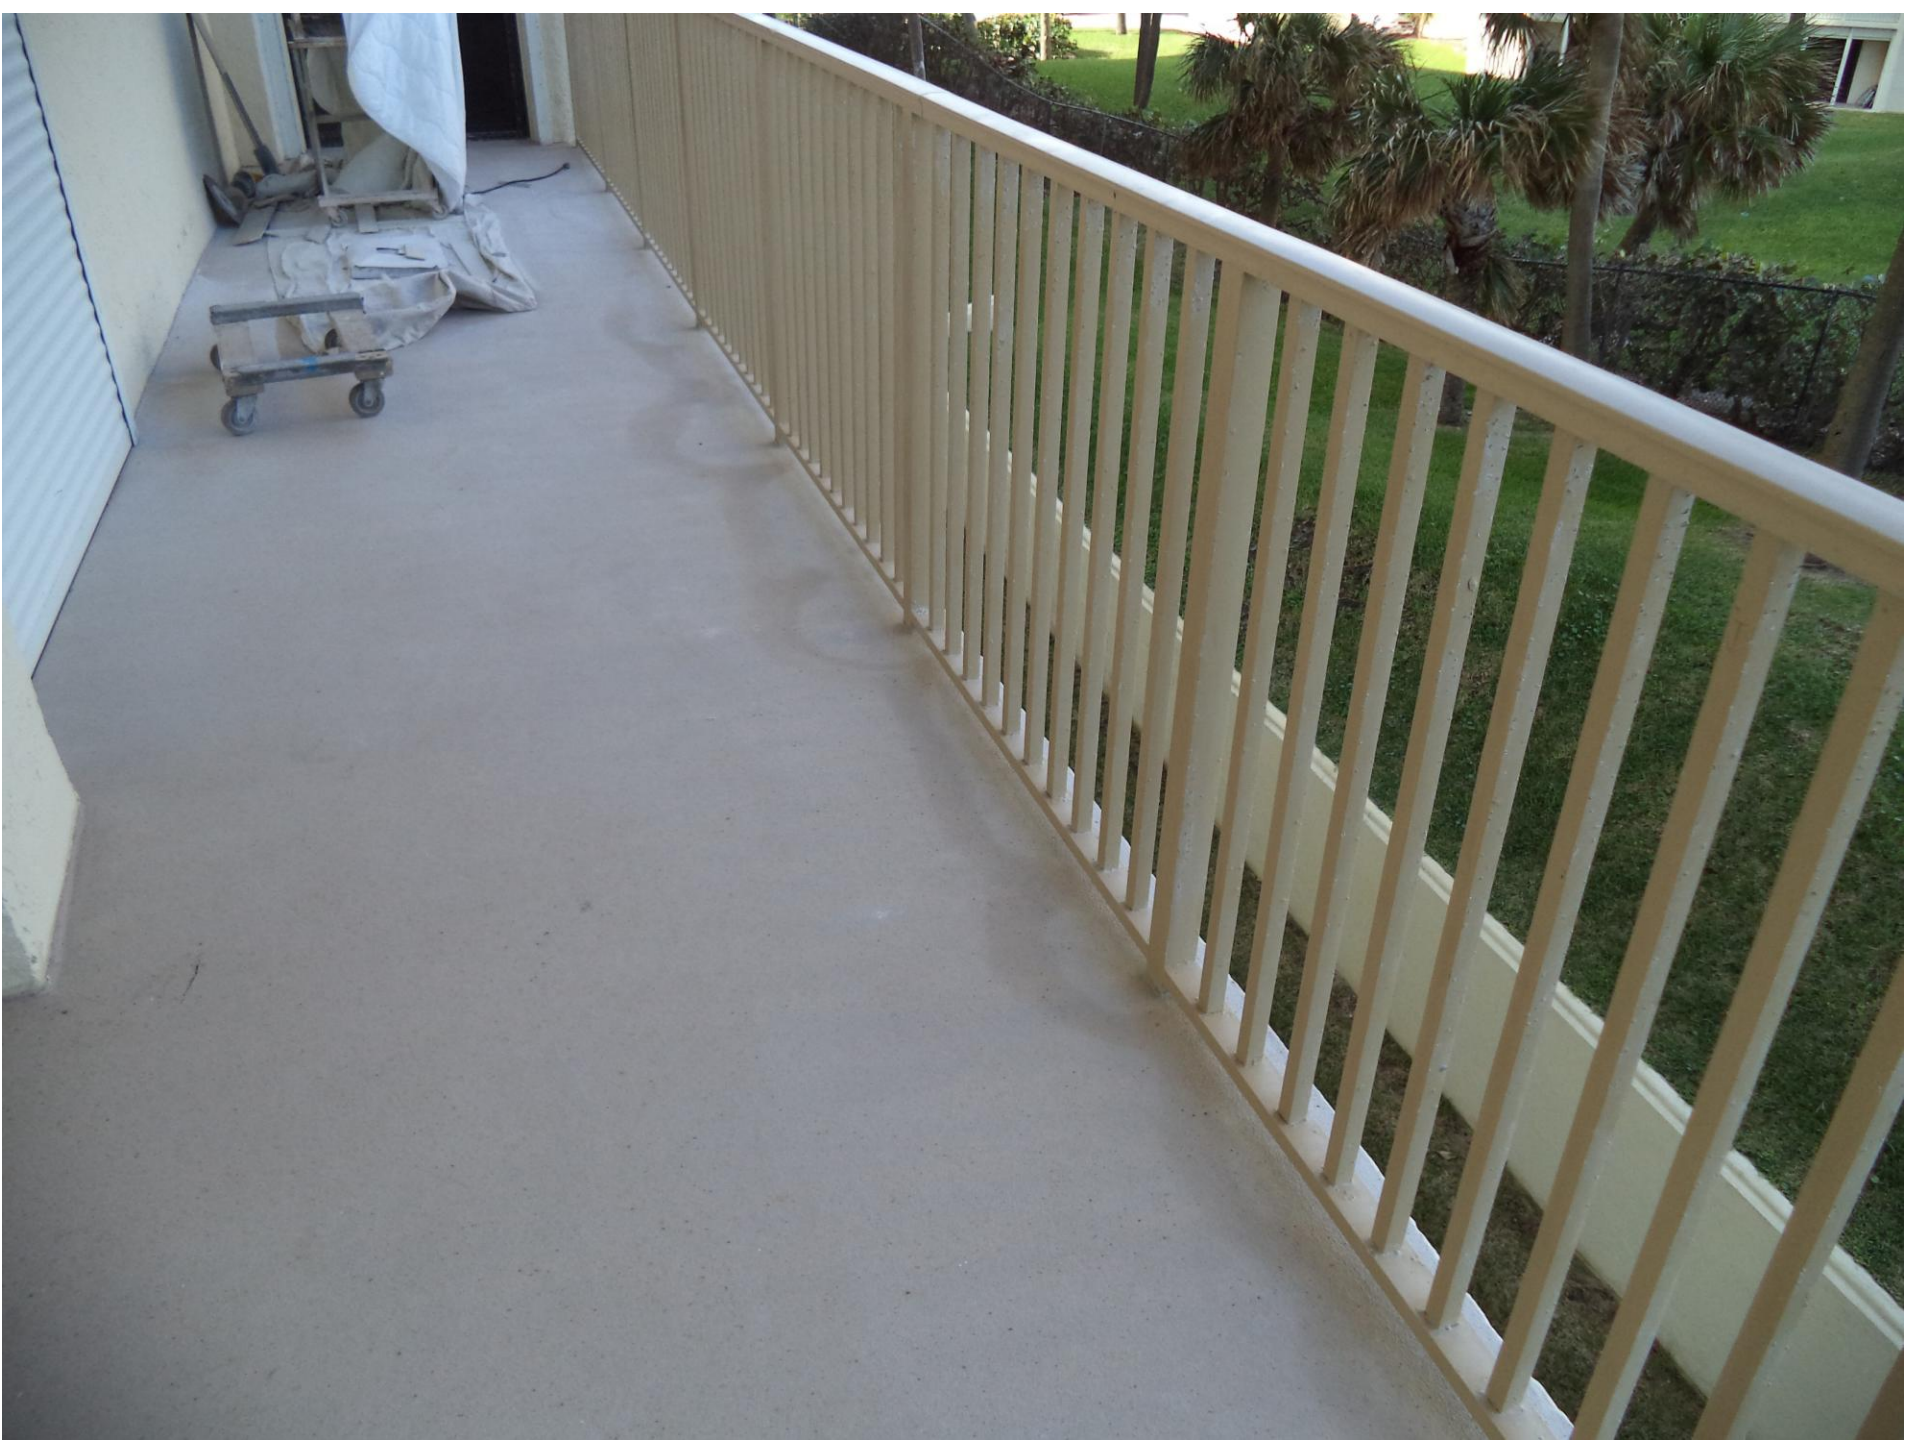
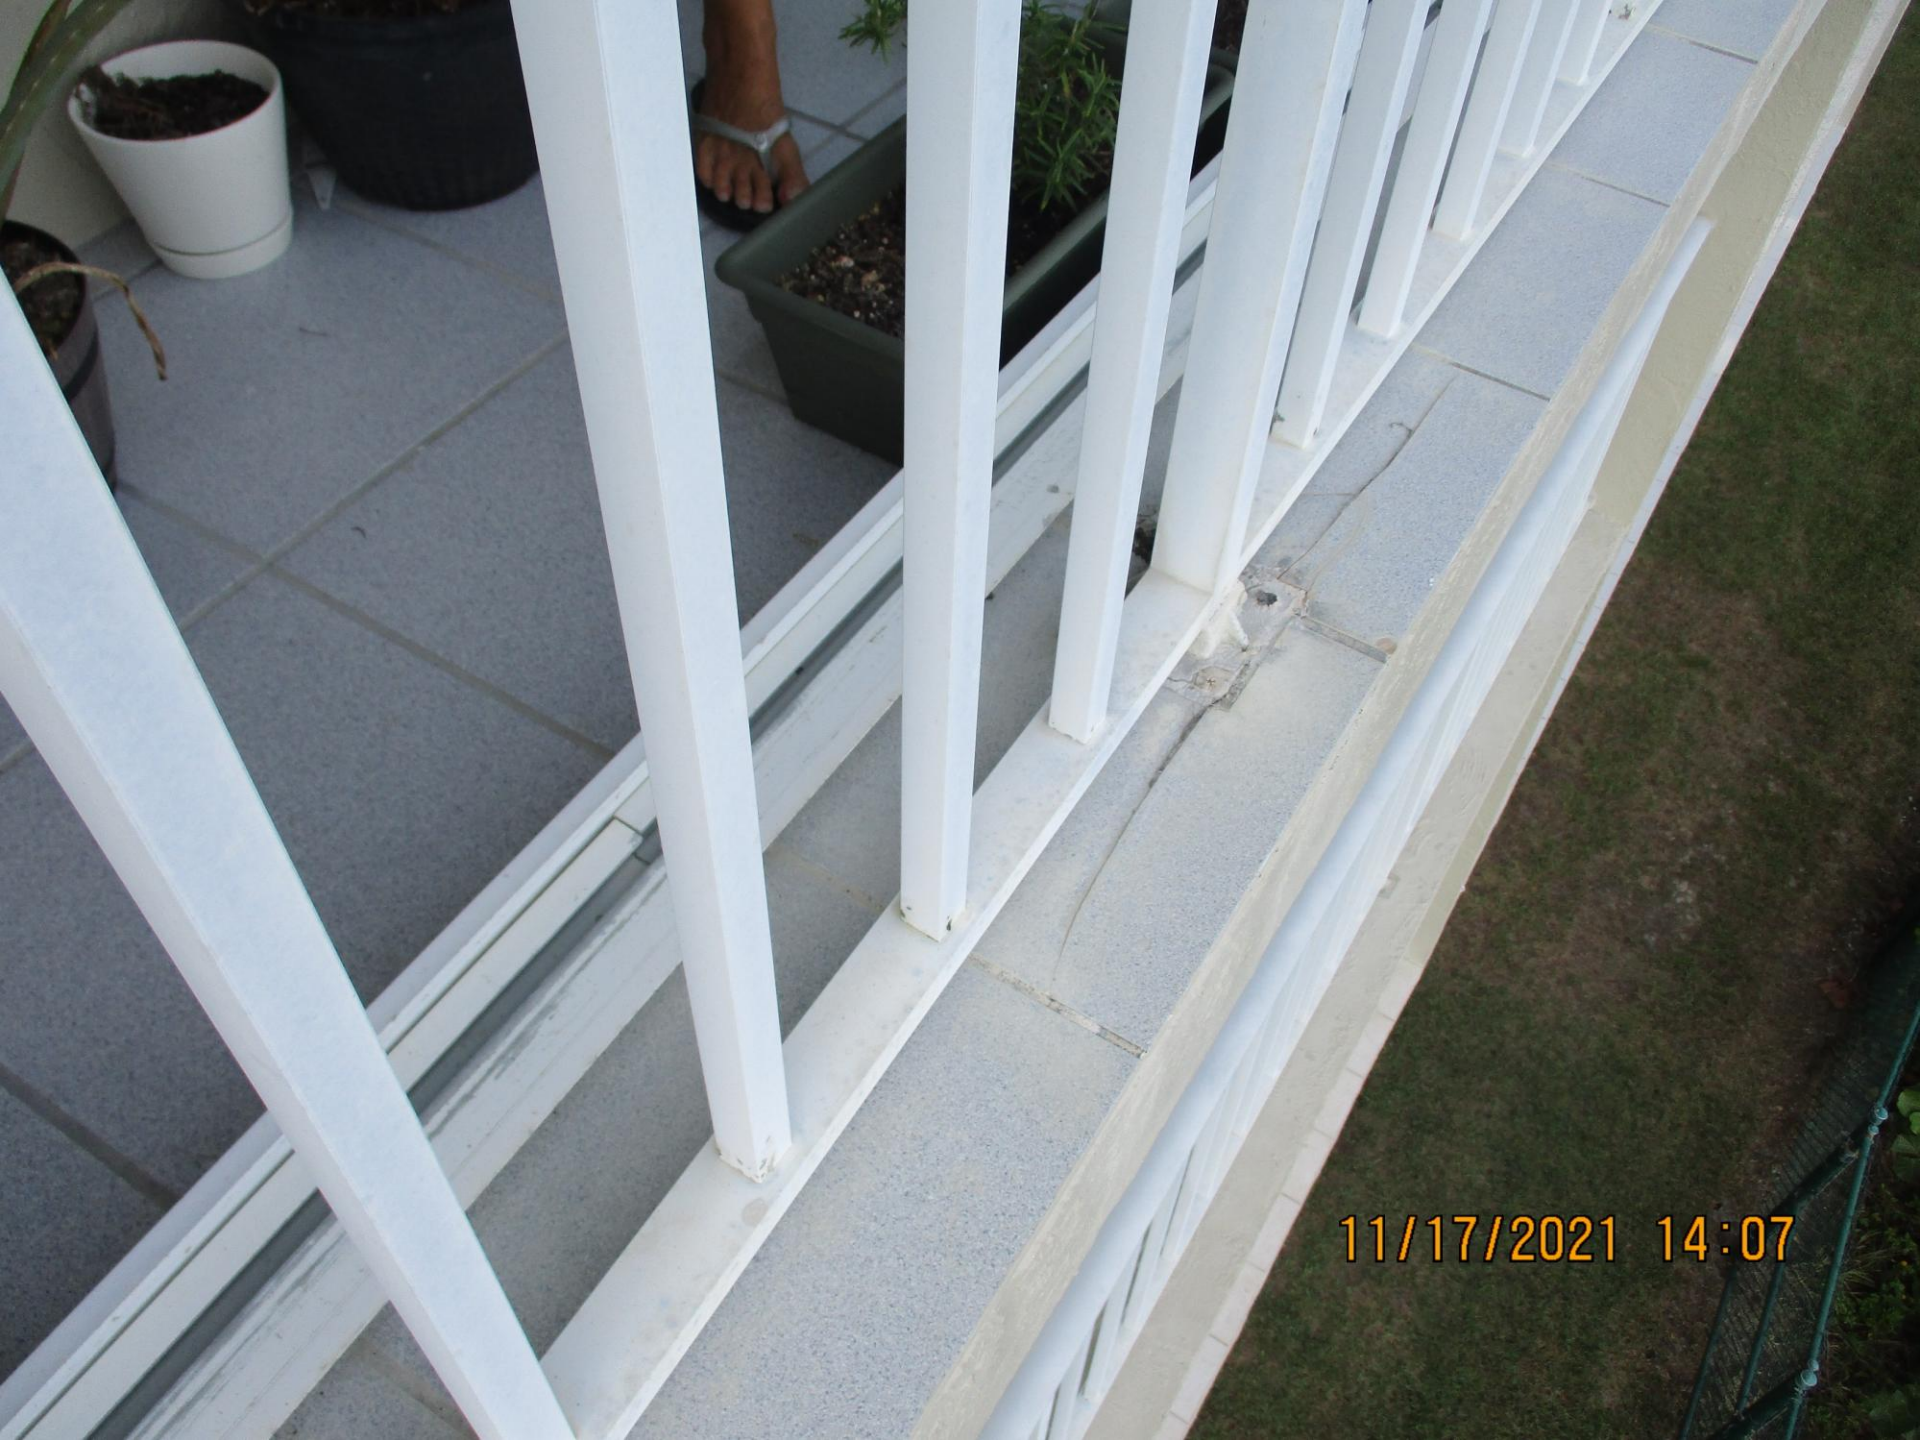
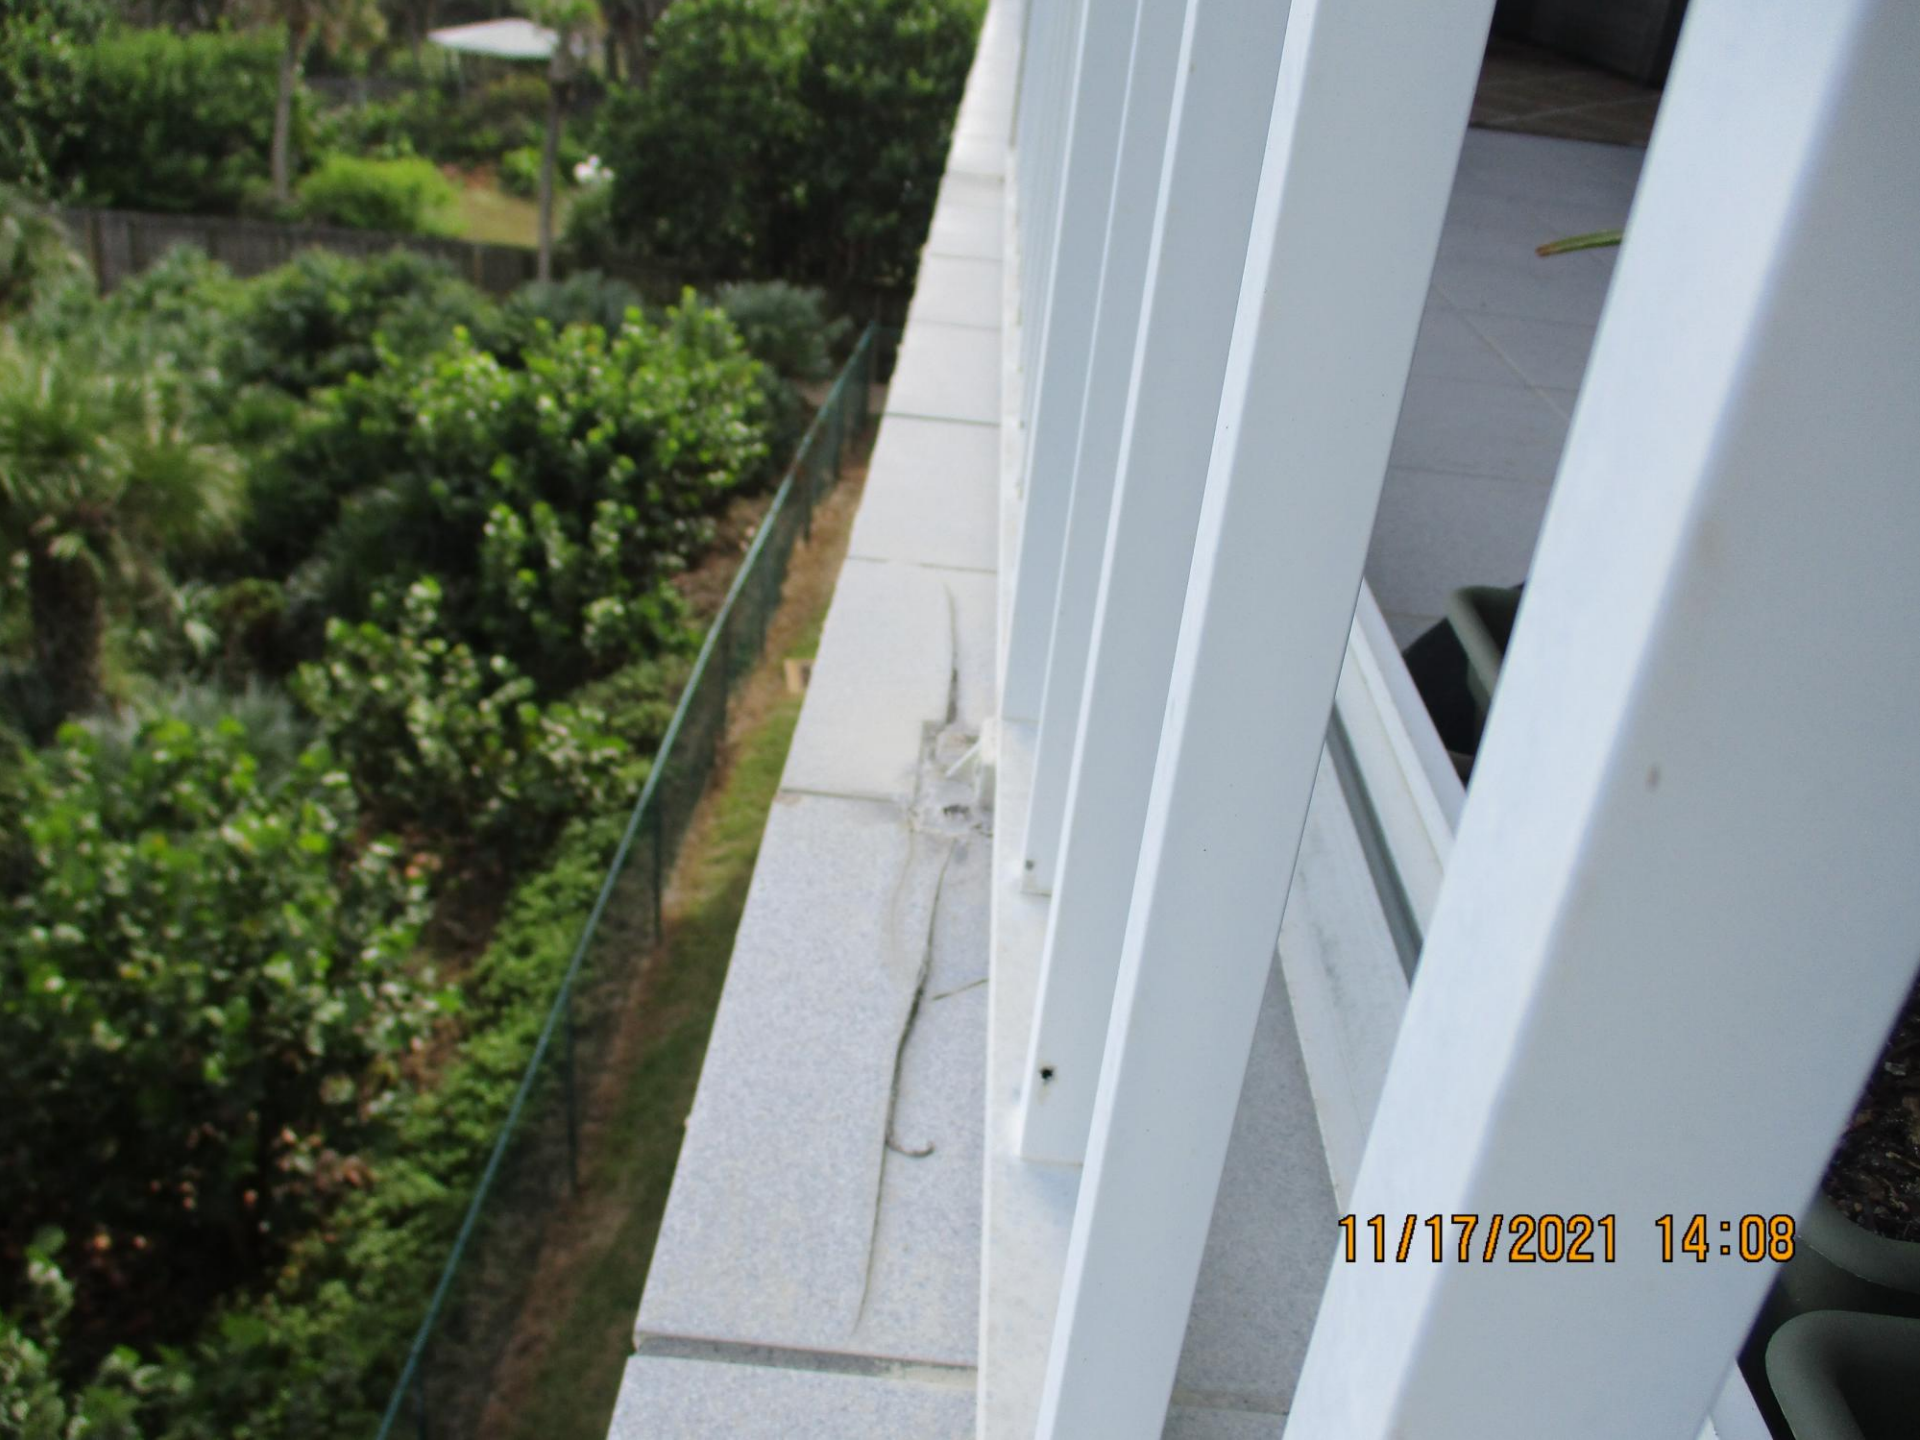
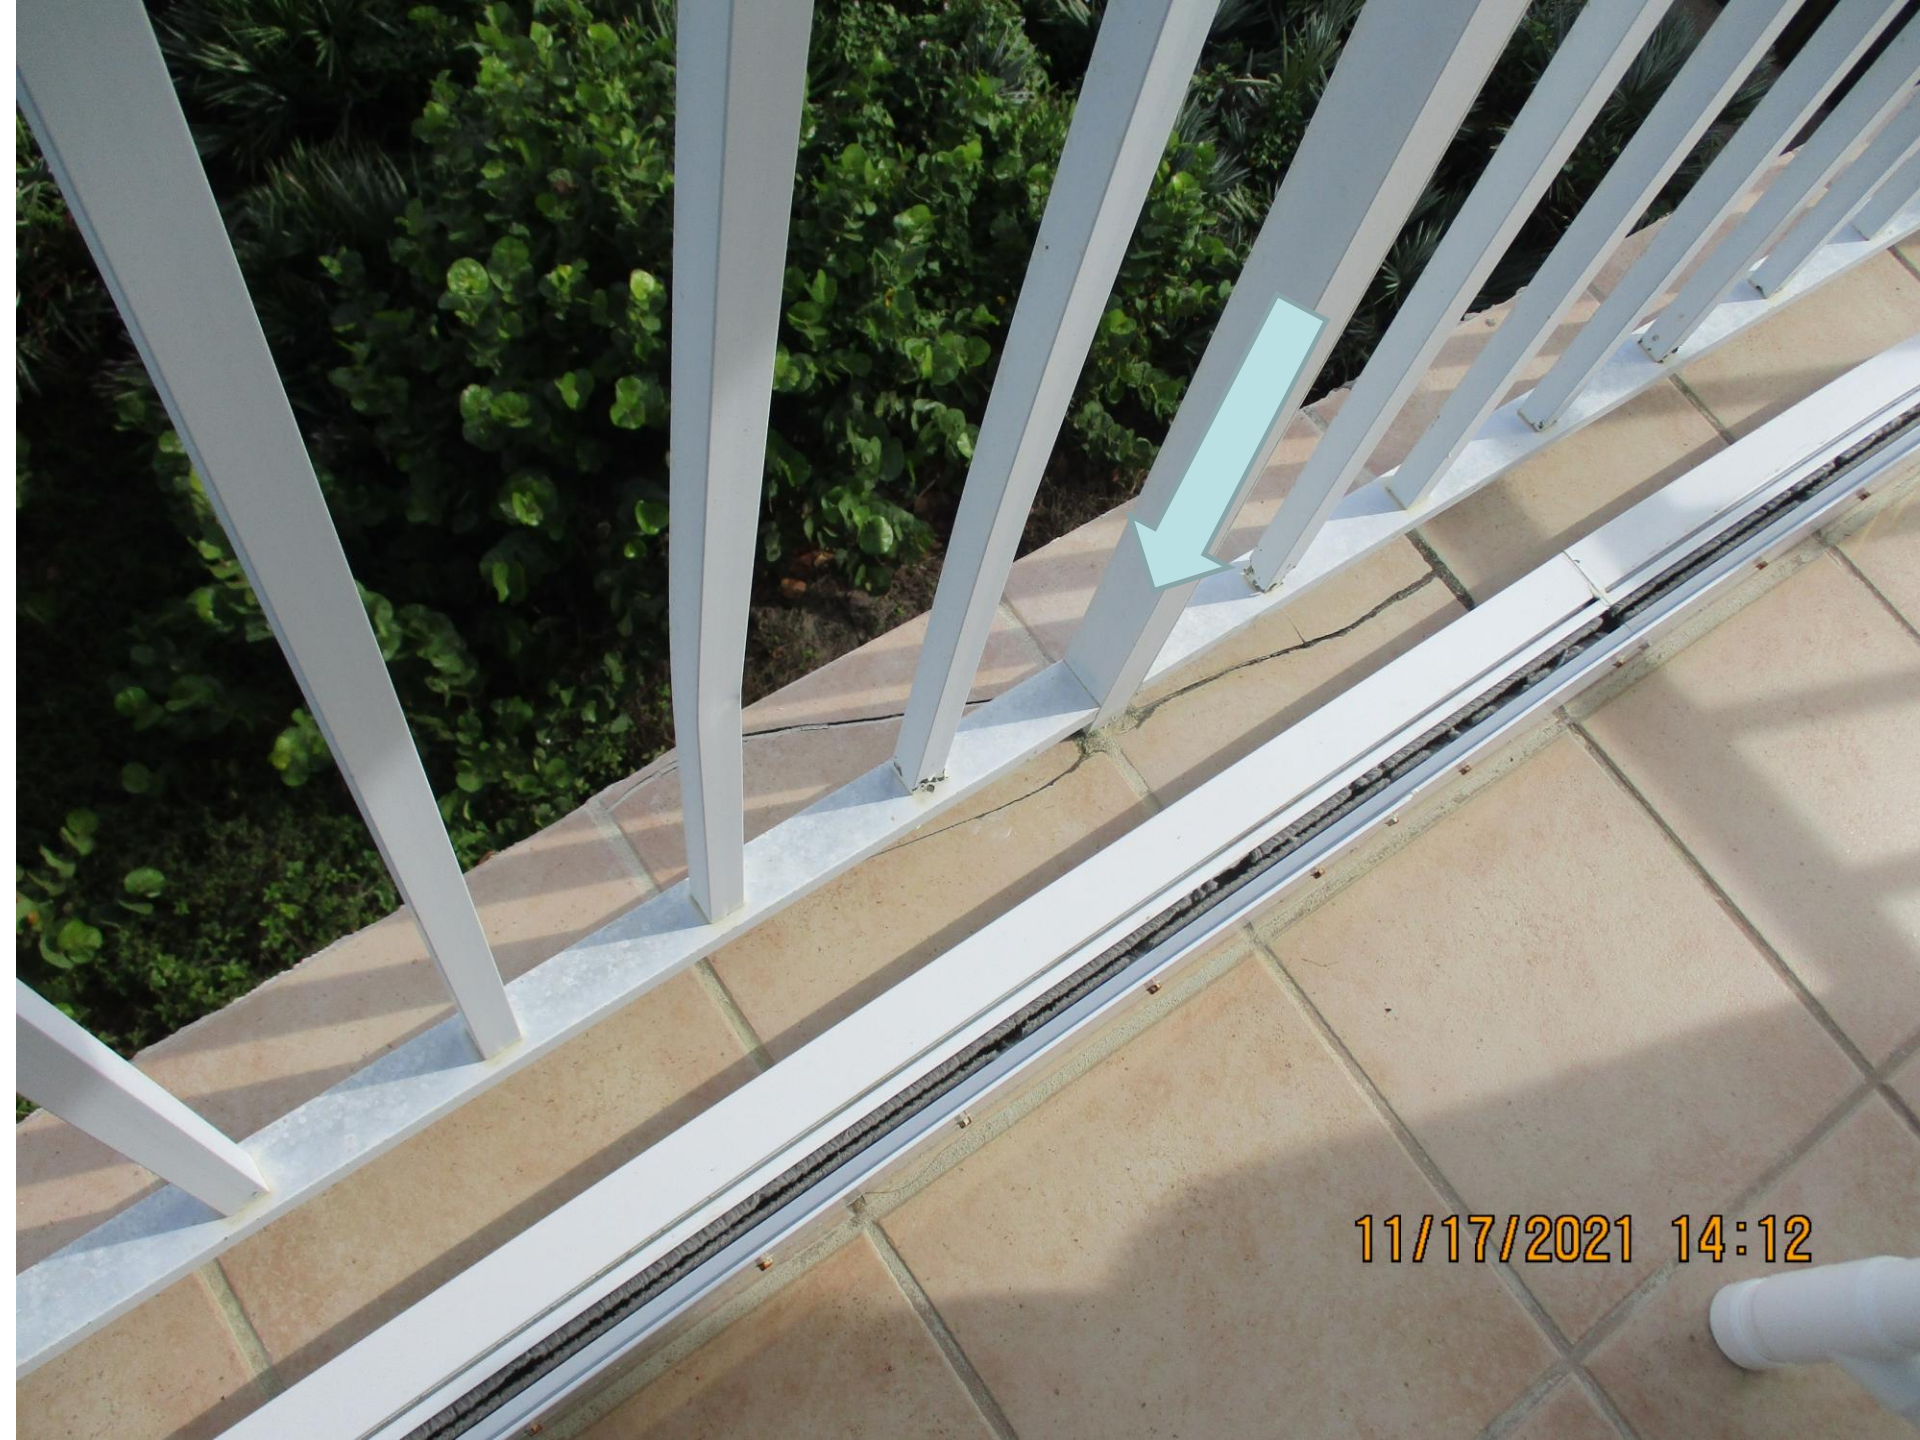
Cored Railings

- RAILINGS-CORED IN PLACE OR IMPROPER FASTENERS
- SHUTTERS-DRAINAGE AND CORRODED FASTENERS
- IMPROPER BALCONY FLOORING-TILE
- SLIDING GLASS DOORS AND WINDOWS
- SCREENED ENCLOSURES
