SCCA Meeting 11-20-2021
**“The Importance of
Proactive Structural
Condominium Maintenance”**

Keystone Engineering
Jim Emory, PE, SI, CGC

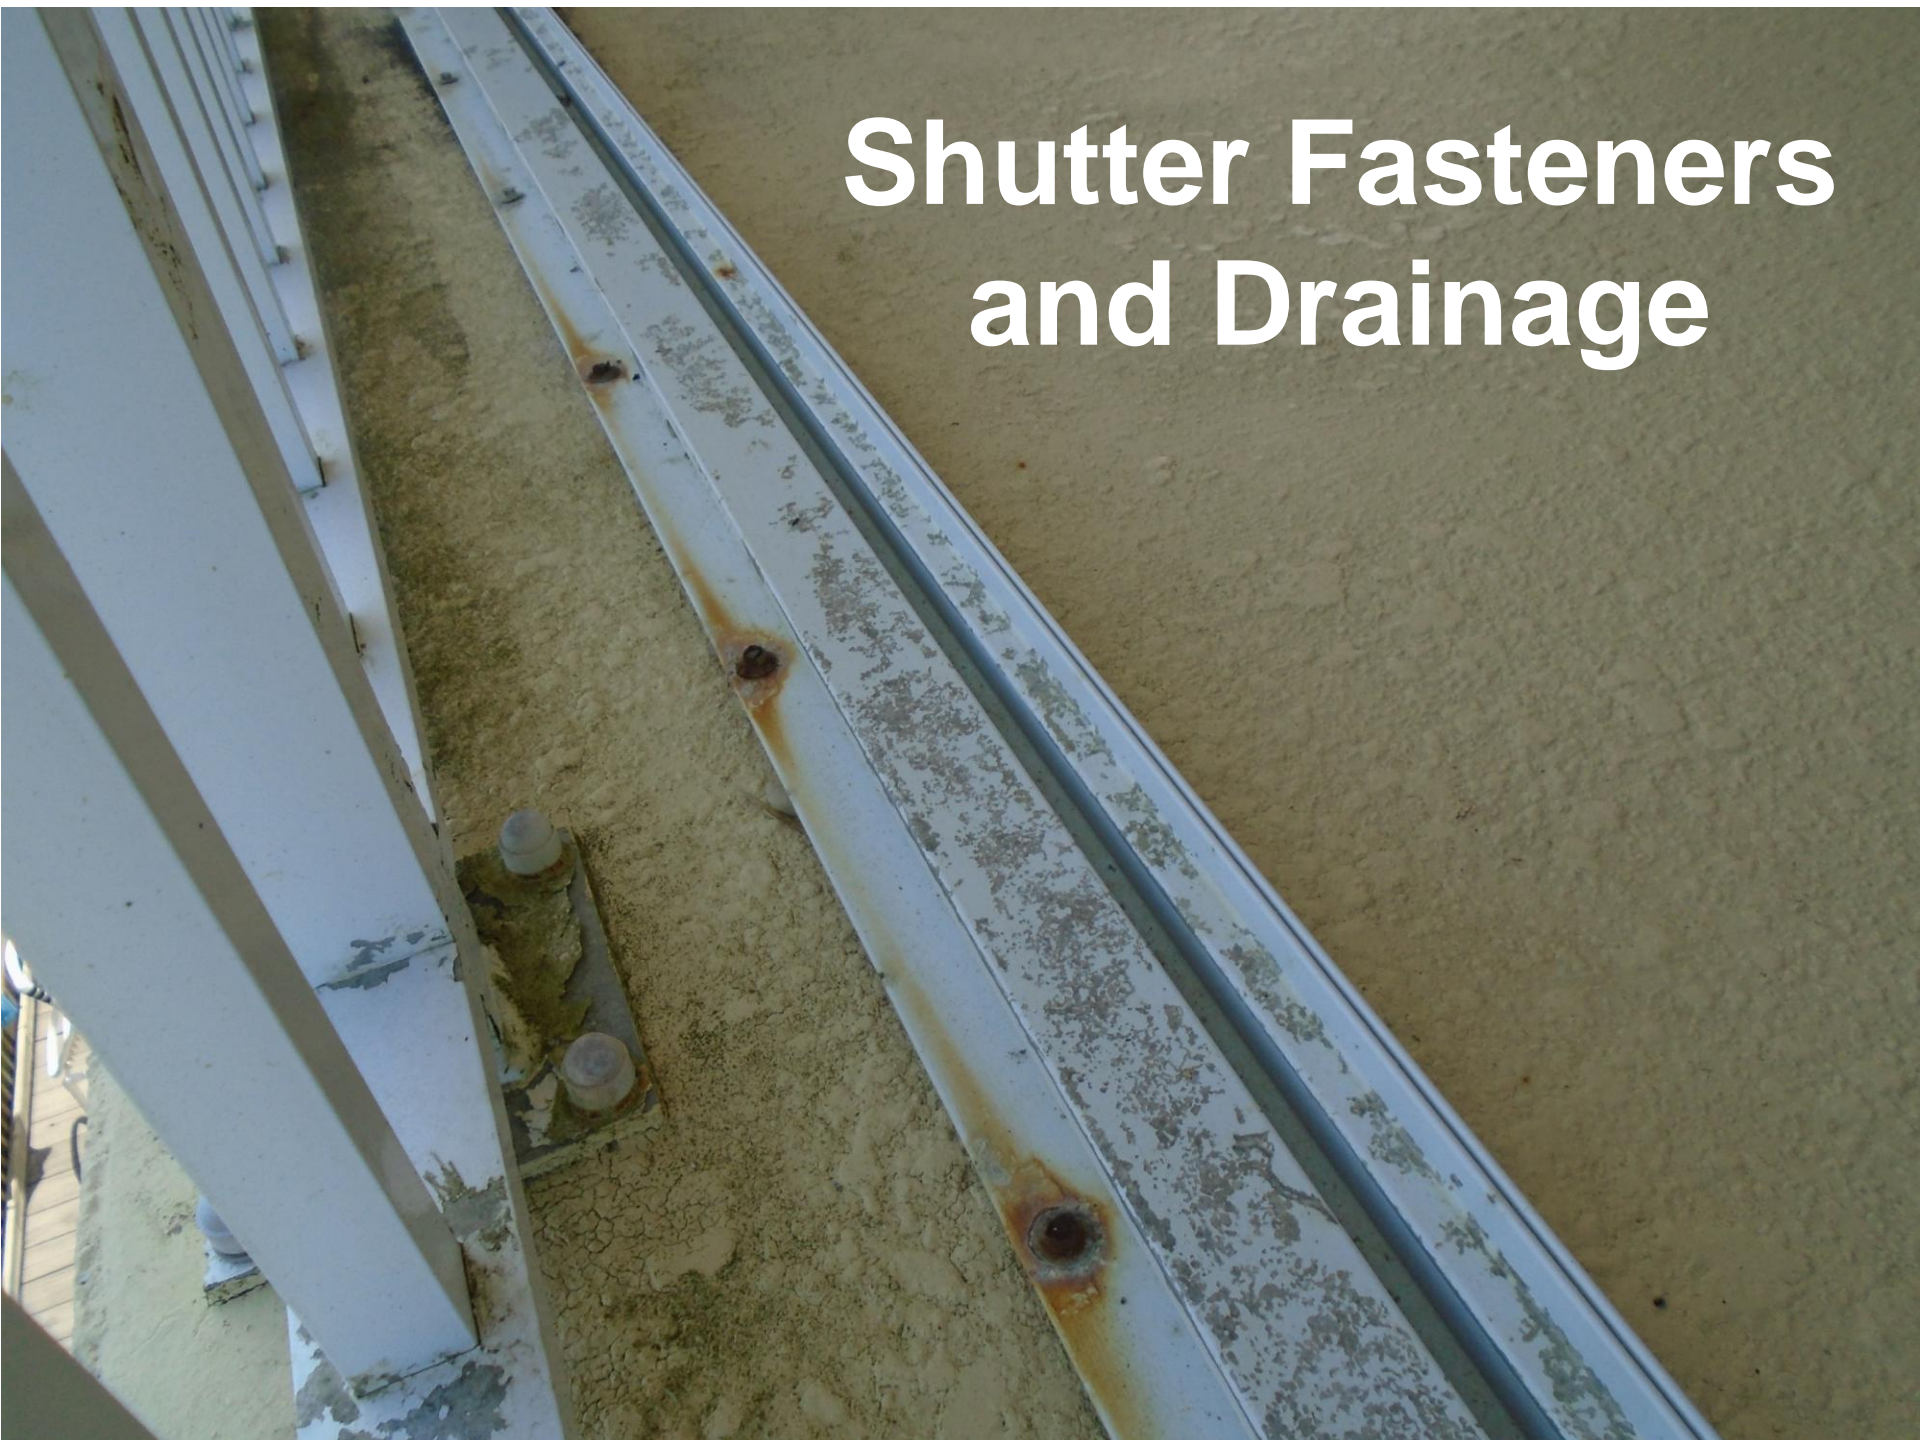
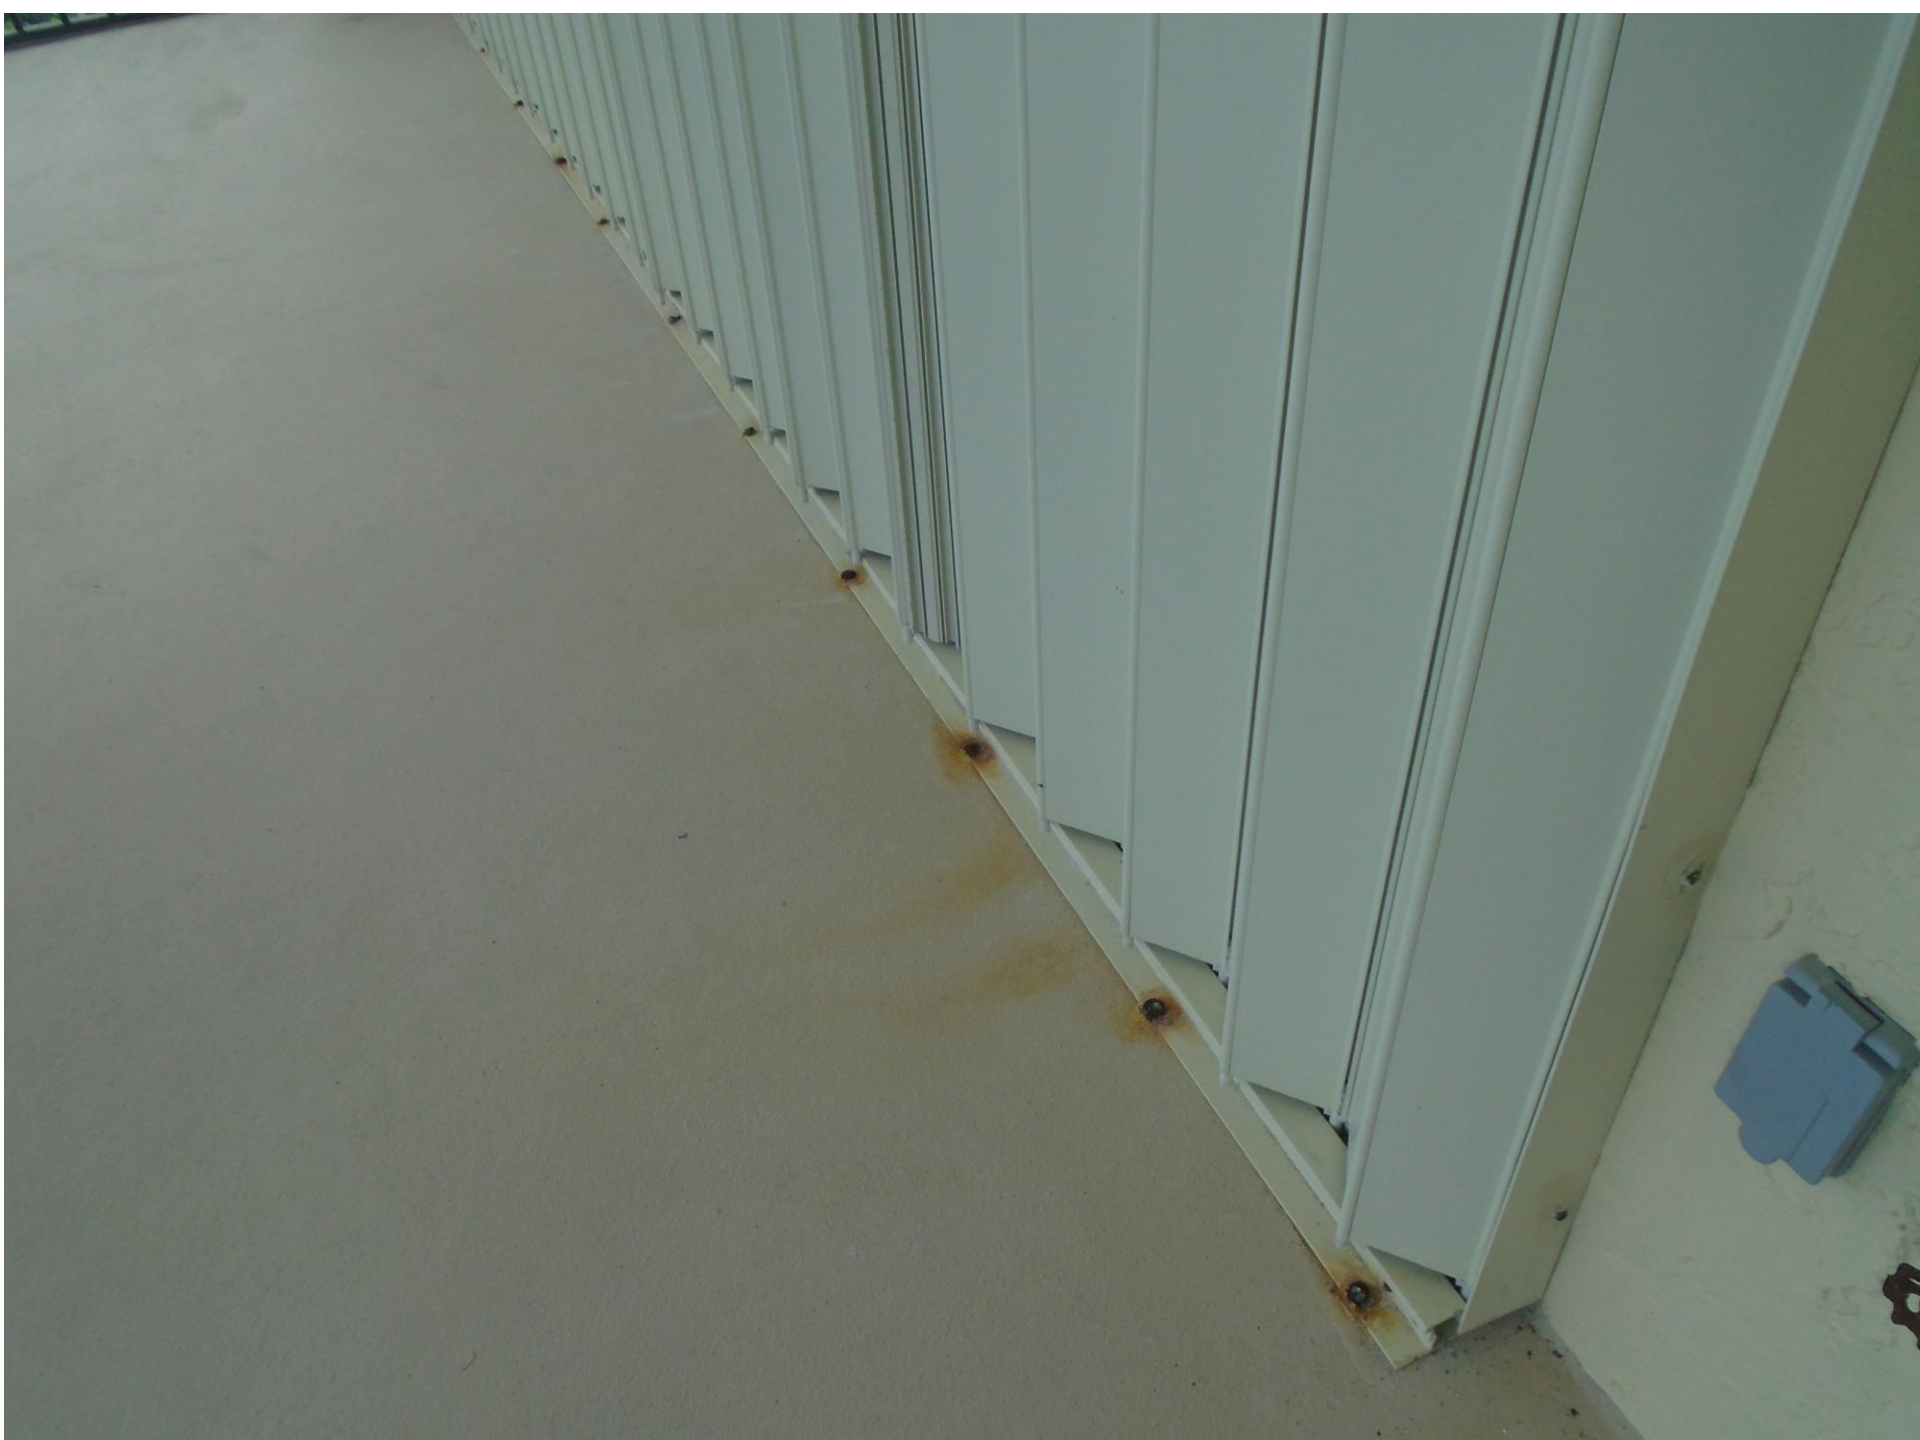
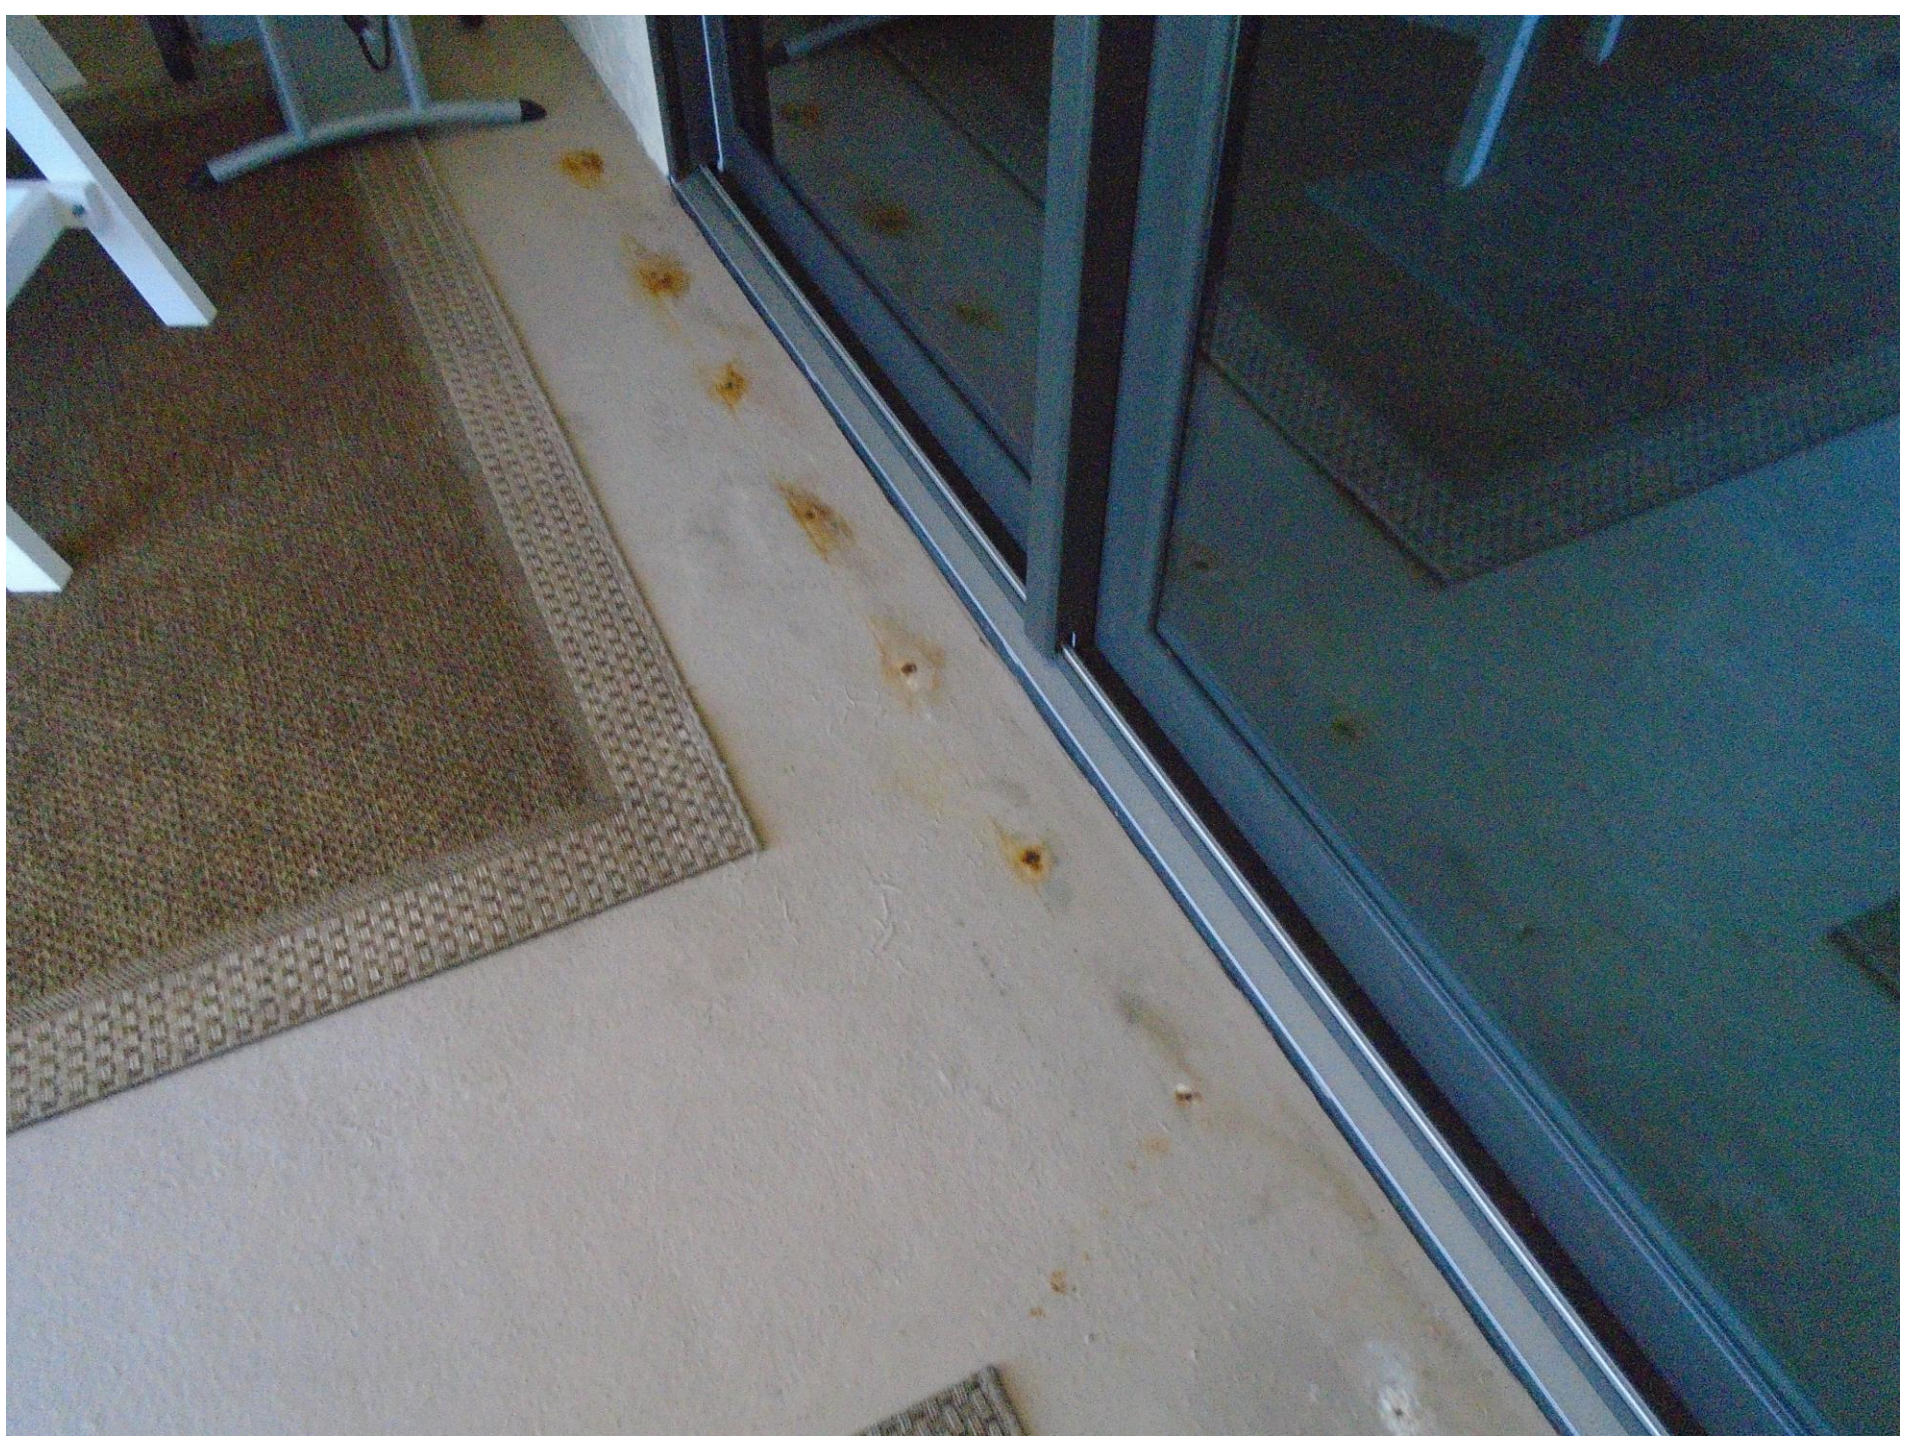
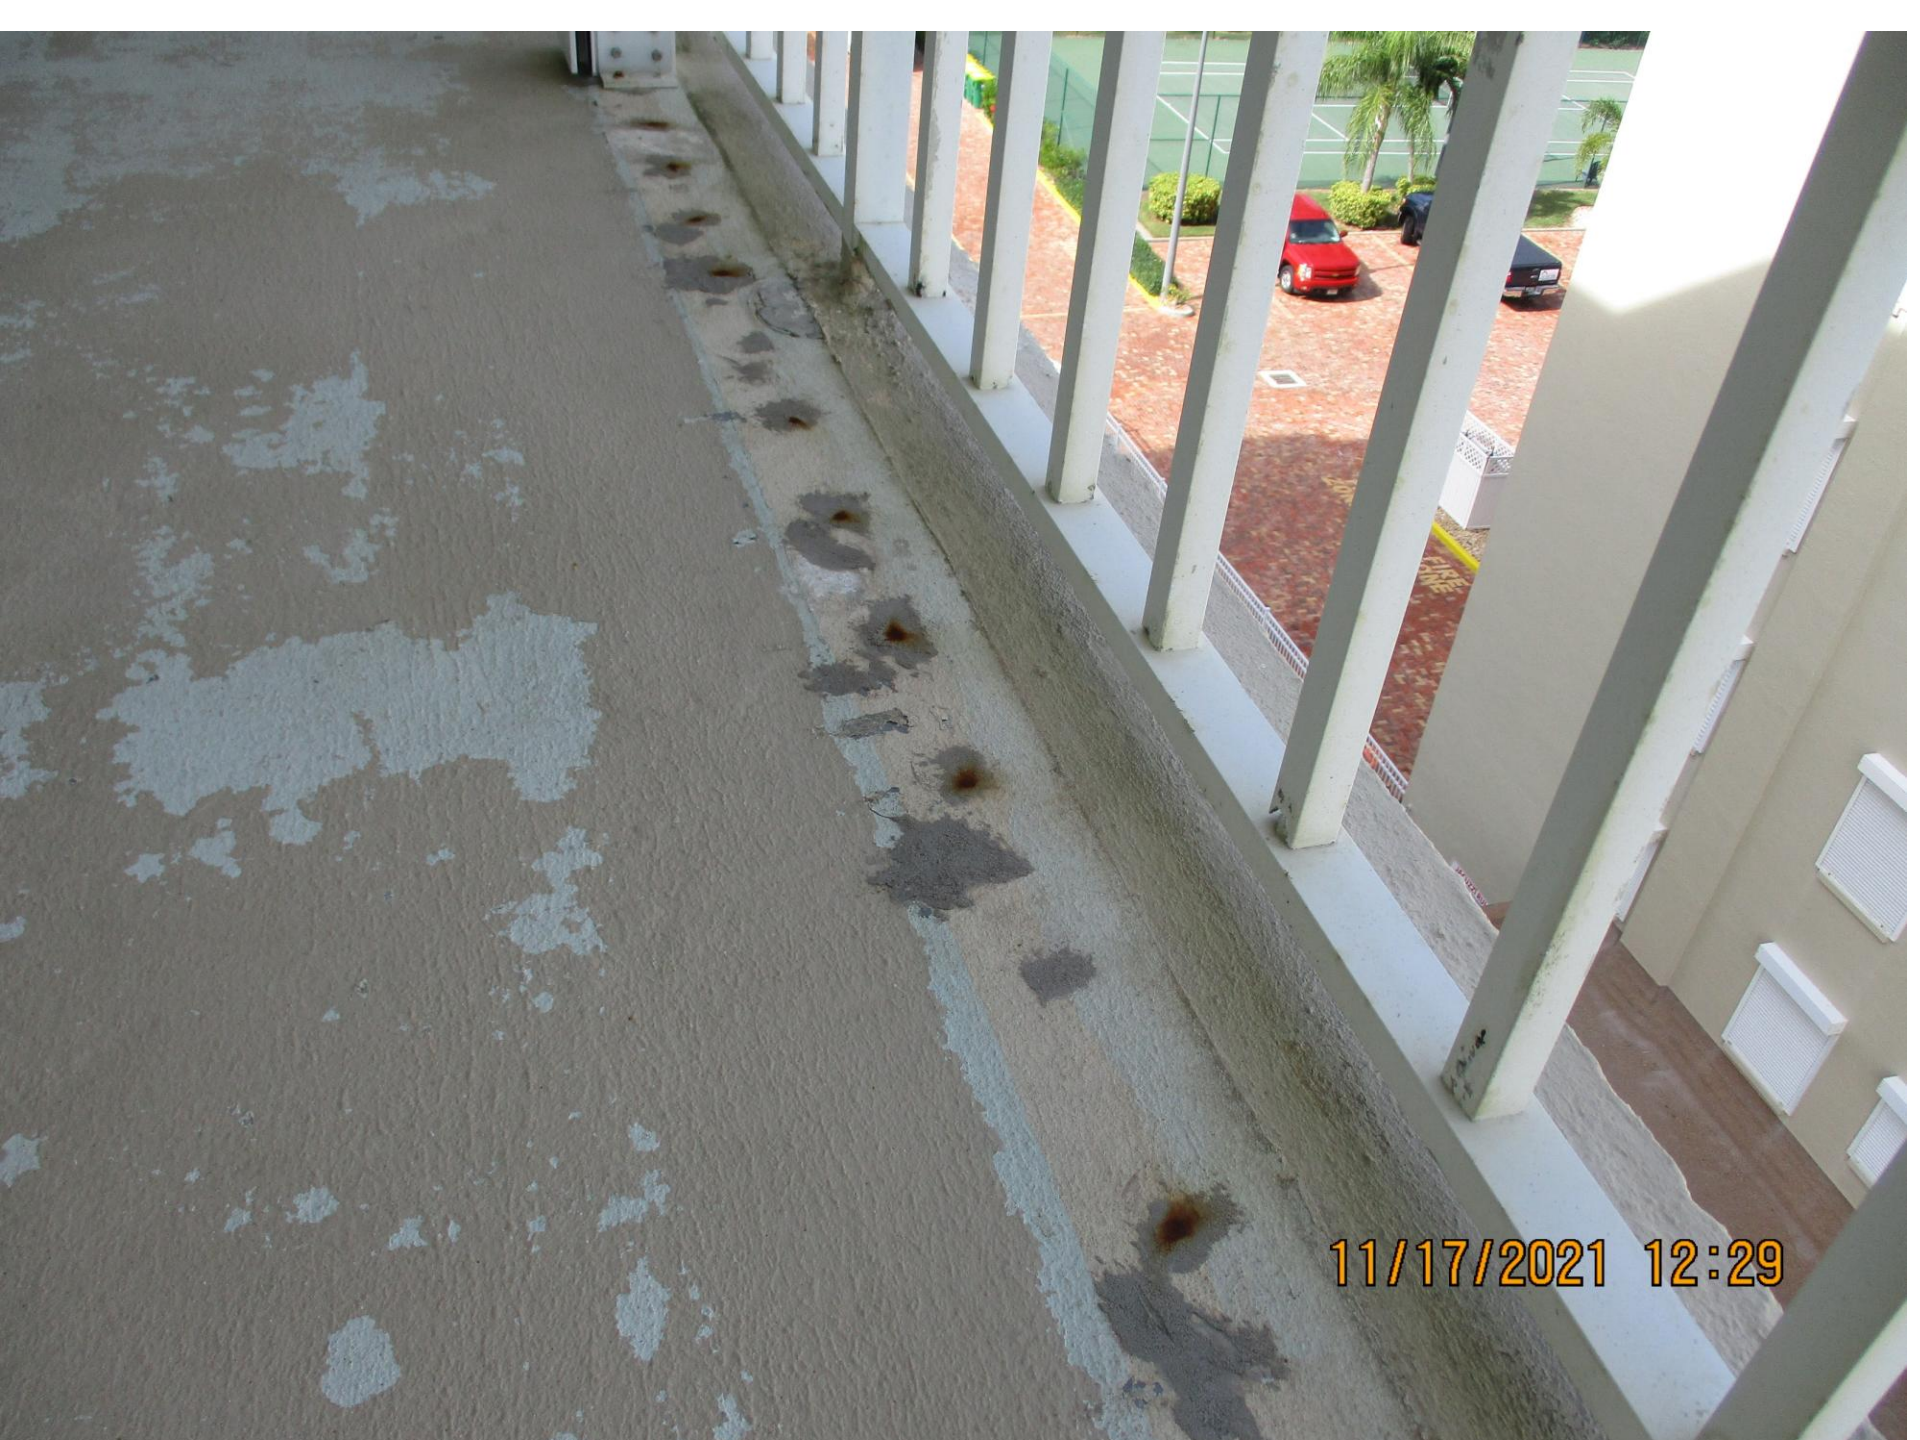
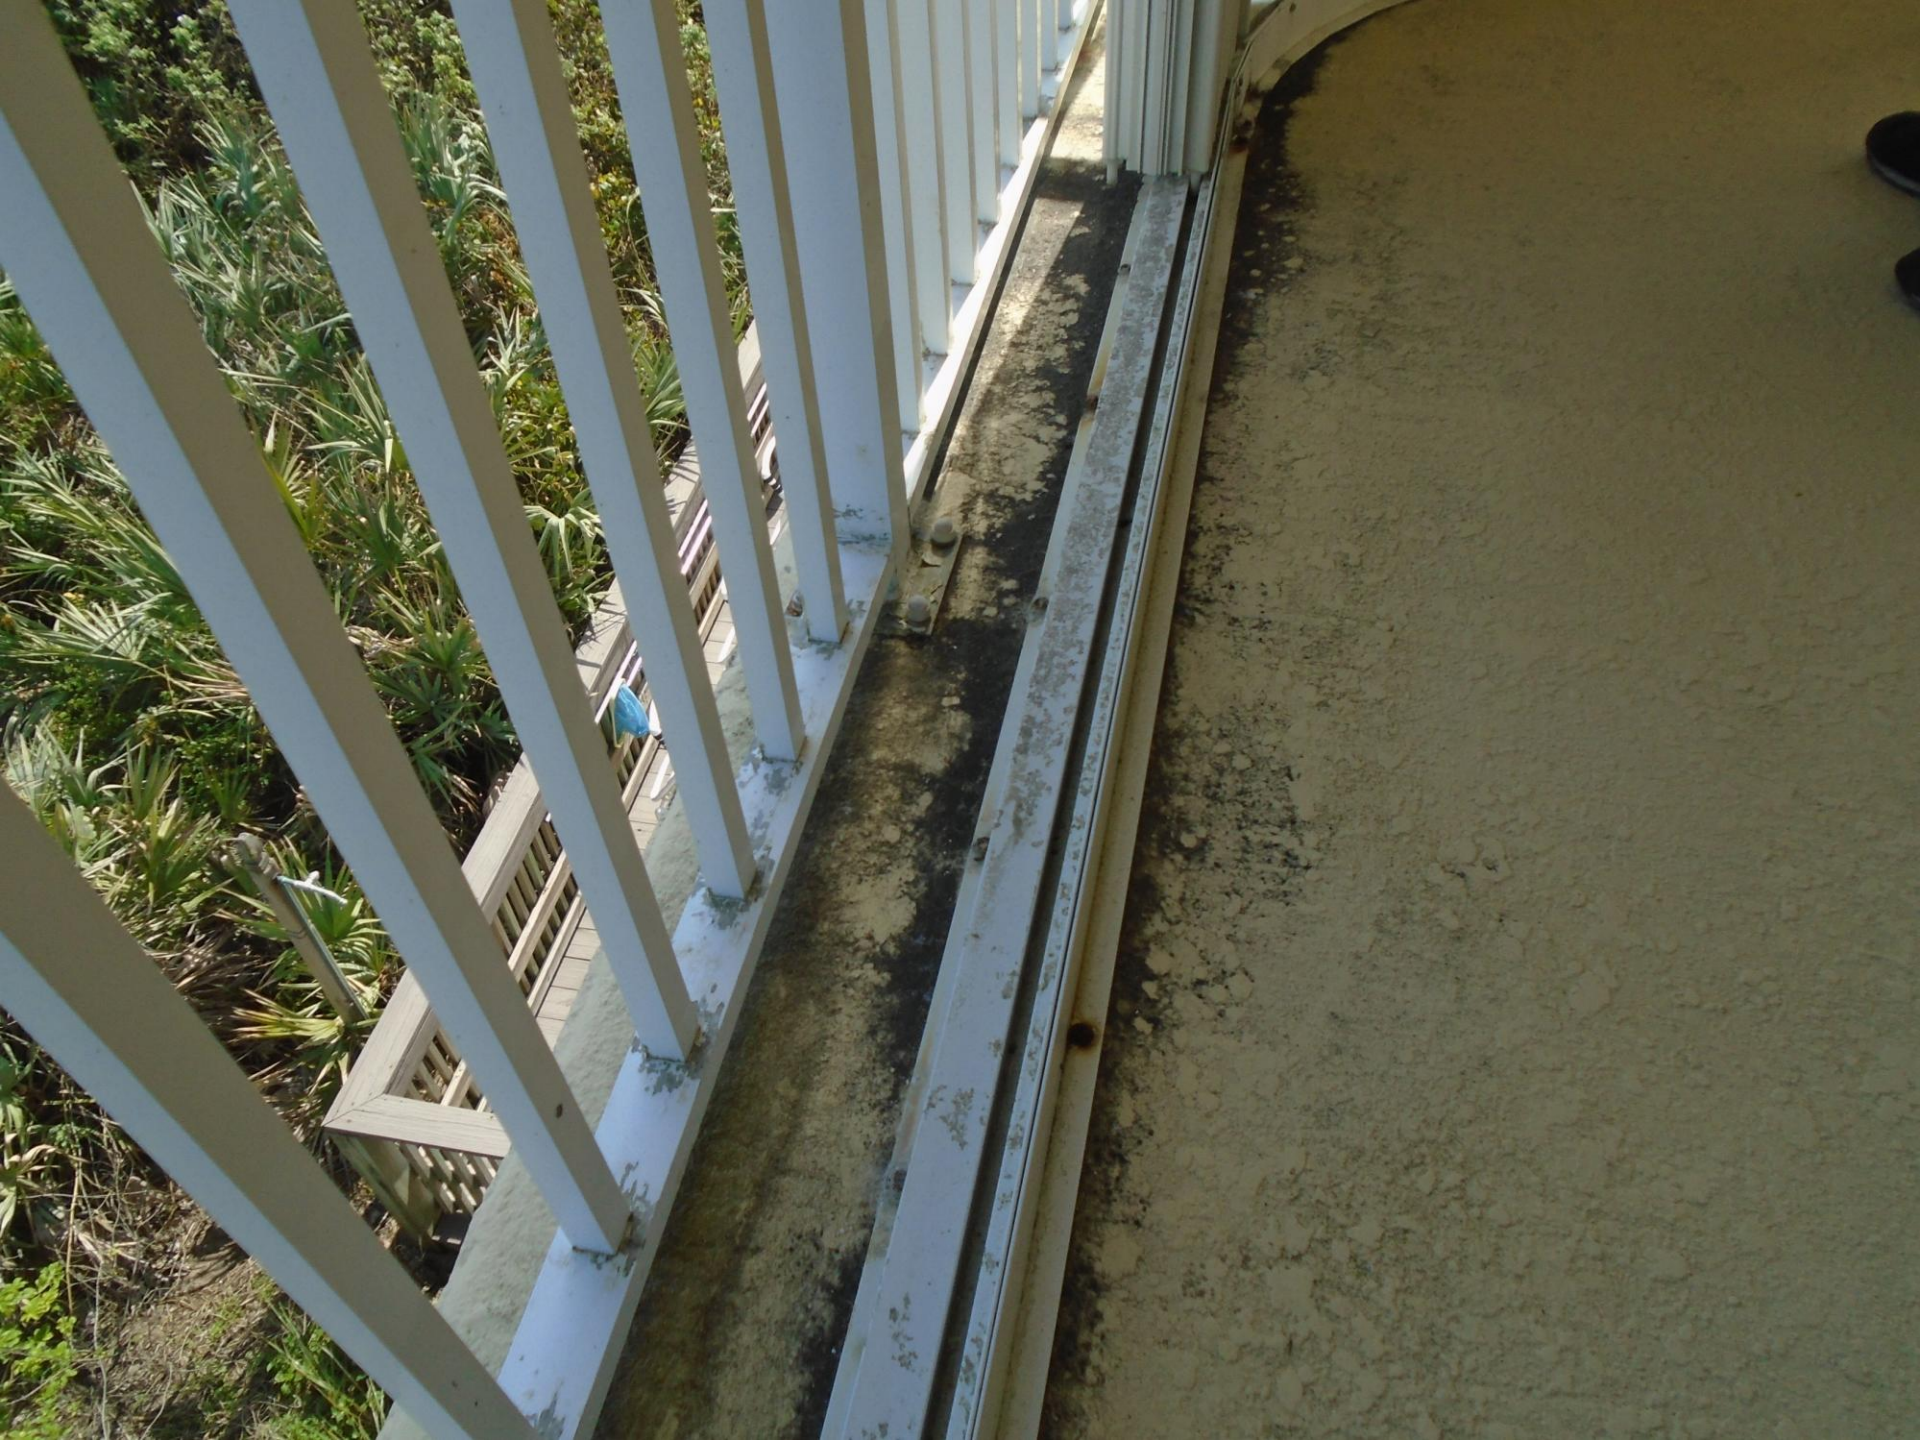
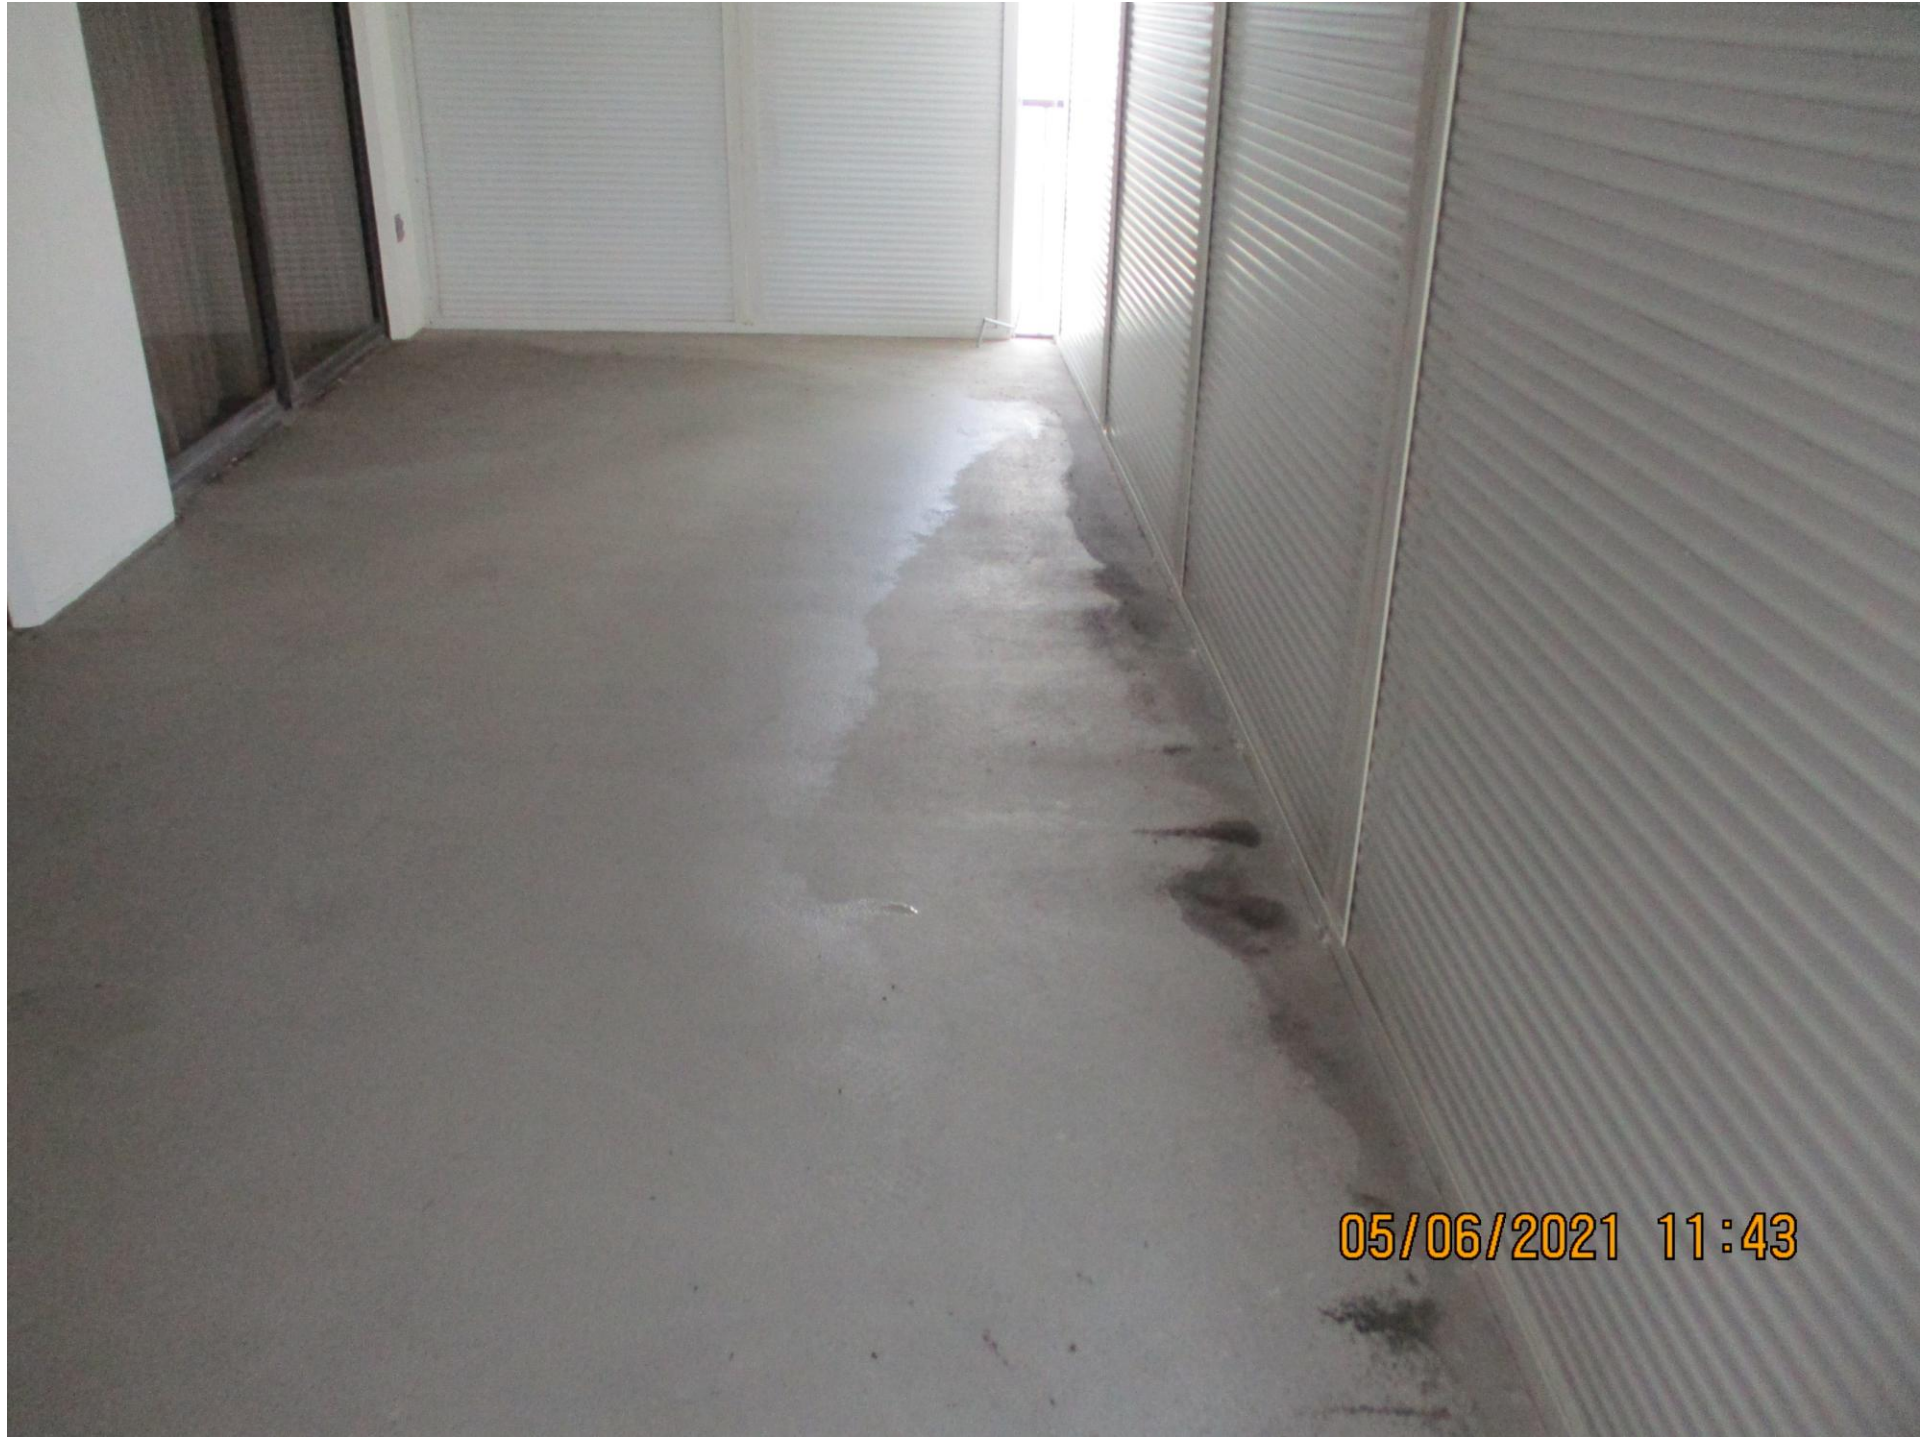
Shutter Fasteners and Drainage

- RAILINGS-CORED IN PLACE OR IMPROPER FASTENERS
- SHUTTERS-DRAINAGE AND CORRODED FASTENERS
- IMPROPER BALCONY FLOORING-TILE
- SLIDING GLASS DOORS AND WINDOWS
- SCREENED ENCLOSURES

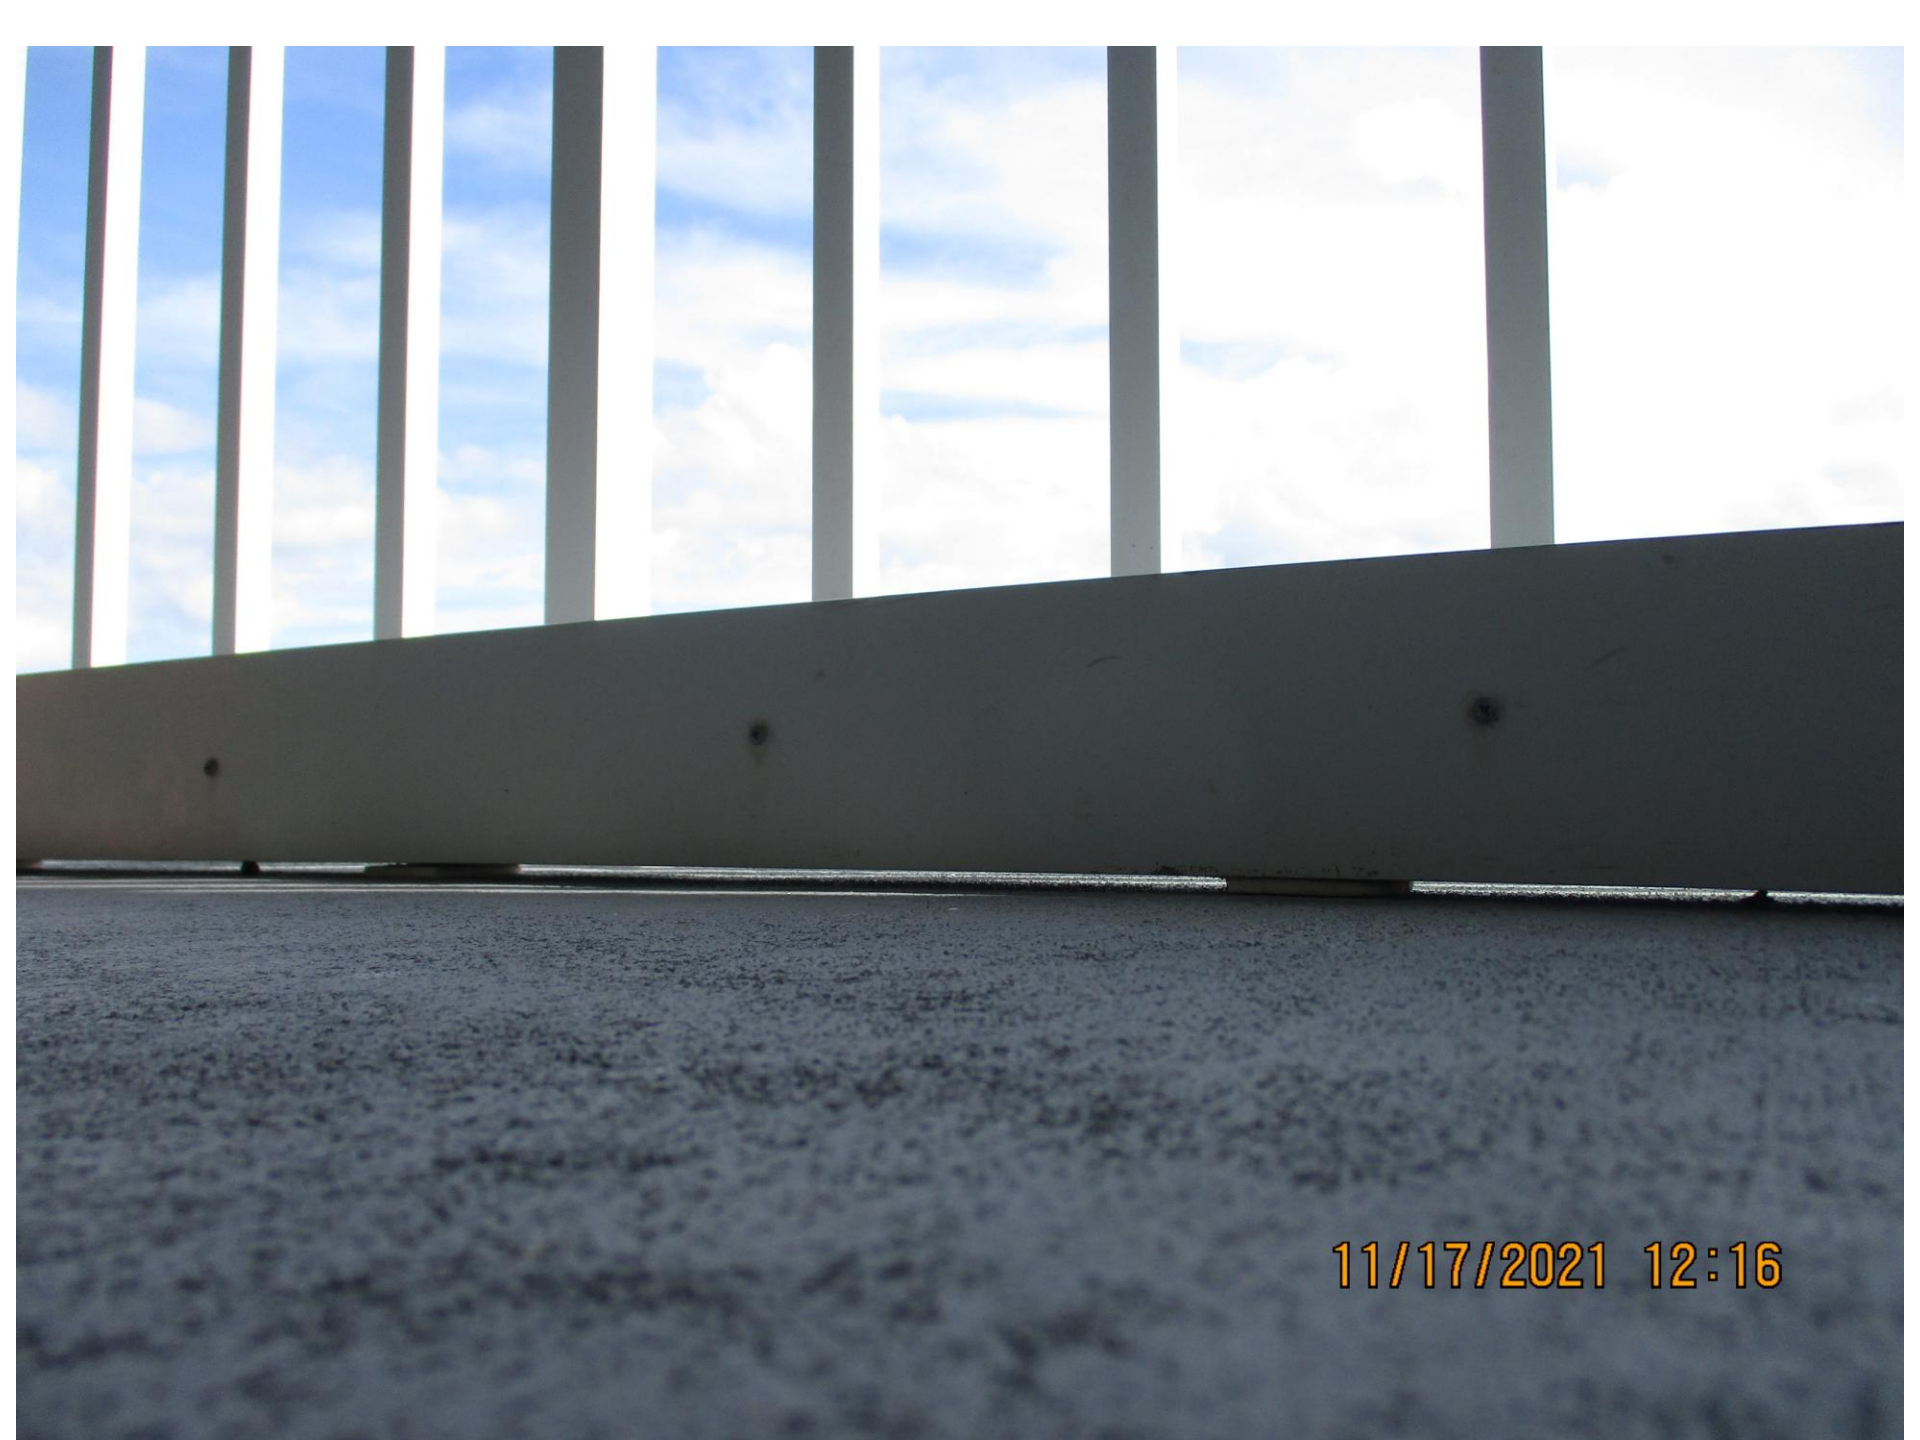
Use of Drainage Shims

A close-up photograph of a window blind's bottom edge. The blind is white and has a series of small, dark, rectangular drainage shims installed along its length. The shims are spaced evenly and appear to be made of a dark material, possibly wood or plastic. The background is a light-colored wall, and the lighting is soft, highlighting the texture of the blind and the placement of the shims.
