SCCA Meeting 11-20-2021
**“The Importance of
Proactive Structural
Condominium Maintenance”**

Keystone Engineering
Jim Emory, PE, SI, CGC

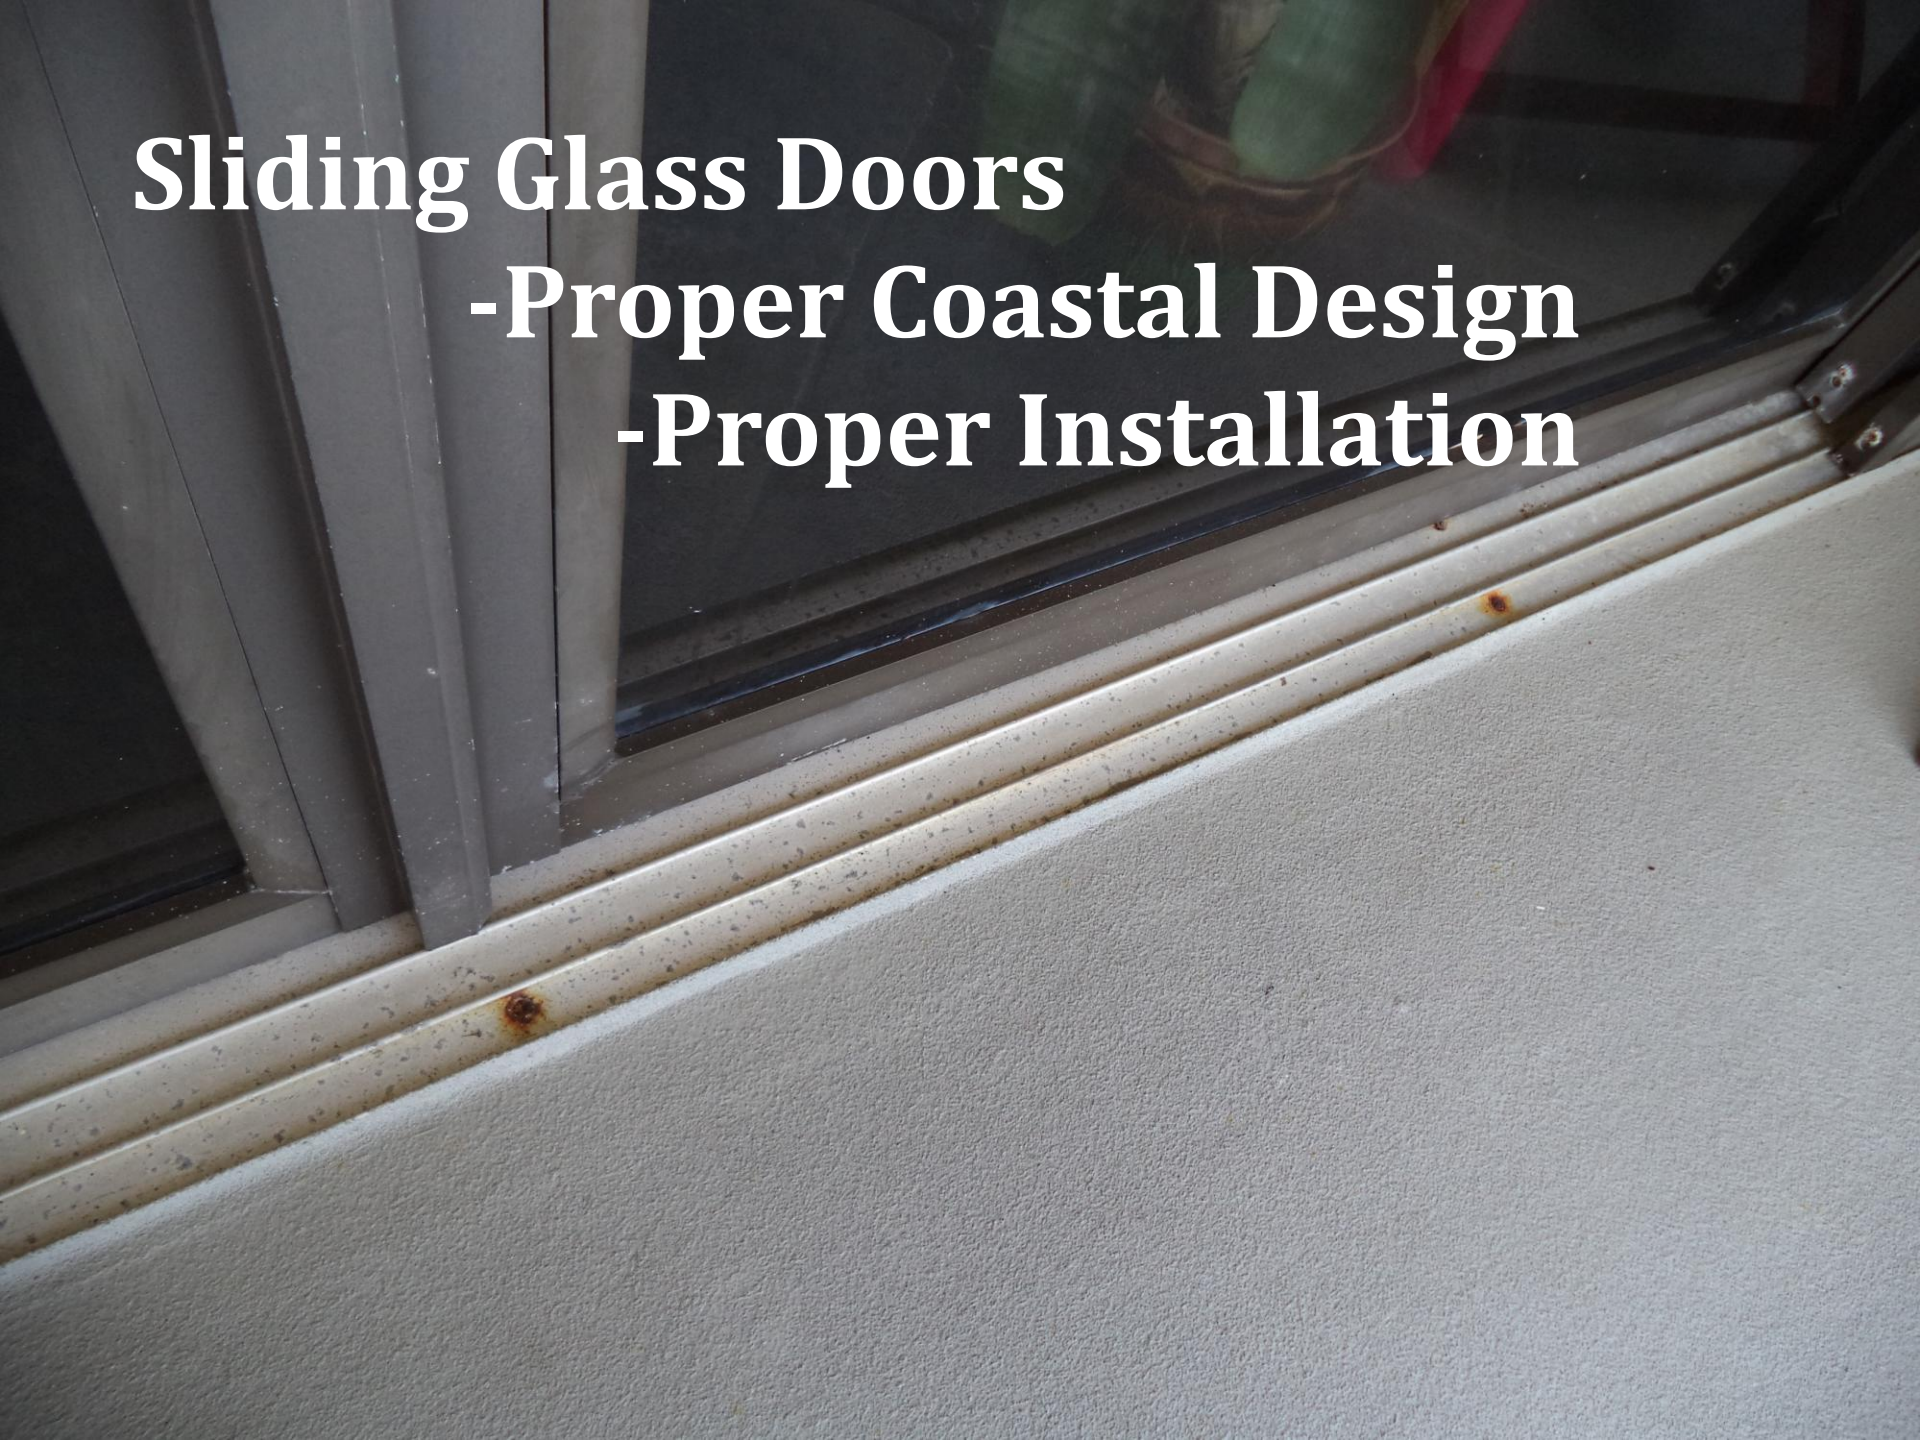
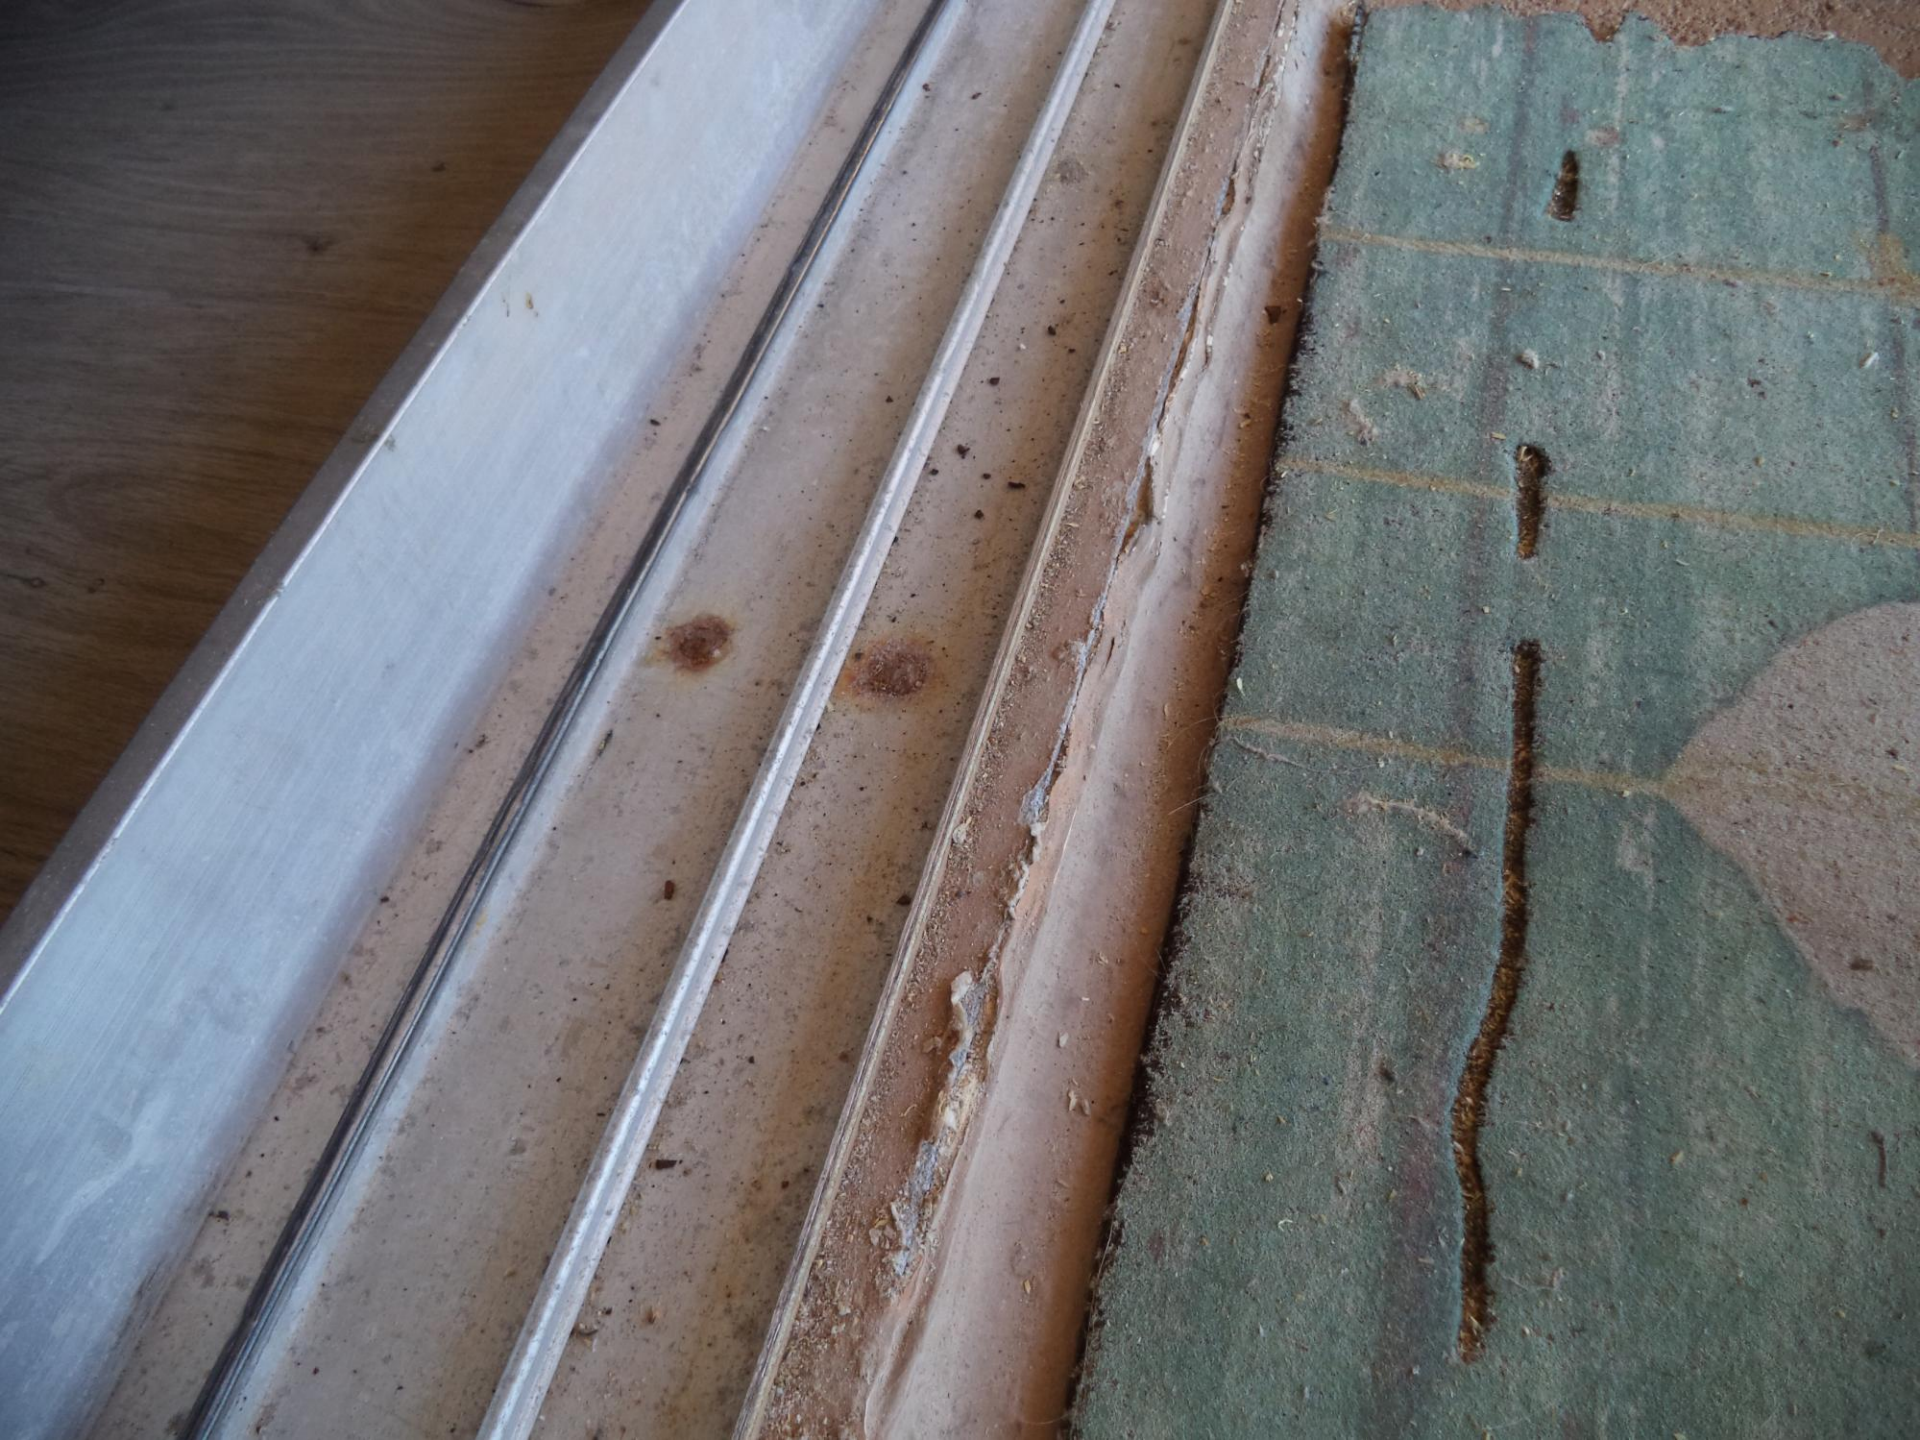
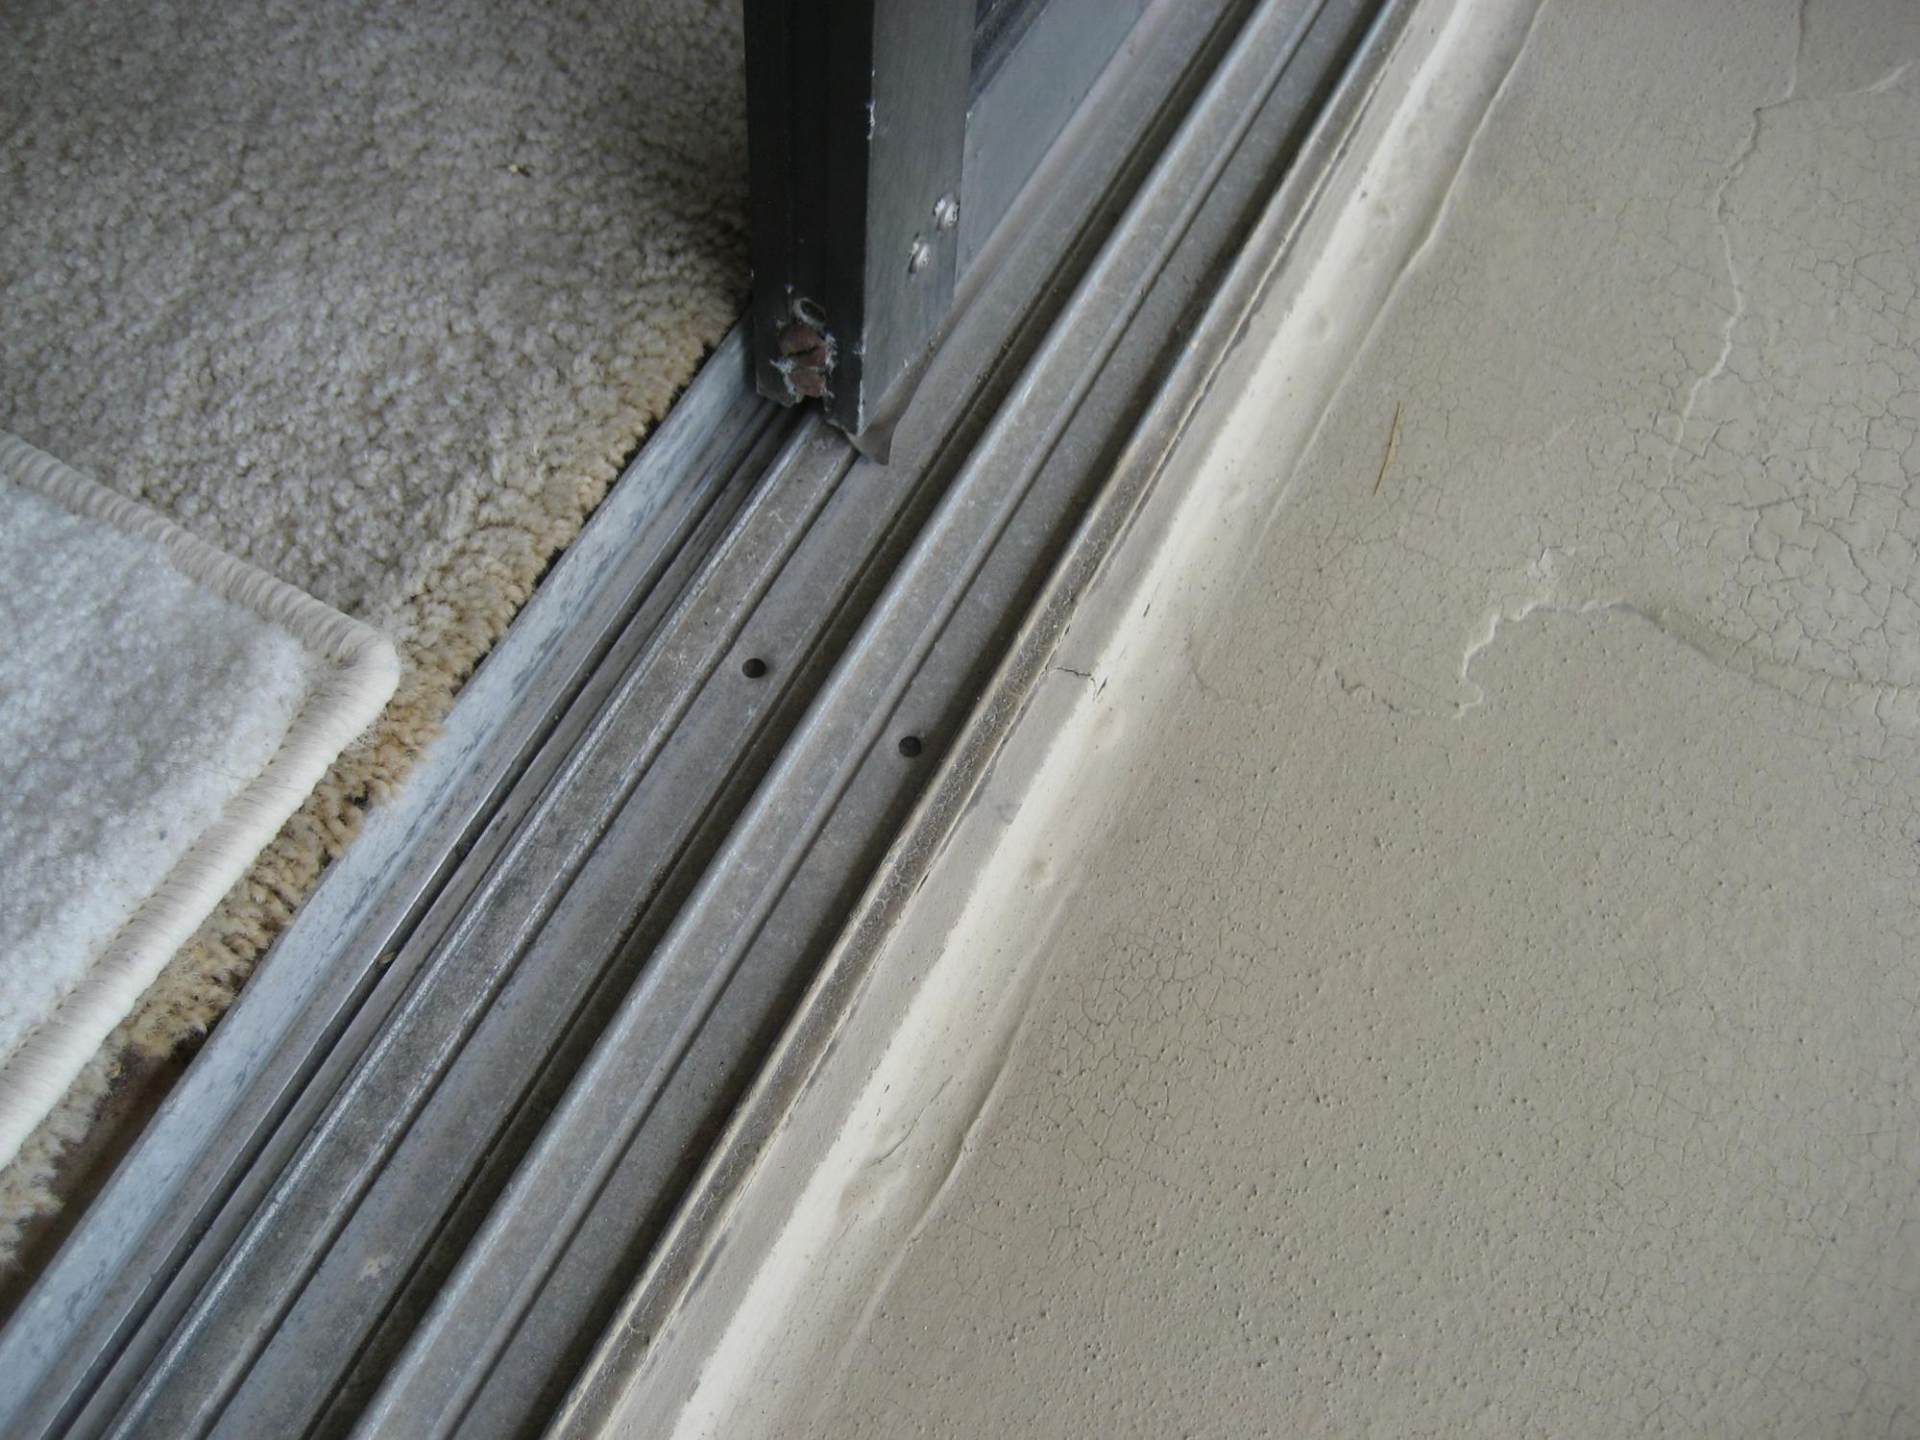
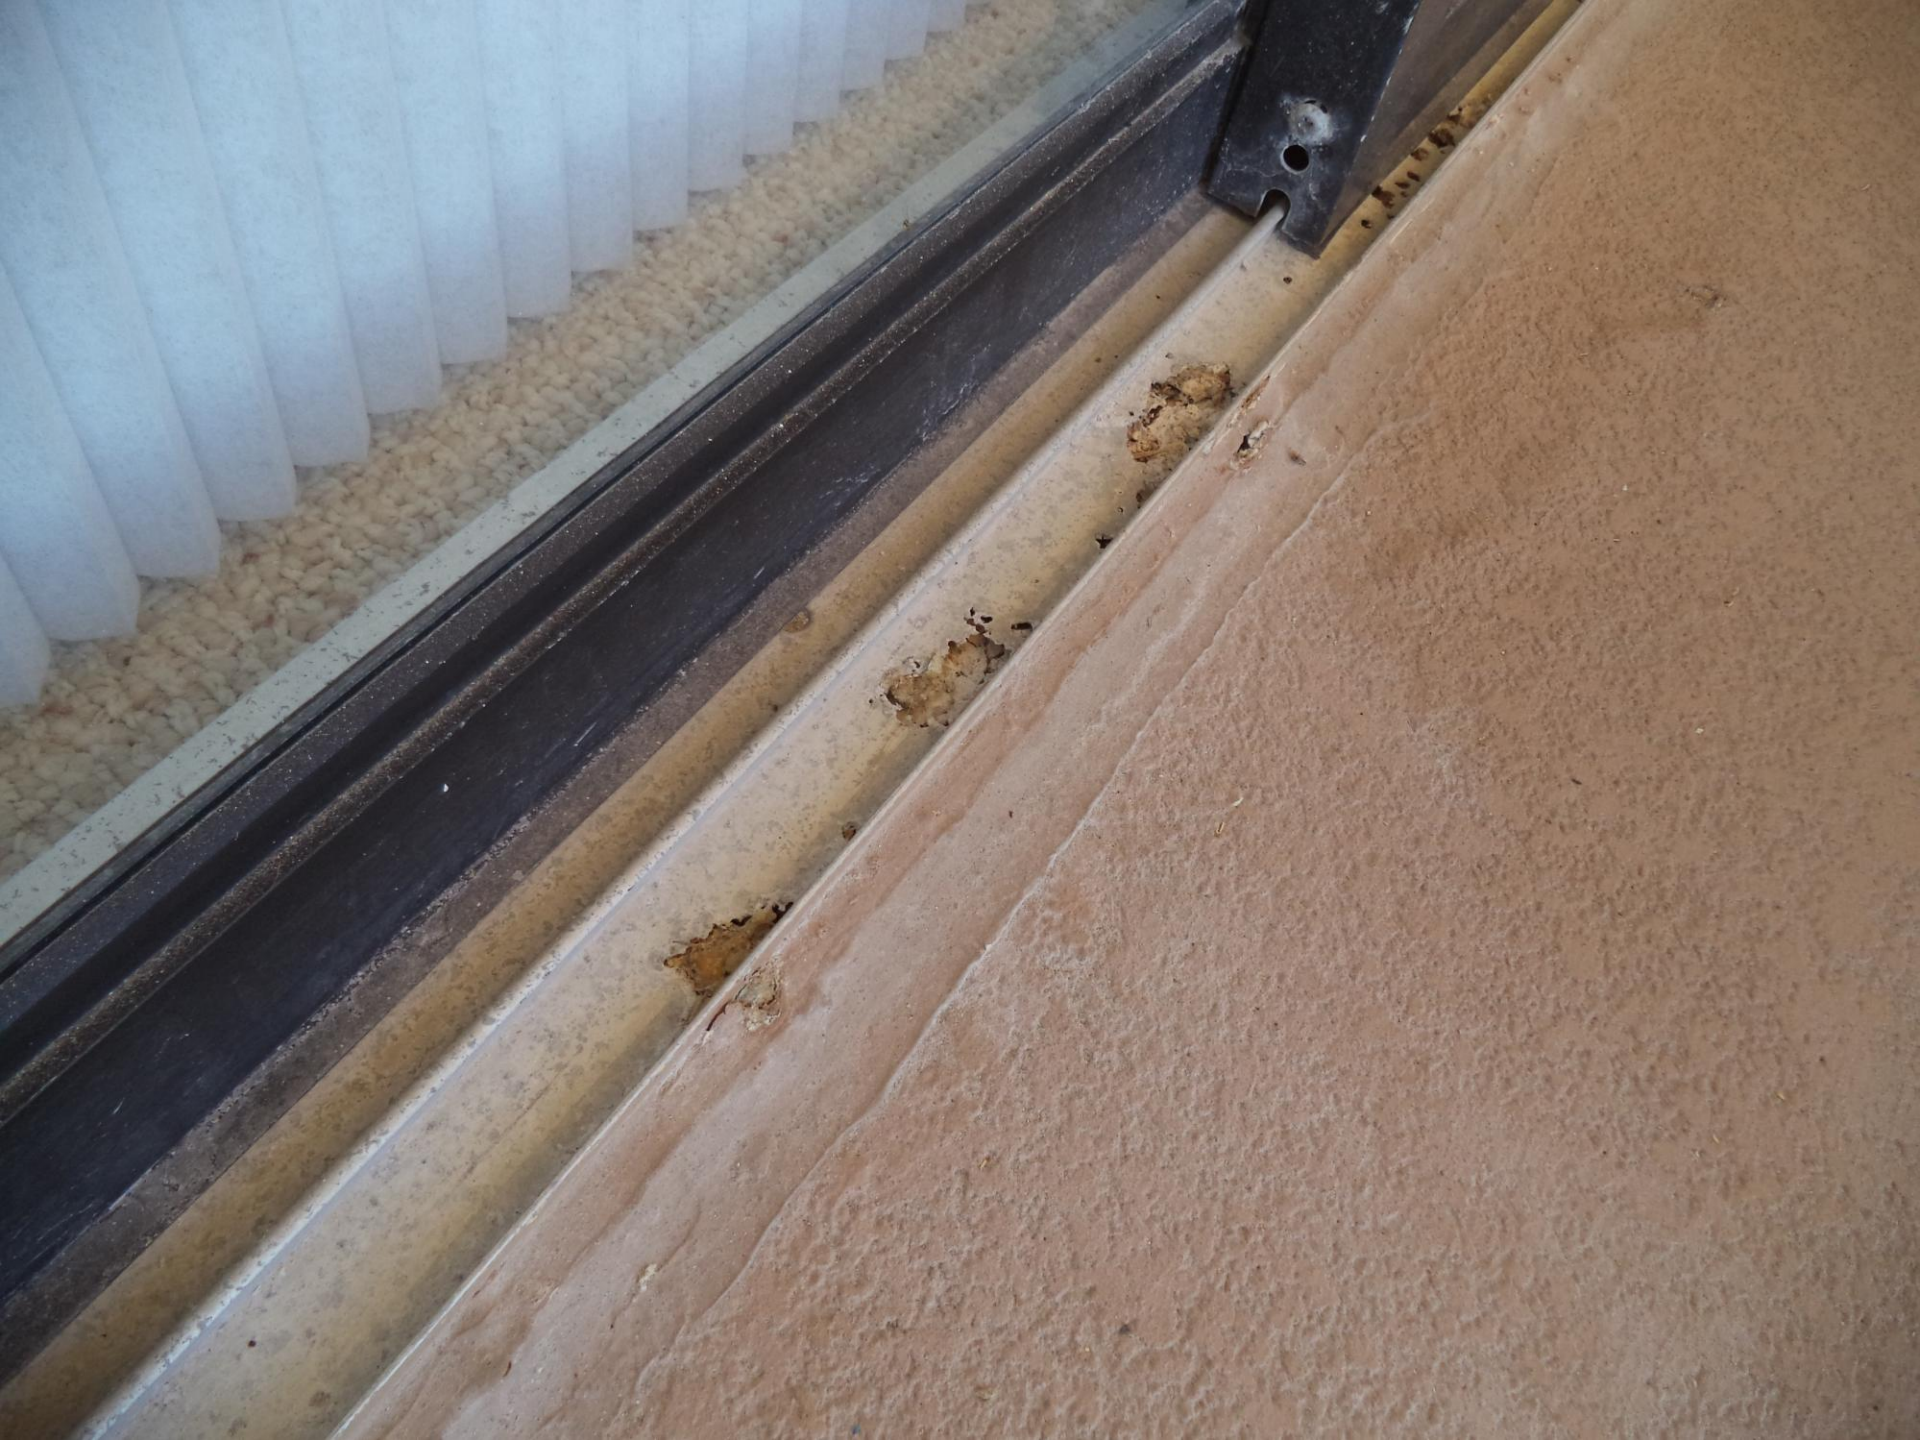
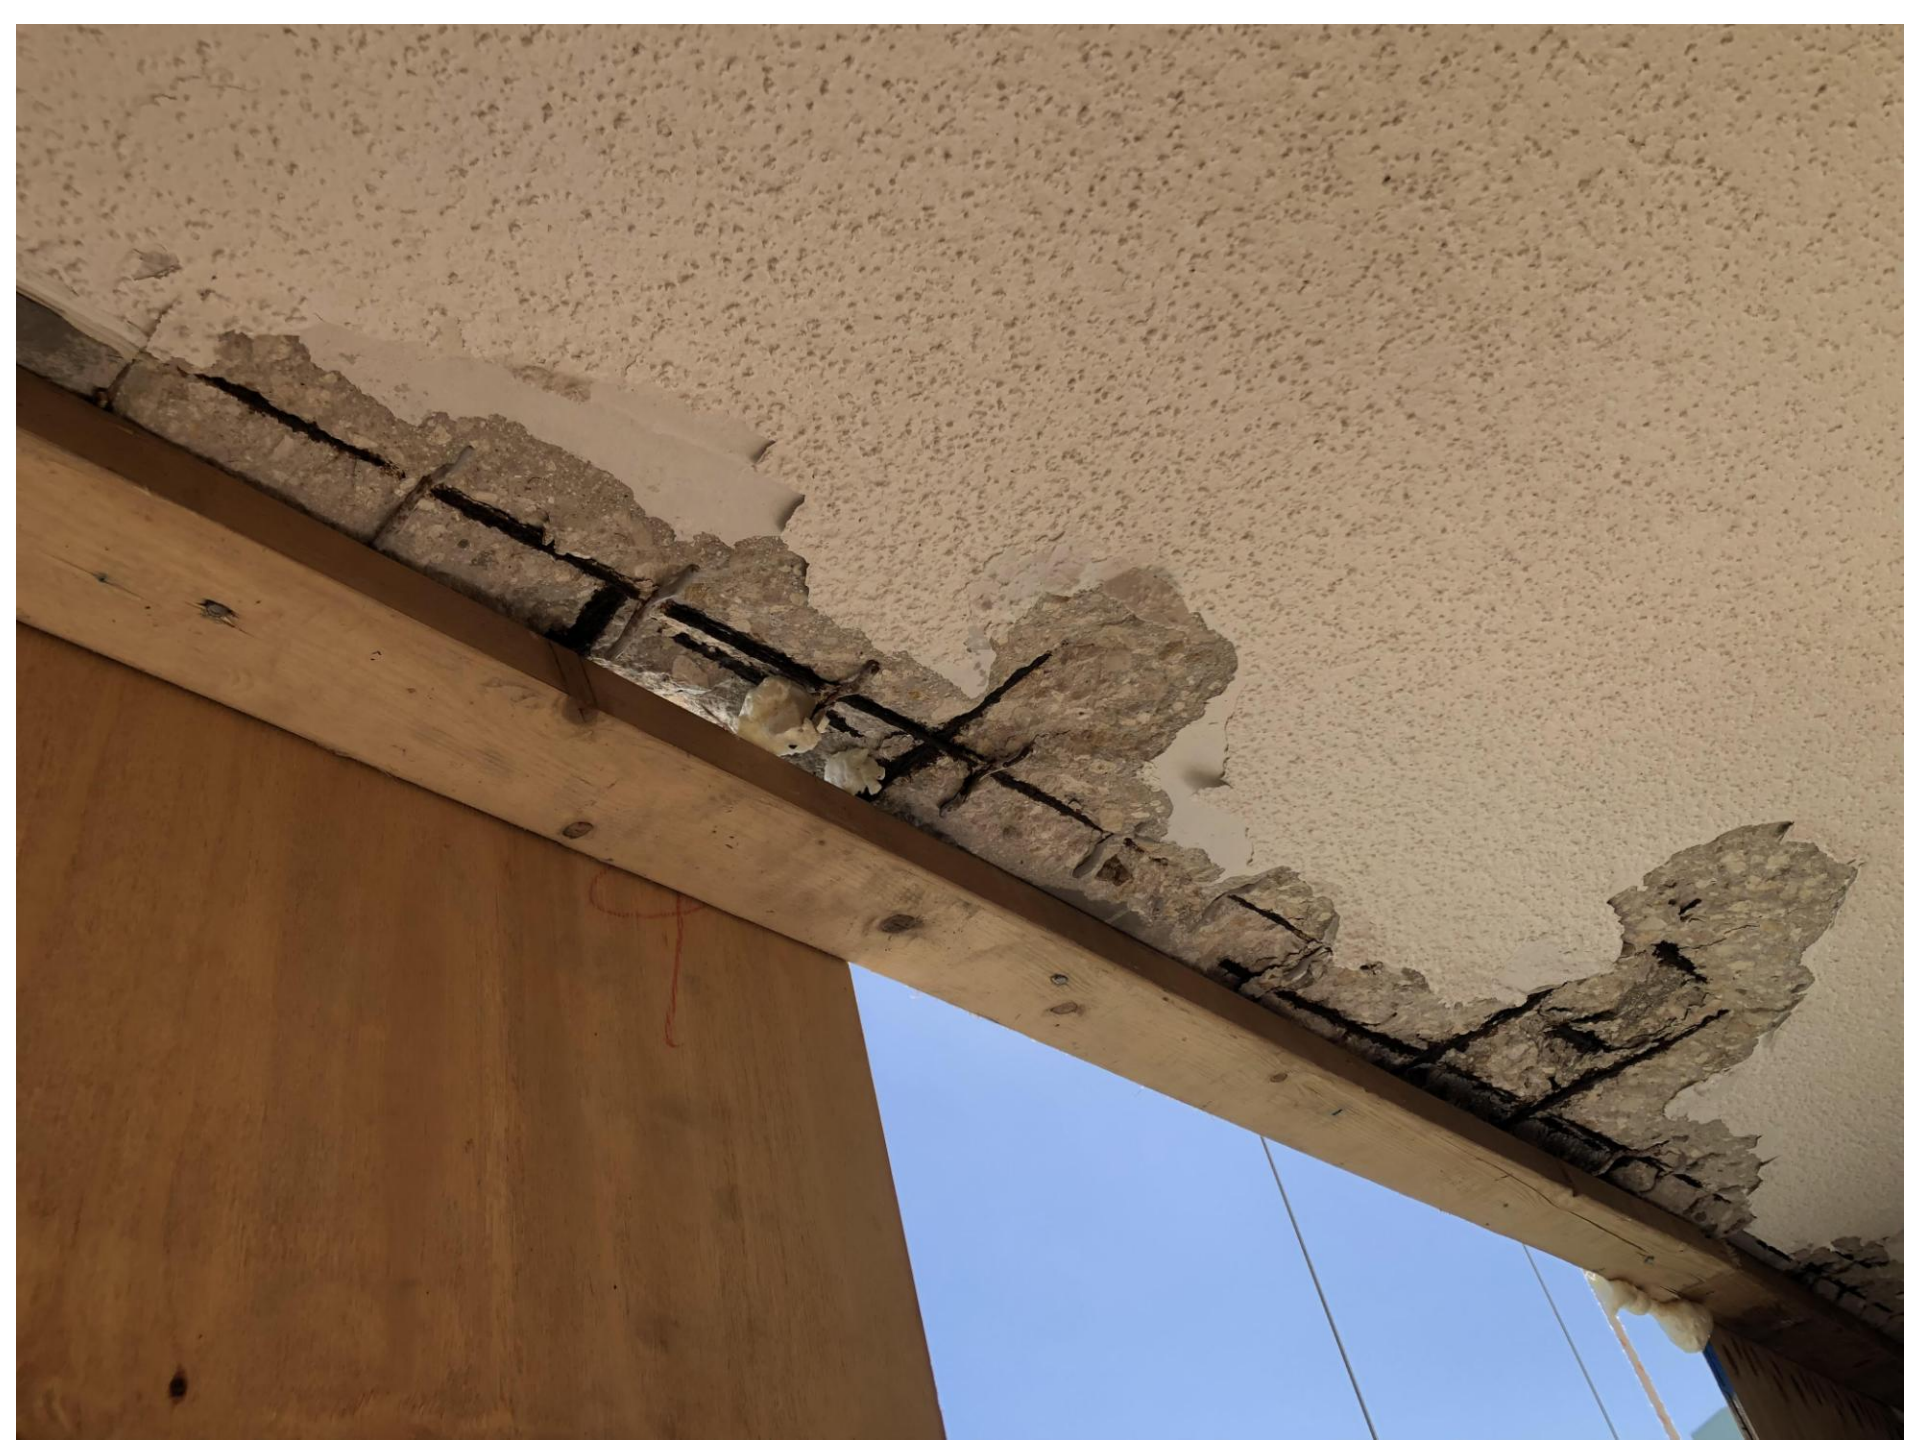
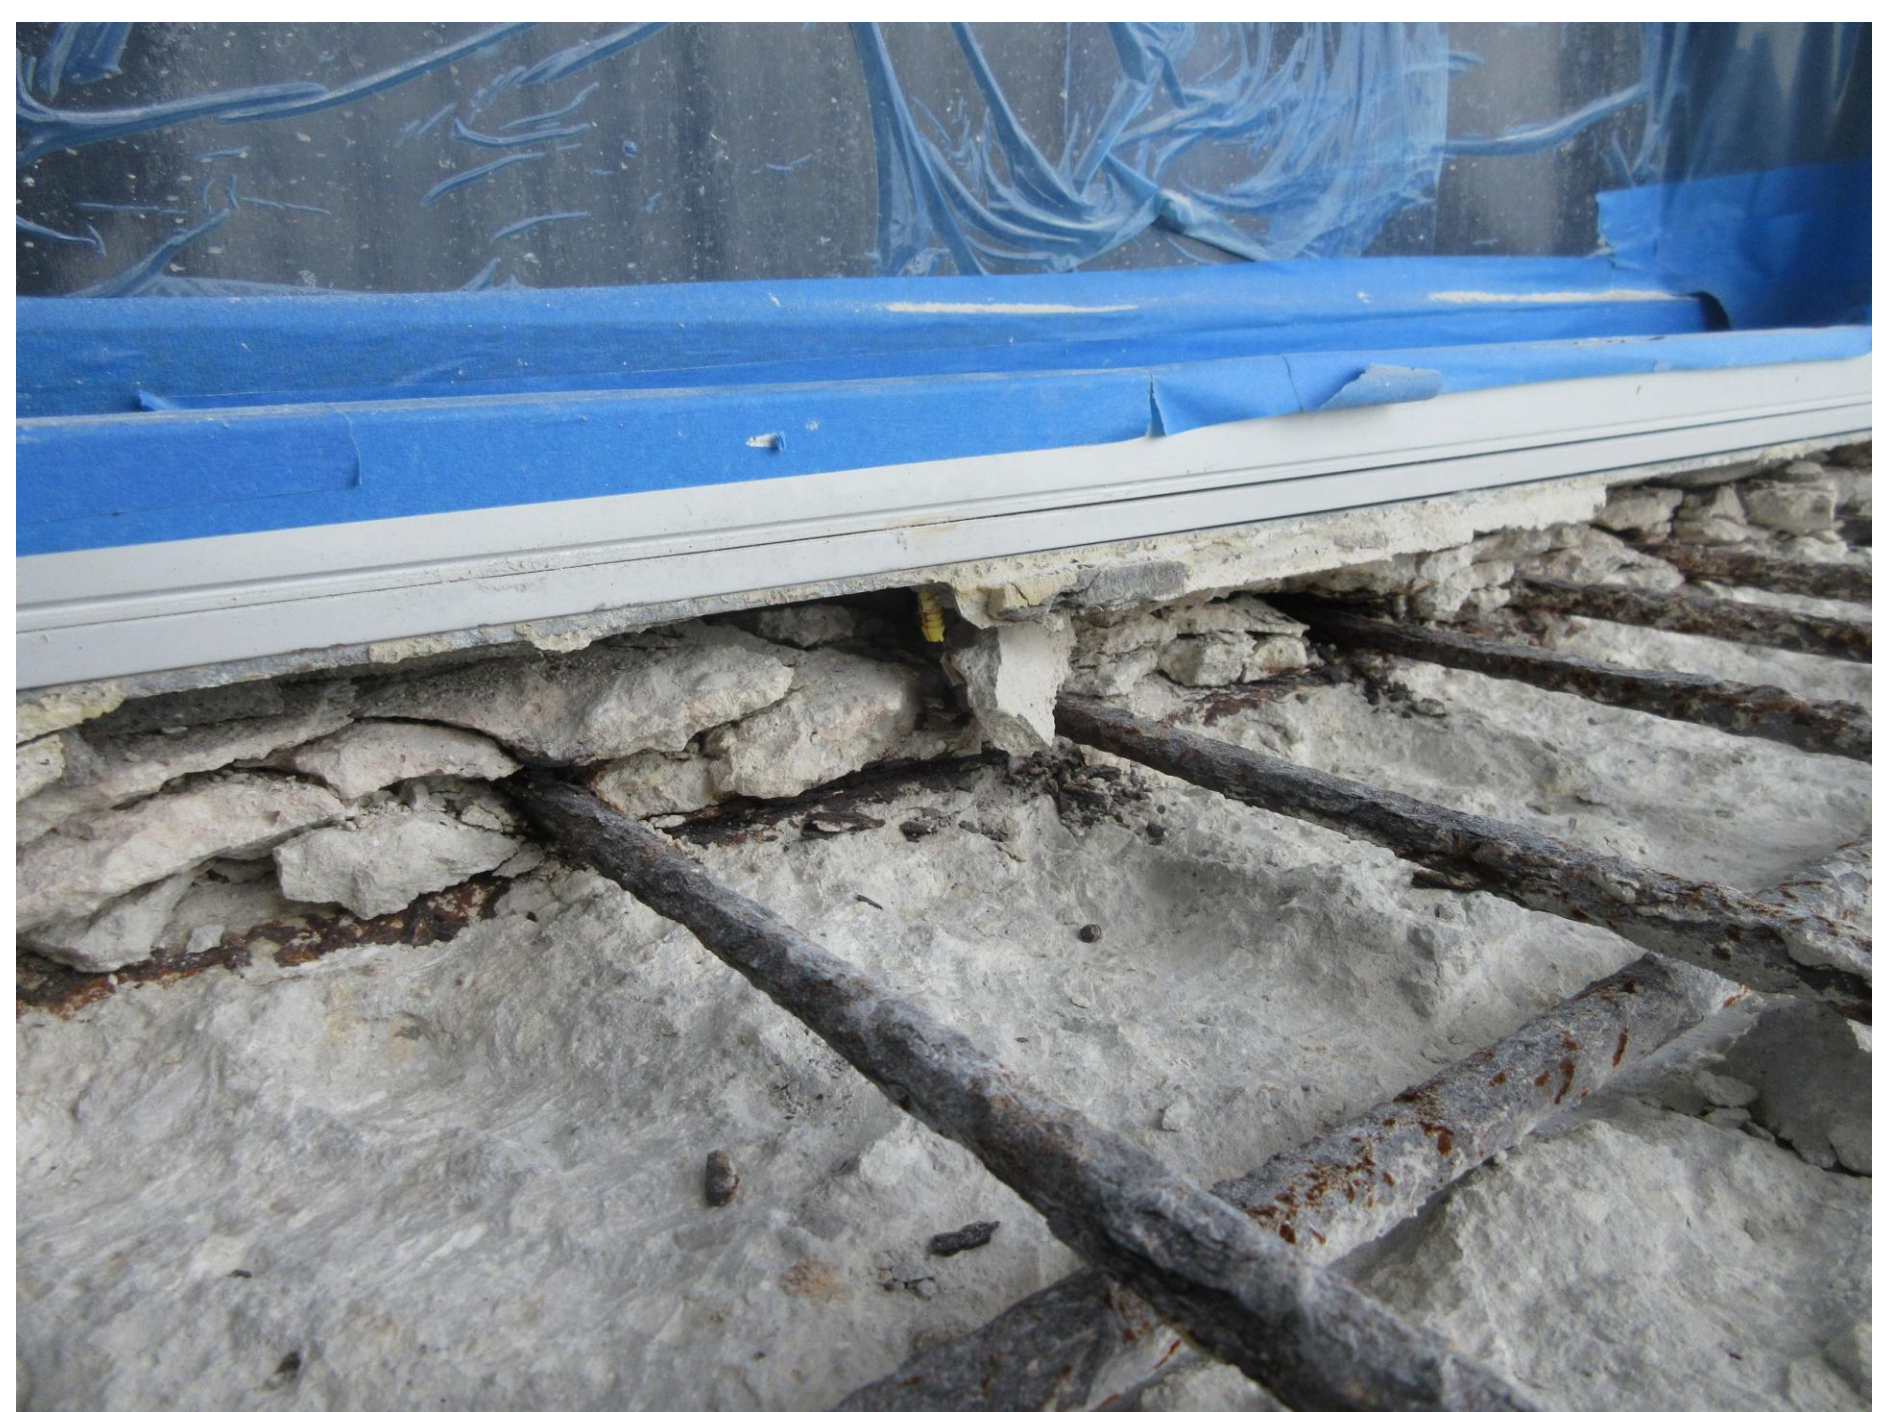
Sliding Glass Doors

-Proper Coastal Design

-Proper Installation
